APPENDIX D

SWM Pond Drawings

APPENDIX B: Existing Drainage Elements and Site Investigation Photos

Culvert/Site Inspection for Teston Road

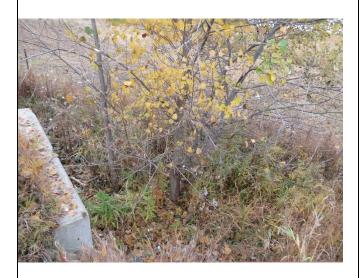
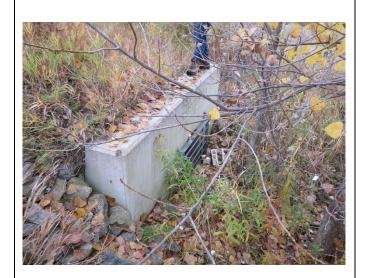
Site Photograph Photo of Culvert ED02: Upstream End

Culvert Field Investiget	ion Data Sheet (Culvert #ED02)
Date (mm/dd/yy): 10/26/2022	Field Crew: Jenny Dai, Ken Luong
Client: York Region	Highway/Road No.: Teston rd.
Culvert Crossing Type: Centreline Culvert	Blockage in Culvert: no
Culvert Material: Concrete	Culvert Condition: Good
Culvert Shape: Circular	Inlet Condition: Good
Culvert Bottom:	Outlet Condition: Good
Culvert Flow Direction: SW (Downstream)	Additional Field Notes:
Culvert Size (mm): 31.5" (800mm)	Inlet: Near inlet, two small diameter trees (< 10cm)
Depth of Water in Culvert: no water	About 10 cm of sediment at inlet
	Outlet: Outlet has plunge pool
	Overall: Field measured 800mm concrete pipe, with HW
	Good condition, not much sediment
	no water
	Recommendation:

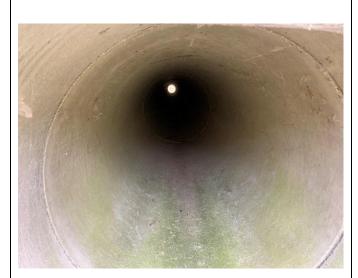
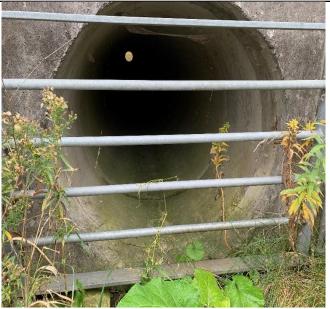
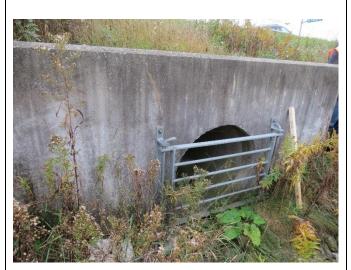
Site Photograph Photo of Culvert ED03: Upstream End

Date (mm/dd/yy): 10/26/2022	Field Crew: Jenny Dai, Ken Luong
Client: York Region	Highway/Road No.: Teston Rd.
Culvert Crossing Type: Centreline Culvert	Blockage in Culvert: no
Culvert Material: Concrete	Culvert Condition: good
Culvert Shape: Circular	Inlet Condition: good
Culvert Bottom:	Outlet Condition: good
Culvert Flow Direction: north to south	Additional Field Notes:
Culvert Size (mm): 35.4" (900mm)	Inlet: Inlet invert perched by about 200mm; headwall
epth of Water in Culvert (mm):	
	Outlet: outlet has a headwall
	Outlet to ditch and ditch ID to into STM network
	Ditch and culvert flows into STM network via DI
	Recommendation:

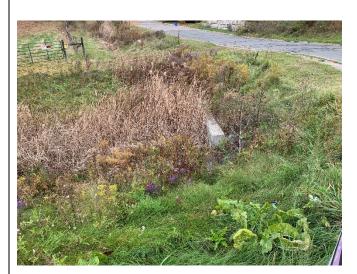
Site Photograph Photo of Culvert ED04: Upstream End

Date (mm/dd/yy): 10/26/2022	tion Data Sheet (Culvert #ED04) Field Crew: Jenny Dai, Ken Luong
Client: York Region	Highway/Road No.: Teston rd.
Culvert Crossing Type: Centreline Culvert	Blockage in Culvert: no
Culvert Material: Concrete	Culvert Condition: good
Culvert Shape: Box	Inlet Condition: good
Culvert Bottom: Open footing	Outlet Condition: good
Culvert Flow Direction: North to South	Additional Field Notes:
Culvert Size (mm): 23.6" * 70.9" (6000mm*1800mm)	
Depth of Water in Culvert (mm.)	Inlet: Field measured opening= 1500mm under slab to top of sediment
Depth of Water in Galvert (min)	Seament
	Outlet: Field measured opening= 1400mm under slab to top of
	sediment
	Overall: measured outside span = 732cm
	wall thickness = 40cm
	approximate inside span = 650cm
	Skew to roadway alignment
	Recommendation:

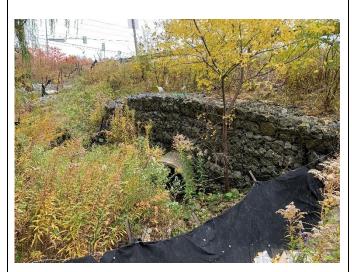
Site Photograph Photo of Culvert 4: Upstream End and WBL Ditch

Date (mm/dd/yy): 10/26/2022	Field Crew: Jenny Dai, Ken Luong
Client: York Region	Highway/Road No.: Teston Rd.
Culvert Crossing Type: Centreline Culvert	Blockage in Culvert: no
Culvert Material: Concrete (Upstream End) with gabion	Culvert Condition: good
Culvert Shape: Circular	Inlet Condition: good
Culvert Bottom:	Outlet Condition: N/A
Culvert Flow Direction: north to south	Additional Field Notes:
Culvert Size (mm): 55" (1050mm)	Inlet:
Depth of Water in Culvert (mm): 0.78" (20mm)	
	Field measured 1000mm concrete pipe embedded with stone substrate 2cm of water Outlet: Cannot see through to another end, suspect pipe is connected to STM sewer downstream
	Recommendation:

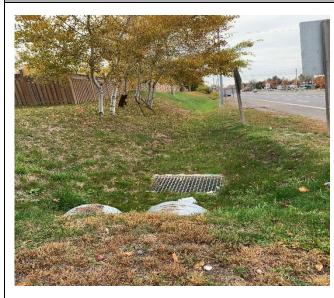
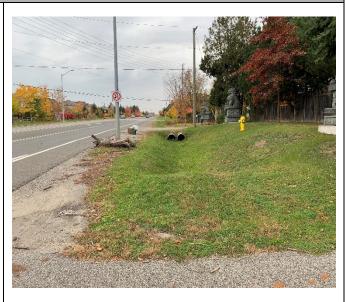
Site Photograph Photo of Outlet Sewer #9:

Field Investigation Data Sheet (Outlet Sewer #9)	
Date (mm/dd/yy): 10/26/2022	Field Crew: Jenny Dai, Ken Luong
	Highway/Road No.: Teston Rd.
	Additional Field Notes:
Client: York Region	Twin CSP above outlet 9 (800mm * 12.06mm and 800mm *
	12.01mm)

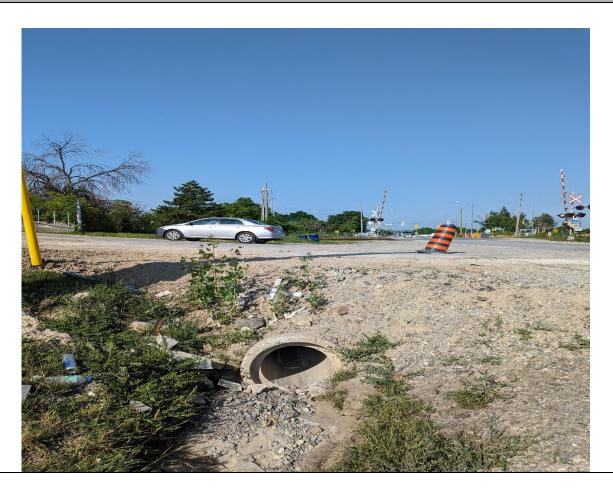
Site Photograph Photo of Culvert "Rail South"

gation Data Sheet (Culvert "Rail South")
Date (mm/dd/yy): 07/11/2023	Field Crew: Ken Luong
Client: York Region	Highway/Road No.: Railway
Culvert Crossing Type:	Blockage in Culvert:
Culvert Material: concrete	Culvert Condition:
Culvert Shape: circular	Inlet Condition: good
Culvert Bottom:	Outlet Condition: buried
Culvert Flow Direction: East to West	Additional Field Notes:
Culvert Size (mm): 450	
Depth of Water in Culvert (mm <i>):</i>	Overall: Culvert crosses entrance roadway and railway
	Recommendation:

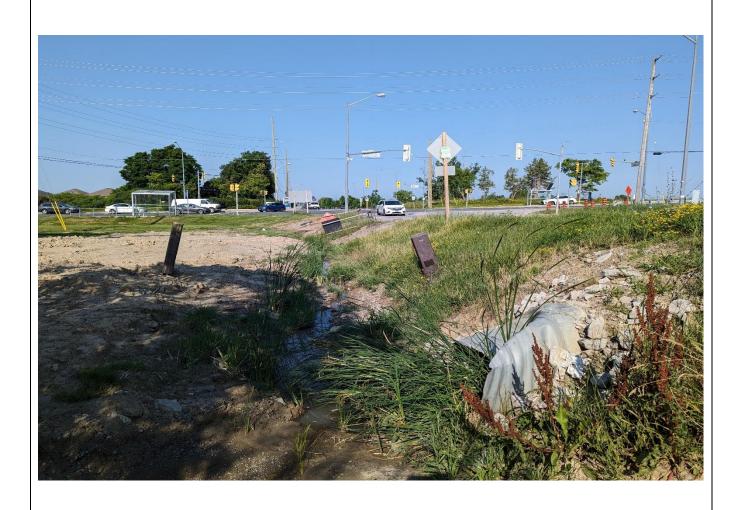
Site Photograph Photo of Culvert WD7

Culvert Field Investigation Data Sheet (Culvert #WD7)	
Date (mm/dd/yy): 10/26/2022	Field Crew: Jenny Dai, Ken Luong
Client: York Region	Highway/Road No.: Teston Rd.
Culvert Crossing Type: Centreline Culvert	Blockage in Culvert:
Culvert Material: CSP - Corrugated Steel Pipe	Culvert Condition: good
Culvert Shape: Circular	Inlet Condition: good
Culvert Bottom:	Outlet Condition: collapsed
Culvert Flow Direction:	Additional Field Notes:
Culvert Size (mm): 53.1" (1350mm)	
Depth of Water in Culvert (mm):	Overall:
	Field measured 1350mm CSP (u/s) - About 5cm of flowing water There is low lying area draining towards the culvert. But construction at time of visit obstructed actual ditch grades. Recommendation:
