Cultural Heritage Report: Existing Conditions

Warden Avenue and Kennedy Road Municipal Class Environmental Assessment

City of Markham Regional Municipality of York, Ontario

Draft Report

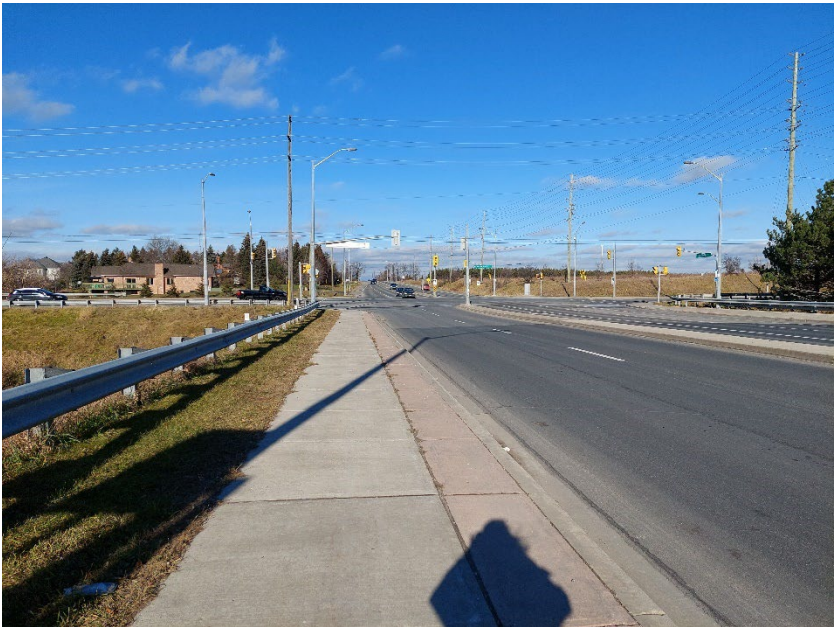
Plate 1: Warden Avenue, looking north to the intersection of Warden Avenue and Major Mackenzie Drive. With concrete curbs and sidewalks along the roadway.

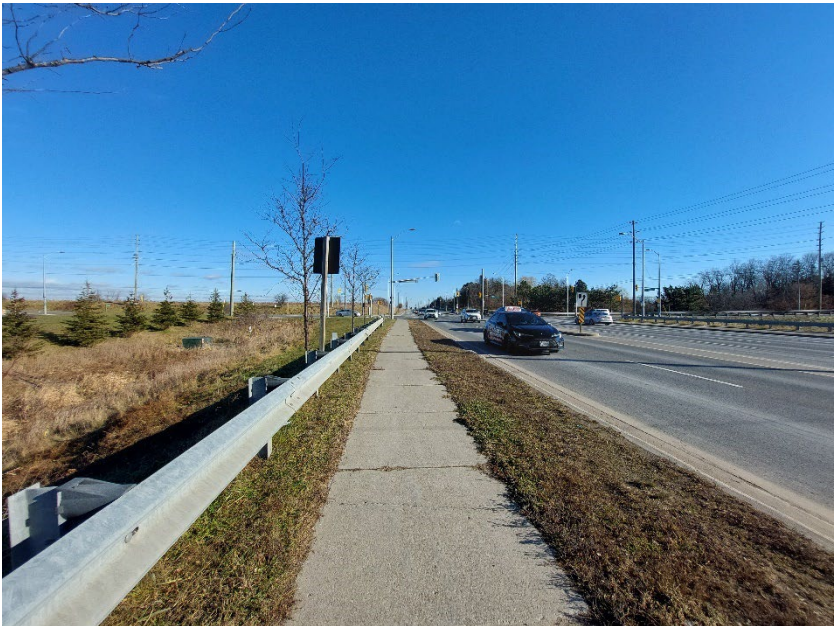
Plate 2: Major Mackenzie Drive, looking east towards Warden Avenue.

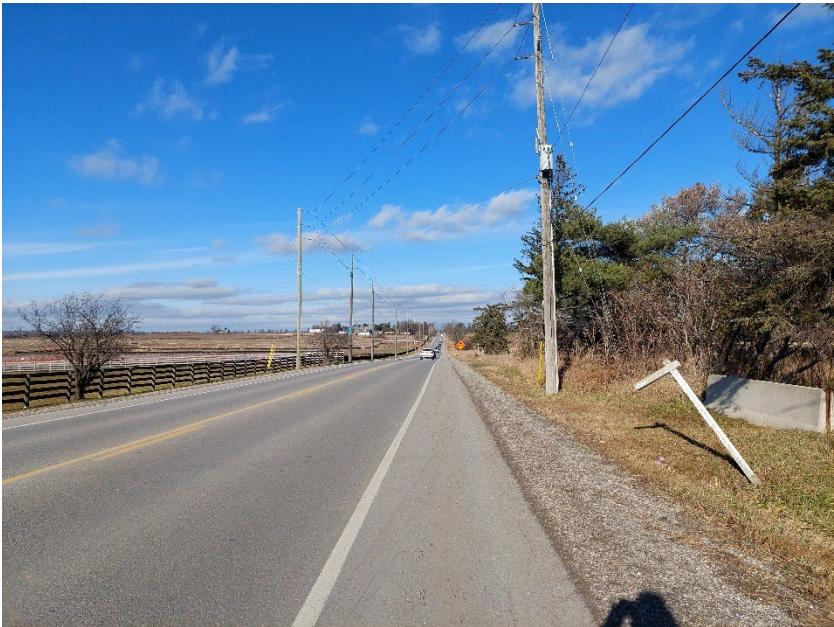
Plate 3: View north along Warden Avenue. The roadway now lacks curbs and sidewalks.

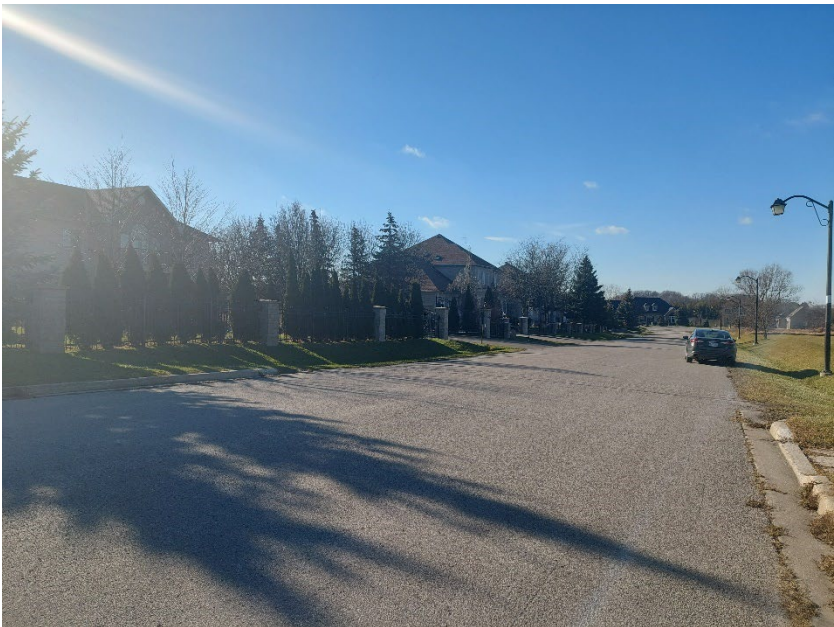
Plate 4: View of Heritage Hill Drive, looking west.

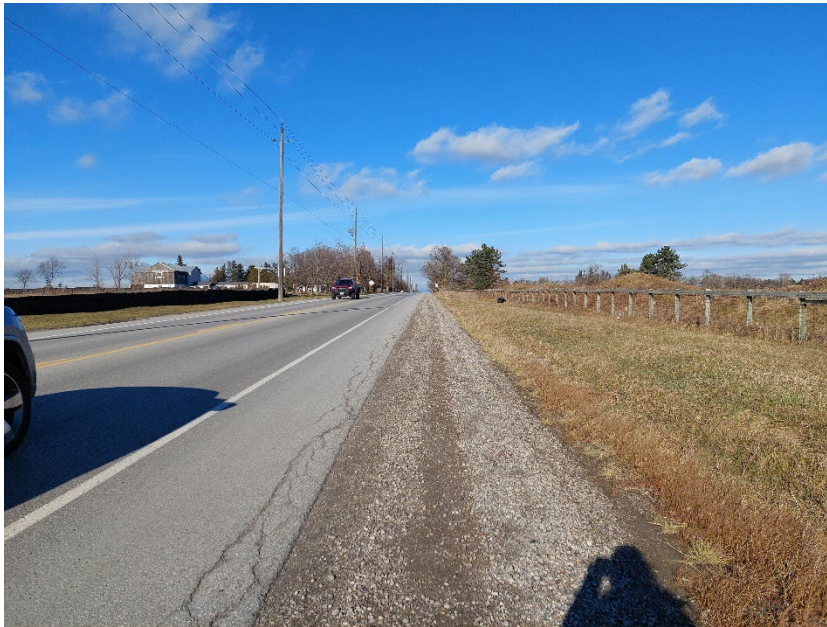
Plate 5: Warden Avenue, with an agricultural property in the distance on the western (left) side of the photograph and part of the Angus Glen Golf Course on the eastern (right) side.

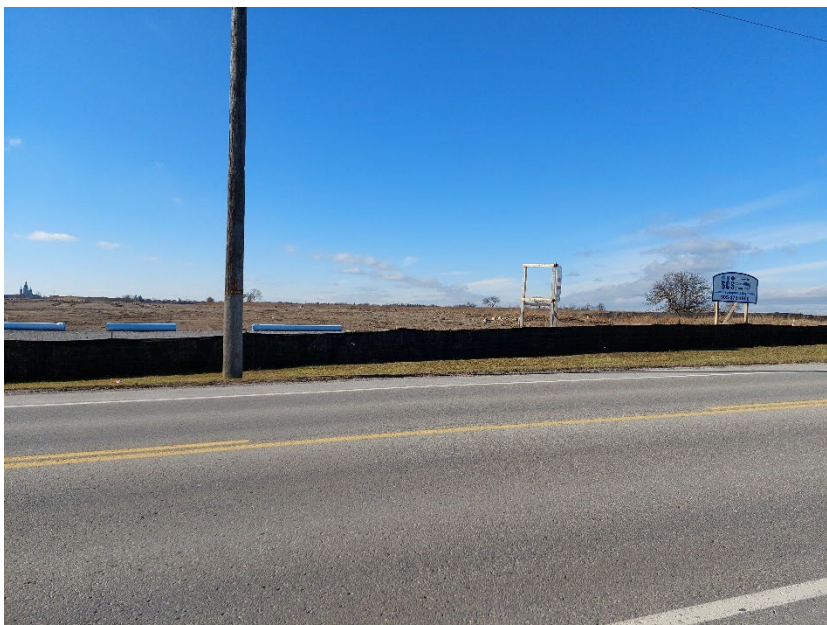
Plate 6: View of construction on the western side of Warden Avenue, looking west-northwest.

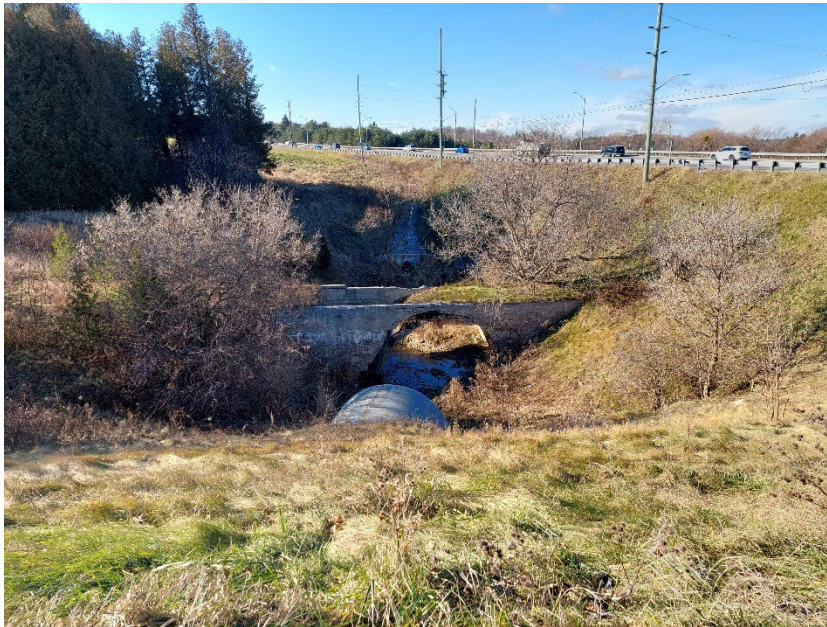
The remains of a bridge associated with the former alignment of Warden Avenue over Berczy Creek from approximately the early twentieth century to the mid- to late-twentieth century is located southwest of the intersection of Warden Avenue and Major Mackenzie Drive (Plate 9). The bridge appears to be constructed of concrete with rebar poles visible, though it is in a very deteriorated state with much of the superstructure collapsed and the extant portion is overgrown with vegetation. As the former structure is in such a state of deterioration, it does not appear to retain any design value and as it did not appear to have potential for historical or contextual associations, it was not identified as having potential for cultural heritage value or interest.

Plate 9: View of the corrugated metal culvert in the foreground and the remains of the former bridge for Warden Avenue in the middle ground, looking west.

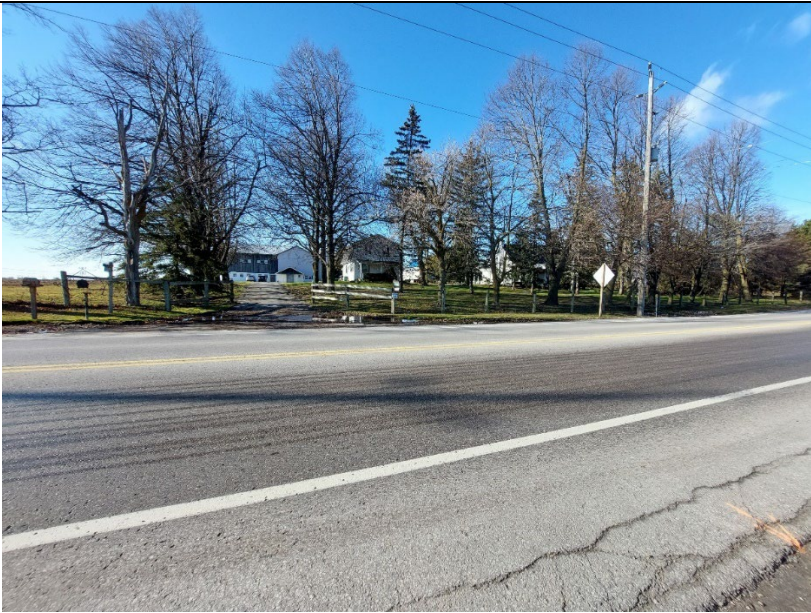
<p>Plate 10: Barn at 10148 Warden Avenue.</p>
W2	C.H.L.	Farmscape	10508 Warden Avenue	Known C.H.L. – Listed on the <i>Register of Properties of Cultural Heritage Value or Interest</i> (City of Markham, n.d.b)	The farmscape is located on the western side of Warden Avenue to the south of Elgin Mills Road. The known heritage attributes include the one-and-a-half storey residence, barns and outbuildings, driveway, mature trees, and agricultural fields. The house was constructed circa 1920 and is known as the Robert and Lovilla Sanderson House (City of Markham, n.d.b). For additional information, please see the City’s website with the listing information available and the research report on the property, which can be found in the <i>Memorandum to Heritage Markham Committee - Heritage Building Evaluations North Markham Planning District (Future Urban Area) Heritage Building Evaluations</i> (City of Markham, 2018a). The residence, barns, and agricultural

<p>Plate 11: The property at 10508 Warden Avenue.</p>

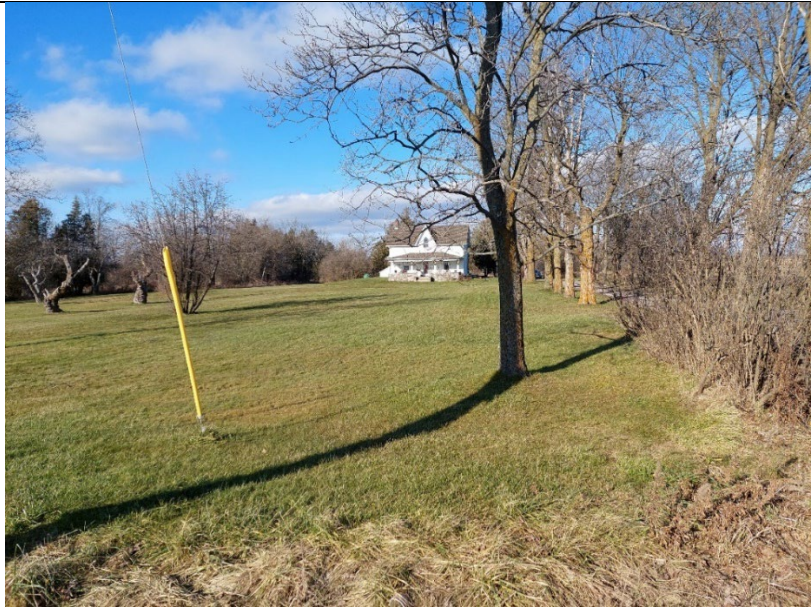
<p data-bbox="2069 1709 2840 1749">Plate 13: The residence at 3450 Elgin Mills Road East.</p>

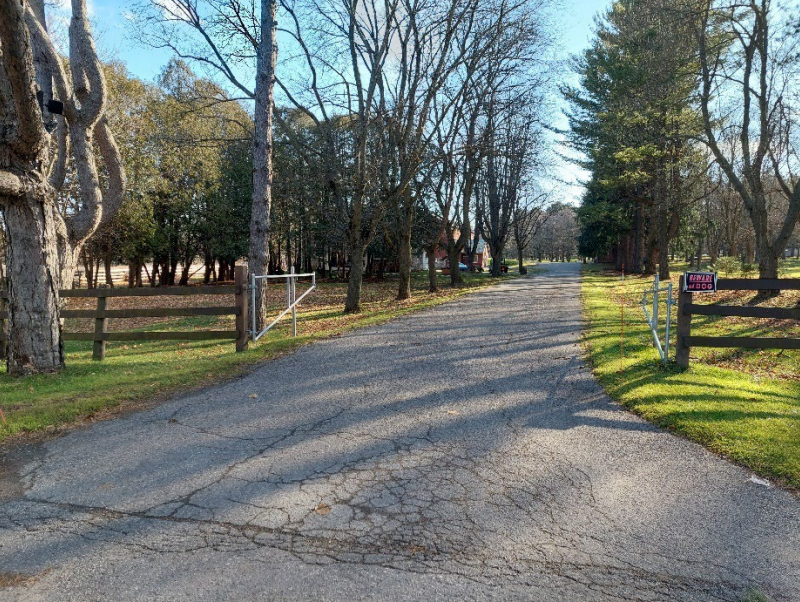
Feature I.D.	Type of Resource	Type of Property	Address or Location	Heritage Status and Recognition	Description of Property and Known or Potential C.H.V.I.	Photographs/ Digital Image
					<p>commemorate Canada’s Centennial (ASI, 2020). A residence is illustrated in the vicinity of the extant structure on the 1878 mapping (Figure 4).</p>	
W5	C.H.L.	Farmscape	4075 Elgin Mills Road East	Known C.H.L. – Listed on the <i>Register of Properties of Cultural Heritage Value or Interest</i> (City of Markham, n.d.b)	<p>The farmscape is located on the south side of Elgin Mills Road East to the east of Warden Avenue. The known heritage attributes include a one-and-a-half storey fieldstone residence with a covered front porch, rear addition, and rectangular footprint. The house is known as the William and Sarah Summerfeldt House and identified as a Classical Revival house by the Markham register (City of Markham, n.d.). For additional information, please see the City’s website with the listing information available and the research report on the property, which can be found in the <i>Memorandum to Heritage Markham Committee - Heritage Building Evaluations North Markham Planning District (Future Urban Area) Heritage Building Evaluations</i> (City of Markham, 2018a). A tree-lined driveway leads from Elgin Mills Road East to the residence and continues past the residence to barns on the property. The property also features active agricultural fields and is heavily treed. A residence is illustrated in the vicinity of the extant structure on the 1878 mapping (Figure 4).</p>

<p>Plate 14: The property at 4075 Elgin Mills Road East.</p>

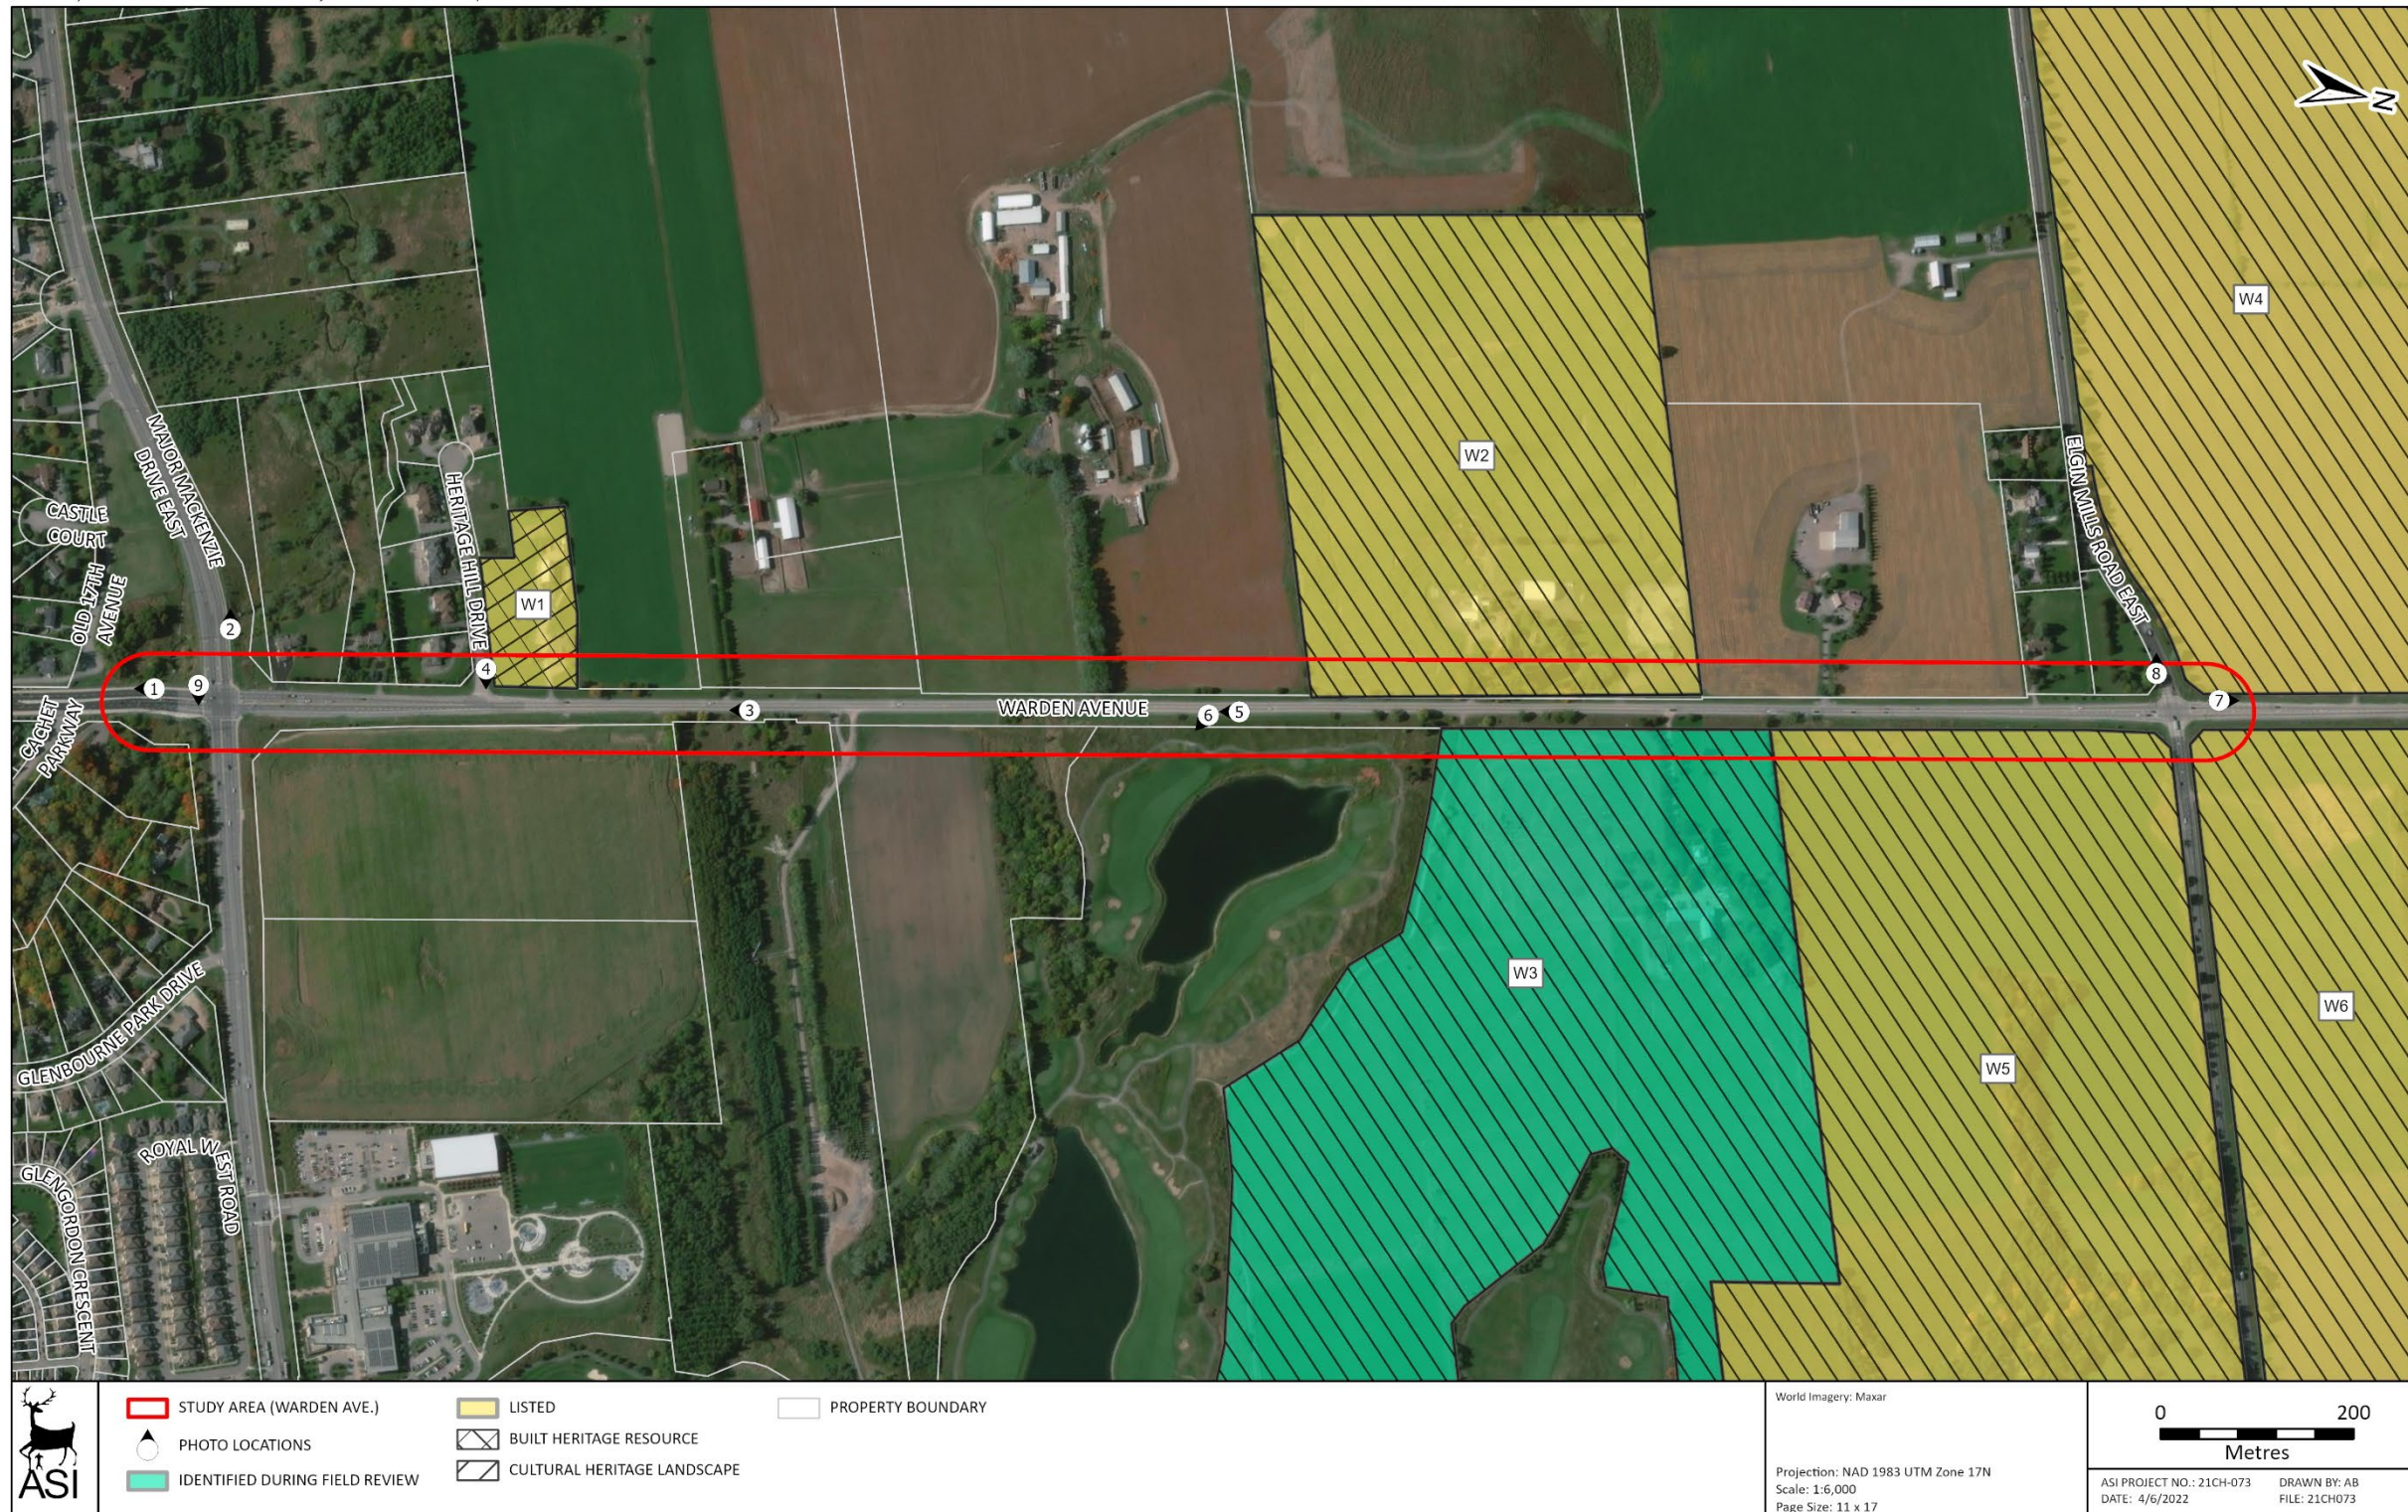
Figure 8: Location of Identified Built Heritage Resources (B.H.R.) and Cultural Heritage Landscapes (C.H.L.) in the Warden Avenue Study Area.

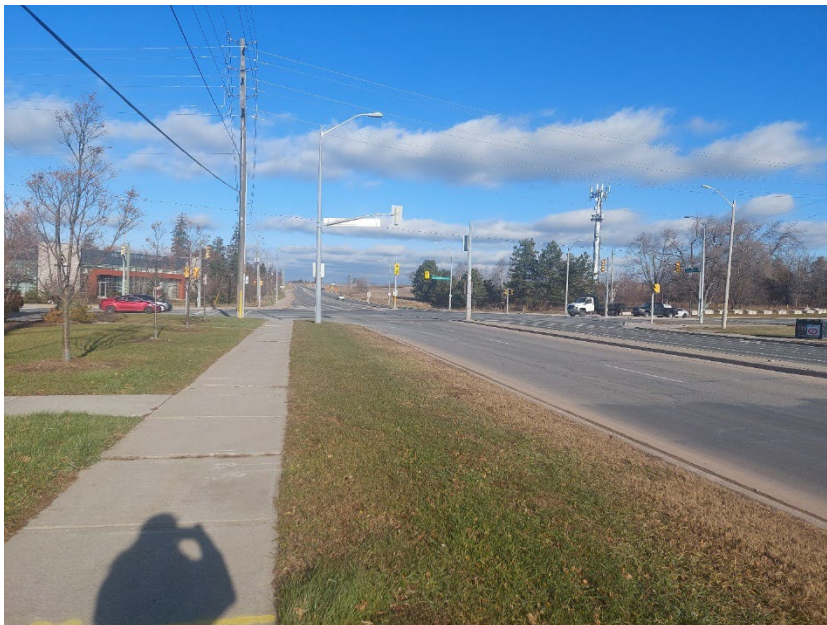
Plate 17: Kennedy Road, looking north from south of Major Mackenzie Drive.

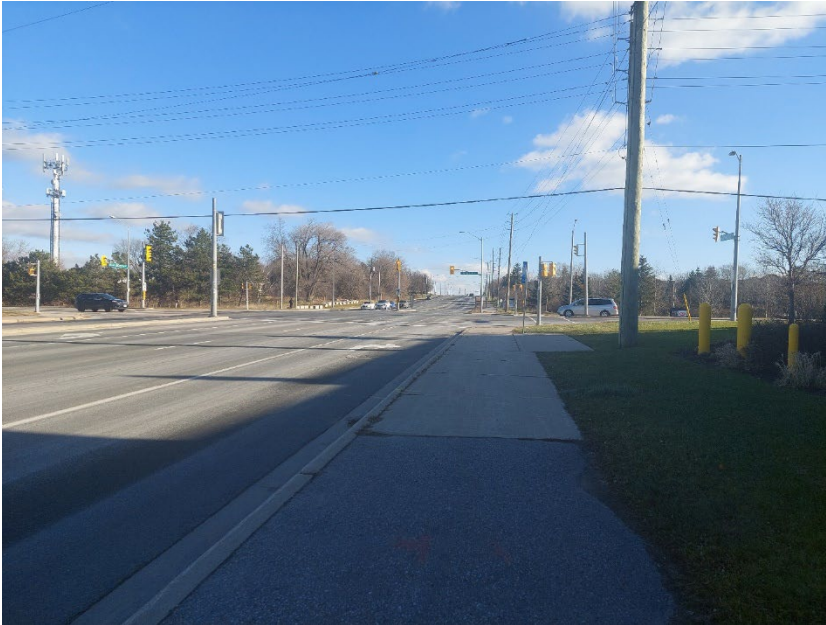
Plate 18: Major Mackenzie Drive, looking east towards Kennedy Road.

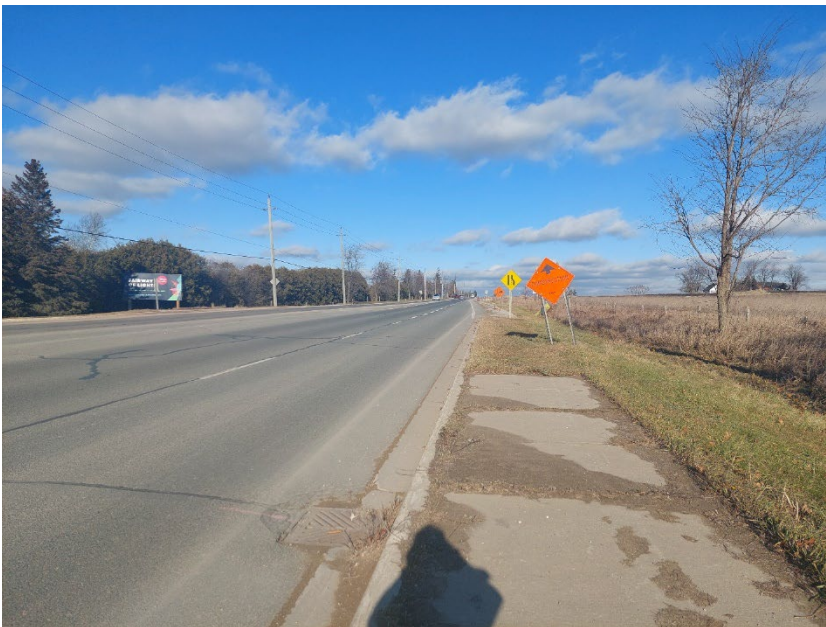
Plate 19: Kennedy Road, looking north. There are concrete curbs and sidewalks along the road, transitioning to no curbs or sidewalks.

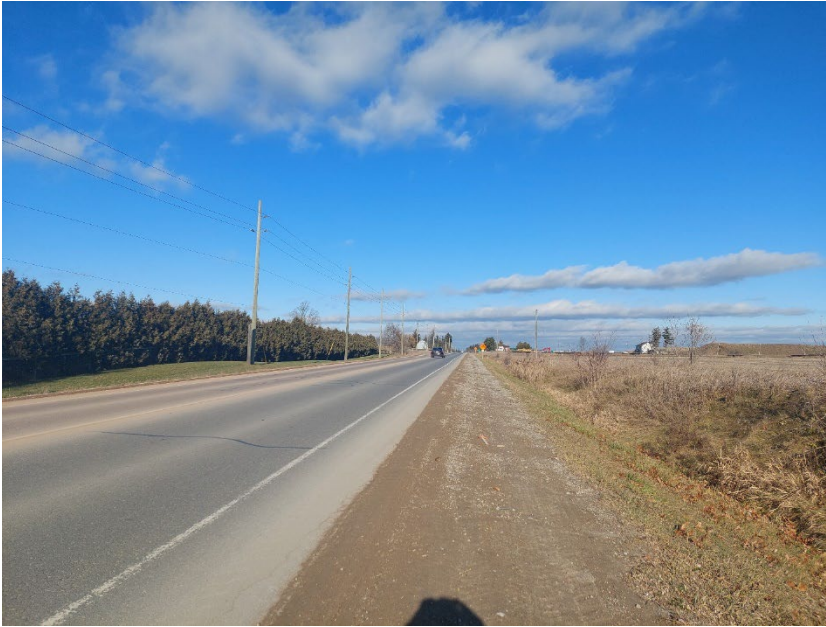
Plate 20: Kennedy Road, looking north. The tree-lined property on the left is the Angus Glen Golf Course and the property on the right is former agricultural.

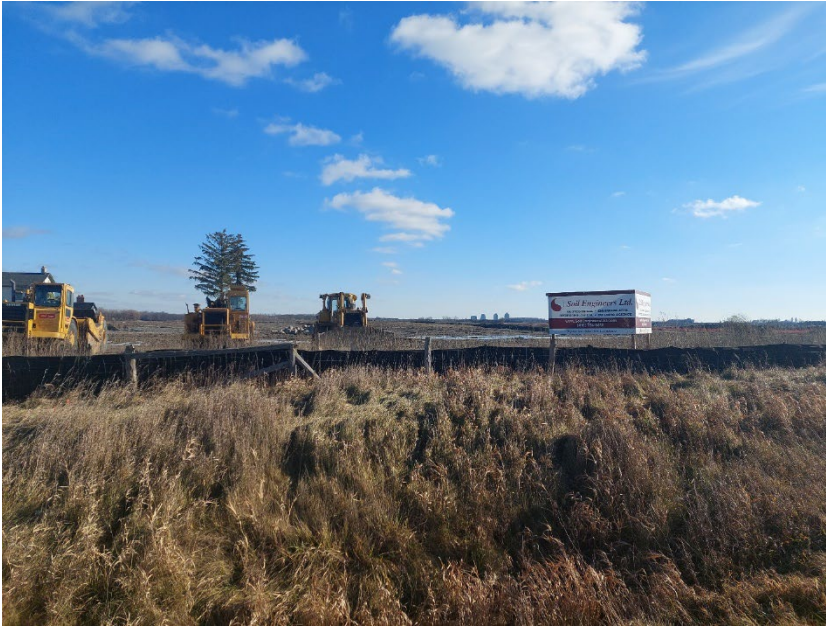
Plate 22: View of construction on the eastern side of Kennedy Road, looking east.

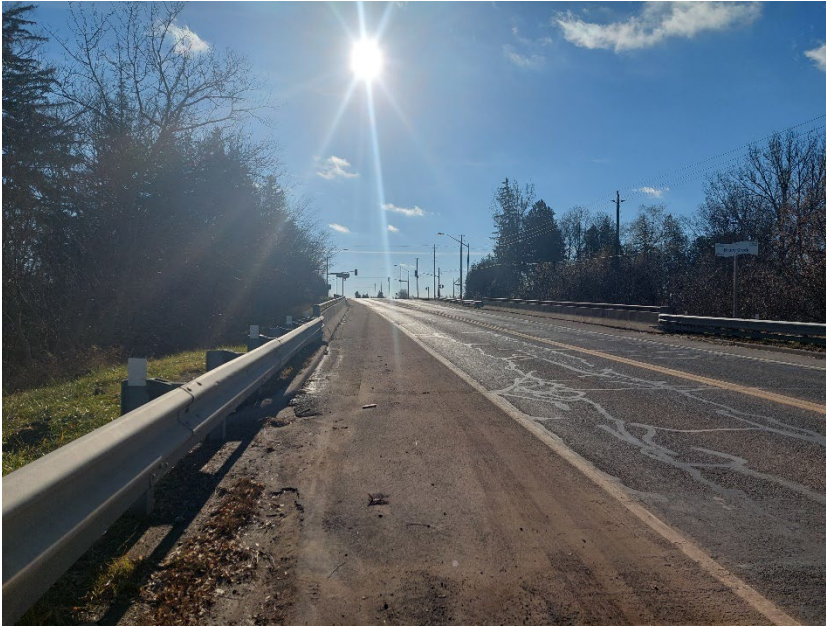
A bridge carries Kennedy Road over Bruce Creek (Plate 24). The bridge is a typical concrete beam bridge built c. 1970s. The watercourse flows in a general east-west alignment beneath the roadway. A *Municipal Heritage Bridges Cultural Heritage and Archaeological Resources Assessment Checklist* (Ministry of Tourism, Culture and Sport, 2016b) was applied to the bridge and it was found that it does not have potential cultural heritage value or interest.

Plate 24: View of the northern portion of the study area, including the bridge over Bruce Creek, looking south.

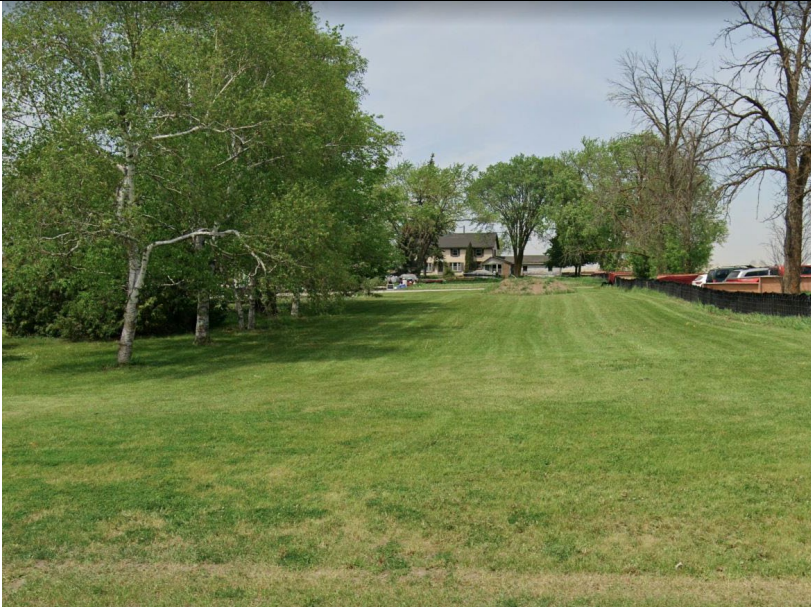
Feature I.D.	Type of Resource	Type of Property	Address or Location	Heritage Status and Recognition	Description of Property and Known or Potential C.H.V.I.	Photographs/ Digital Image
K1	C.H.L.	Farmscape	4638 Major Mackenzie Drive East	Known CHL – Listed on the <i>Register of Properties of Cultural Heritage Value or Interest</i> (City of Markham, n.d.b)	<p>The farmscape is located on the north side of Major Mackenzie Drive to the east of Kennedy Road. The known heritage attributes include the two-storey vernacular farmhouse, known as the Pingle-Brown House, that was constructed circa 1855, enlarged during the early twentieth century and remodelled during the 1940s (City of Markham, n.d.b). For additional information, please see the City’s website with the listing information available and the research report on the property, which can be found in the <i>Memorandum to Heritage Markham Committee - Heritage Building Evaluations North Markham Planning District (Future Urban Area) Heritage Building Evaluations</i> (City of Markham, 2018a). The property also features a row of mature trees along the driveway, outbuildings, and agricultural fields. The property is currently under construction. The 1860 mapping (Figure 3) depicts a residence in the vicinity of the extant structure.</p>

<p>Plate 26: The property at 4638 Major Mackenzie Drive East (Google Streetview 2021).</p>

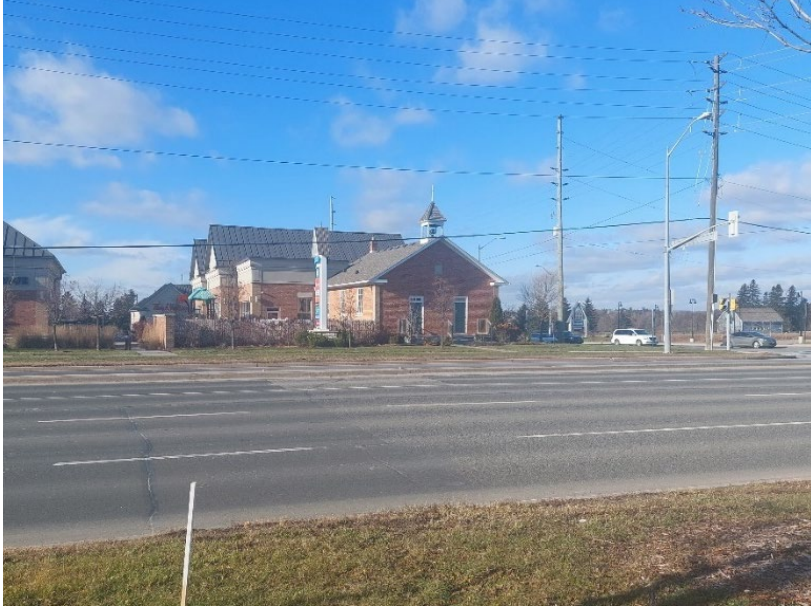
Feature I.D.	Type of Resource	Type of Property	Address or Location	Heritage Status and Recognition	Description of Property and Known or Potential C.H.V.I.	Photographs/ Digital Image
K2	B.H.R.	Schoolhouse	10000 Kennedy Road	Known B.H.R. – Designated under Part IV of the <i>Ontario Heritage Act</i> (By-law # 2021-91 and # 307-83)	The schoolhouse is located at the southwest corner of the intersection of Kennedy Road and Major Mackenzie Drive within a commercial plaza. The known heritage attributes include the red brick schoolhouse that was constructed in 1862. For additional information, please see the City’s website with the by-law information available. The 1878 mapping (Figure 4) depicts a schoolhouse in the location of the extant structure.

<p data-bbox="2069 983 2840 1018">Plate 27: The schoolhouse at 10000 Kennedy Road.</p>

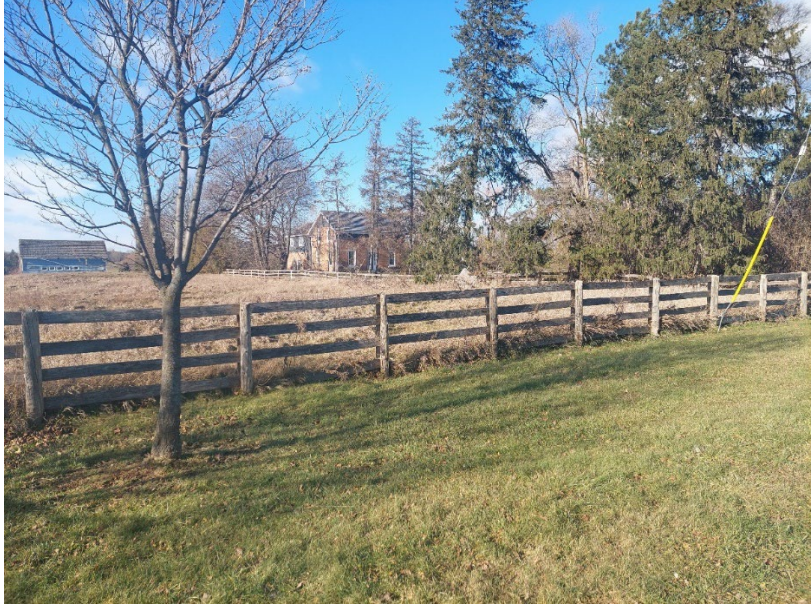
Feature I.D.	Type of Resource	Type of Property	Address or Location	Heritage Status and Recognition	Description of Property and Known or Potential C.H.V.I.	Photographs/ Digital Image
K3	B.H.R.	Residence	10060 Kennedy Road	Known B.H.R. – Listed on the <i>Register of Properties of Cultural Heritage Value or Interest</i> (City of Markham, n.d.b)	The residence is located on the western side of Kennedy Road to the north of Major Mackenzie Drive. The residence is currently within the Angus Glen Golf Course property. The known heritage attributes include the one-and-a-half storey brick residence with elements of the Georgian architectural style, that was constructed circa 1875 and is known as the John C. P. Pingle House (City of Markham, n.d.b). For additional information, please see the City’s website with the listing information available and the research report on the property, which can be found in the <i>Memorandum to Heritage Markham Committee - Heritage Building Evaluations Part 2 North Markham Planning District (Future Urban Area) Heritage Building Evaluations</i> (City of Markham, 2018b). The 1917 topographic map (Figure 5) depicts a brick/stone residence in the location of the extant structure.

<p data-bbox="2069 983 2766 1018">Plate 29: The property at 10060 Kennedy Road.</p>

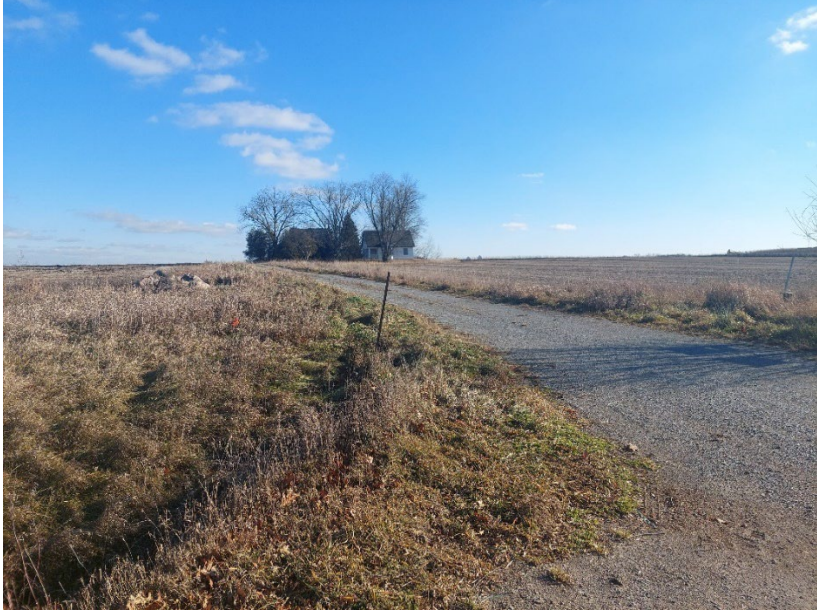
Feature I.D.	Type of Resource	Type of Property	Address or Location	Heritage Status and Recognition	Description of Property and Known or Potential C.H.V.I.	Photographs/ Digital Image
K4	C.H.L.	Farmscape	10225 Kennedy Road	Known C.H.L. – Designated under Part IV of the <i>Ontario Heritage Act</i> (By-law # 2008-22)	<p>The farmscape is located on the eastern side of Kennedy Road to the north of Major Mackenzie Drive. The known heritage attributes include the Homer Wilson farmhouse, the J. P. Carr cottage, and the Pingle Farm Cemetery. The Homer Wilson farmhouse was likely constructed circa 1900 and is a red brick, two storey residence, with T-shaped footprint. The J. P. Carr cottage was constructed in 1950, is a frame building, and a late example of an Arts and Crafts bungalow. The Pingle (also written Pingel in the by-law) Farm Cemetery is a small family cemetery that dates to prior to 1866, when the Pingle’s sold the farm. It is located to the north of the driveway and approximately 12 metres east from the roadway. The white marble obelisk-style grave marker likely replaced earlier head stones. For additional information, please see the City’s website with the by-law information available. The 1917 topographic map (Figure 5) depicts a brick/stone residence in the location of the extant Homer Wilson house.</p>

<p>Plate 30: View to the two residences at 10225 Kennedy Road.</p>

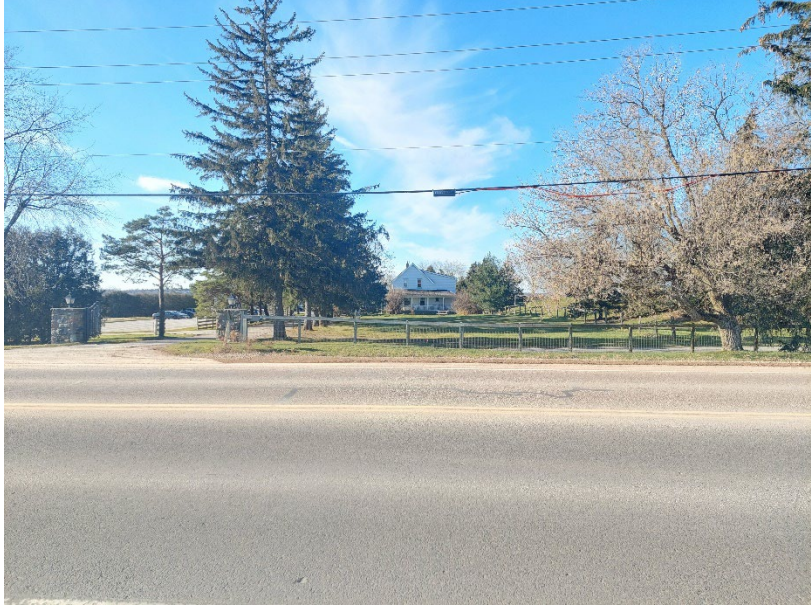
Feature I.D.	Type of Resource	Type of Property	Address or Location	Heritage Status and Recognition	Description of Property and Known or Potential C.H.V.I.	Photographs/ Digital Image
K5	B.H.R.	Residence	10228 Kennedy Road	Known B.H.R. – Listed on the <i>Register of Properties of Cultural Heritage Value or Interest</i> (City of Markham, n.d.b)	The residence is located on the western side of Kennedy Road to the north of Major Mackenzie Drive. The residence is currently within the Angus Glen Golf Course property. The known heritage attributes include the one-and-a-half storey vernacular residence, that was constructed circa 1870 and known as the George H. Pingle House (City of Markham, n.d.b). For additional information, please see the City’s website with the listing information available and the research report on the property, which can be found in the <i>Memorandum to Heritage Markham Committee - Heritage Building Evaluations Part 2 North Markham Planning District (Future Urban Area) Heritage Building Evaluations</i> (City of Markham, 2018b). The 1878 mapping (Figure 4) depicts a residence in the vicinity of the extant structure.

<p data-bbox="2069 983 2778 1016">Plate 32: The residence at 10228 Kennedy Road.</p>

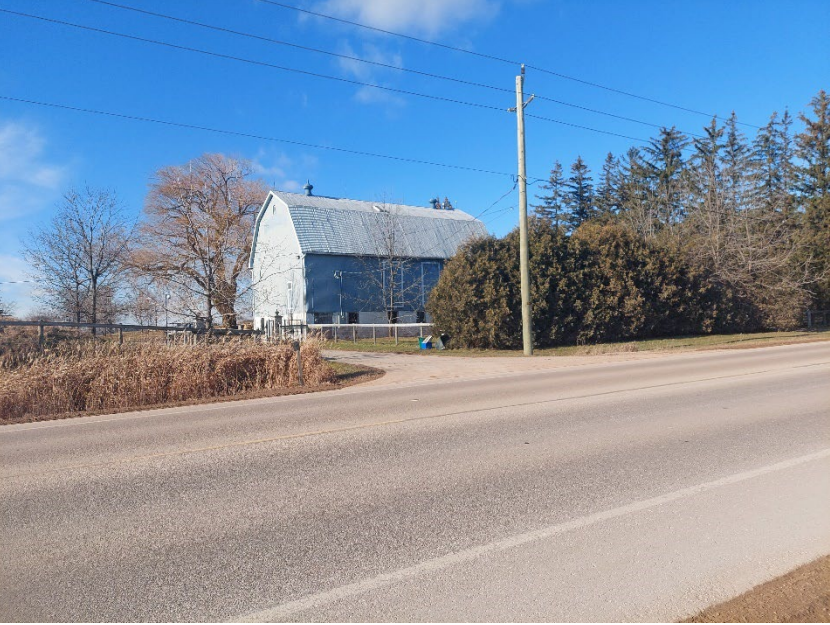
Feature I.D.	Type of Resource	Type of Property	Address or Location	Heritage Status and Recognition	Description of Property and Known or Potential C.H.V.I.	Photographs/ Digital Image
K8	B.H.R.	Barn	10476 Kennedy Road ²	Known B.H.R. – Listed on the <i>Register of Properties of Cultural Heritage Value or Interest</i> (City of Markham, n.d.b)	The barn is located on the western side of Kennedy Road, south of Elgin Mills Road. The barn is listed on the <i>Register of Properties of Cultural Heritage Value or Interest</i> (City of Markham, n.d.b) within 10450 Kennedy Road, though is located within the property parcel for 10476 Kennedy Road. The known heritage attributes include the gambrel roof barn that was constructed in 1930 (City of Markham, n.d.b). For additional information, please see the City’s website with the listing information available. The 1954 aerial photograph (Figure 6) captures the barn in its extant location.

<p data-bbox="2063 1003 2685 1036">Plate 37: The barn at 10476 Kennedy Road.</p>

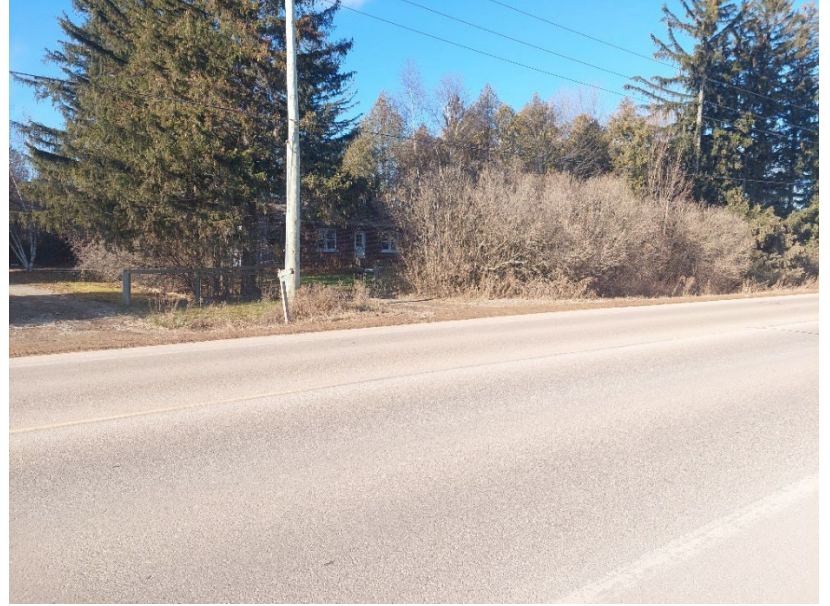
K9	C.H.L.	Farmscape	10476 Kennedy Road	Known C.H.L. – Listed on the <i>Register of Properties of Cultural Heritage Value or Interest</i> (City of Markham, n.d.b)	The farmscape is located on the western side of Kennedy Road to the south of Elgin Mills Road. The known heritage attributes include the bungalow known as the Thomas and Elizabeth Hobbs House that was constructed circa 1927 (City of Markham, n.d.b). For additional information, please see the City’s website with the listing information available and the research report on the property, which can be found in the <i>Memorandum to Heritage Markham Committee - Heritage Building Evaluations Part 2 North Markham Planning District (Future Urban Area) Heritage Building Evaluations</i> (City of Markham, 2018b). The property also features barns, a short

<p data-bbox="2063 1653 2766 1685">Plate 38: The property at 10476 Kennedy Road.</p>

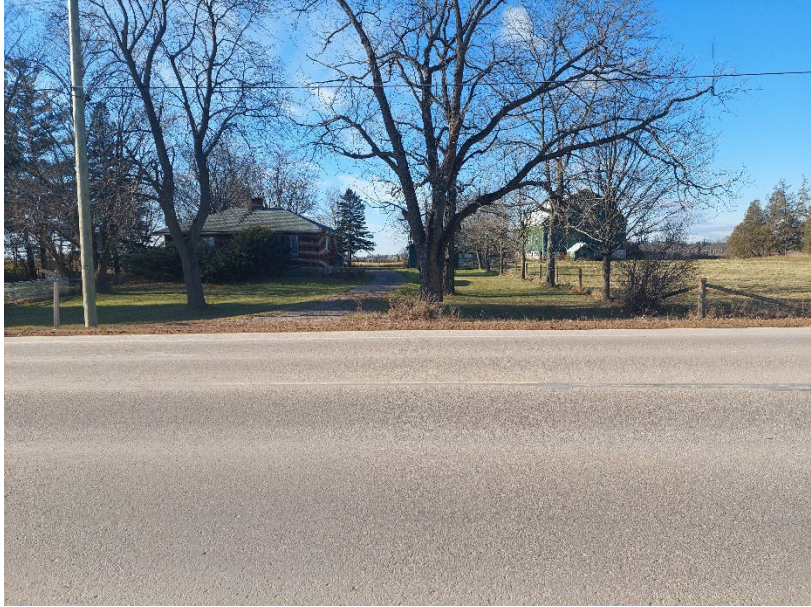
Feature I.D.	Type of Resource	Type of Property	Address or Location	Heritage Status and Recognition	Description of Property and Known or Potential C.H.V.I.	Photographs/ Digital Image
					entrance drive, and mature vegetative plantings. The 1954 aerial photograph (Figure 6) captures the residence in its extant location.	
K10	C.H.L.	Farmscape	10504 Kennedy Road	Known C.H.L. – Listed on the <i>Register of Properties of Cultural Heritage Value or Interest</i> (City of Markham, n.d.b)	The farmscape is located on the western side of Kennedy Road, to the south of Elgin Mills Road. The known heritage attributes include the Storry-Appleton Barn Complex, the barn was constructed circa 1910 (City of Markham, n.d.). For additional information, please see the City’s website with the listing information available and the research report on the property, which can be found in the <i>Memorandum to Heritage Markham Committee - Heritage Building Evaluations Part 2 North Markham Planning District (Future Urban Area) Heritage Building Evaluations</i> (City of Markham, 2018b). The property features a mid-century residence, a large gambrel-roof plank barn, two smaller barns, outbuildings, a tree-lined driveway, and active agricultural fields. The 1954 aerial photograph (Figure 6) captures the barn in its extant location.

<p data-bbox="2069 1130 2759 1165">Plate 39: The property at 10504 Kennedy Road.</p>

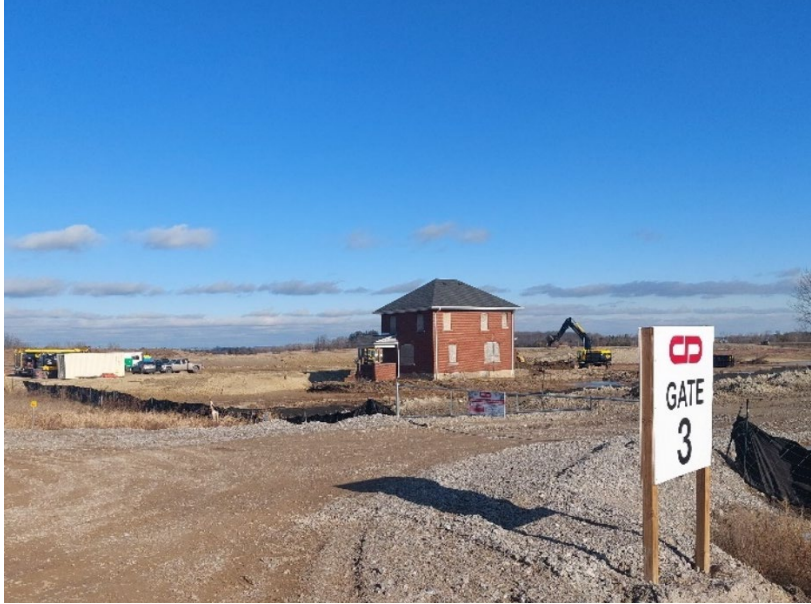
Feature I.D.	Type of Resource	Type of Property	Address or Location	Heritage Status and Recognition	Description of Property and Known or Potential C.H.V.I.	Photographs/ Digital Image
K11	B.H.R.	Residence	10537 Kennedy Road	Known B.H.R. – Designated under Part IV of the <i>Ontario Heritage Act</i> (By-law # 2014-16)	The residence is located on the eastern side of Kennedy Road to the south of Elgin Mills Road. The known heritage attributes include the Arthur and Hannah Wegg House, constructed circa 1922 (City of Markham, n.d.b). The residence is an American Foursquare with Edwardian Classical detailing. For additional information, please see the City’s website with the by-law information available. The 1954 aerial photograph (Figure 6) captures the residence in its extant location.

<p data-bbox="2069 979 2766 1016">Plate 40: The property at 10537 Kennedy Road.</p>
K12	B.H.R.	Residence	10725 Kennedy Road	Known B.H.R. – Listed on the <i>Register of Properties of Cultural Heritage Value or Interest</i> (City of Markham, n.d.b)	The residence is located on the eastern side of Kennedy Road to the south of Elgin Mills Road. The known heritage attributes include the one storey brick house that was constructed circa 1851 and is known as the Francis Walker House. For additional information, please see the City’s website with the listing information available and the research report on the property, which can be found in the <i>Memorandum to Heritage Markham Committee - Heritage Building Evaluations North Markham Planning District (Future Urban Area) Heritage Building Evaluations</i> (City of Markham, 2018a).. The 1860 mapping (Figure 3) depicts a residence in the vicinity of the extant structure.

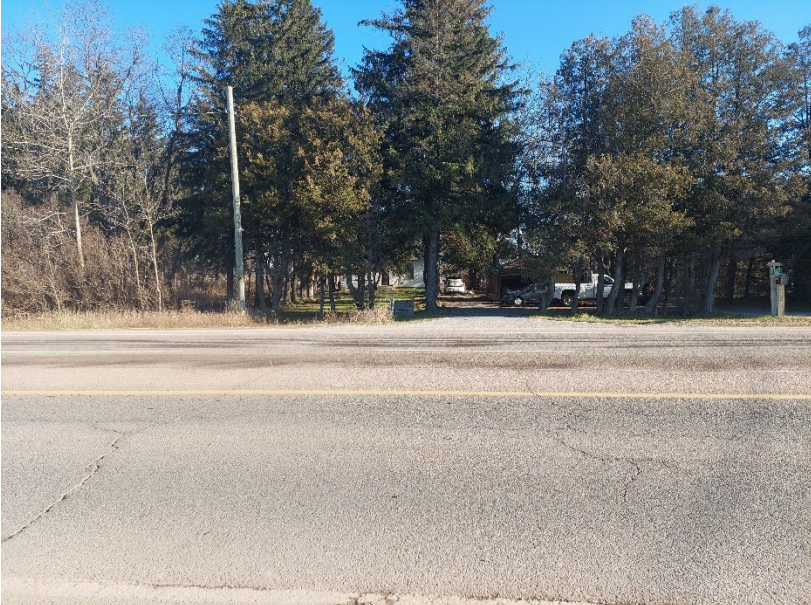
<p data-bbox="2069 1626 2766 1663">Plate 41: The property at 10725 Kennedy Road.</p>

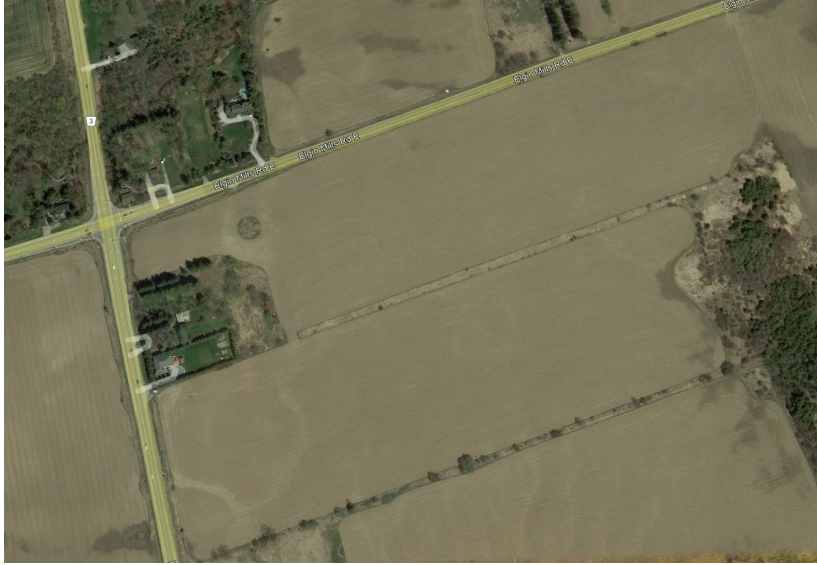
<p data-bbox="2066 943 2843 1018">Plate 42: Aerial view of the agricultural fields at 4551 Elgin Mills Road (Google Earth 2018).</p>

Feature I.D.	Type of Resource	Type of Property	Address or Location	Heritage Status and Recognition	Description of Property and Known or Potential C.H.V.I.	Photographs/ Digital Image
K13	C.H.L.	Agricultural Fields	4551 Elgin Mills Road East	Known C.H.L. – Listed on the <i>Register of Properties of Cultural Heritage Value or Interest</i> (City of Markham, n.d.b)	The agricultural fields are located on the south side of Elgin Mills Road to the west of Kennedy Road. The known heritage attribute of the property was a one-storey brick Ontario Regency house, known as the Archibald Fenwick House, that was moved to 7 Heritage Corners Lane in the Marham Heritage Estates neighbourhood in 2009 (City of Markham, n.d.b). For additional information, please see the City’s website with the listing information available. The 1860 mapping (Figure 3) depicts a residence in the vicinity of the former location of the residence.
