Cultural Heritage Report: Existing Conditions

Warden Avenue and Kennedy Road Municipal Class Environmental Assessment

City of Markham Regional Municipality of York, Ontario

Draft Report

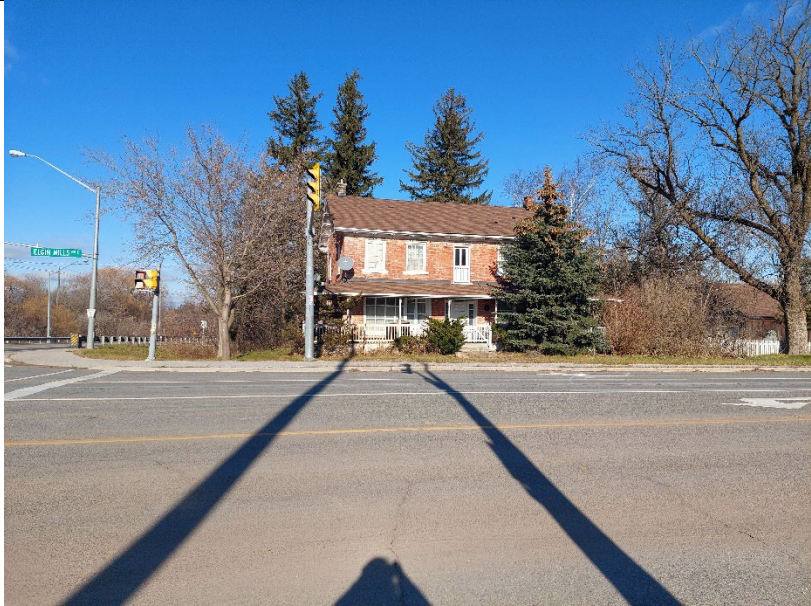
<p data-bbox="2069 1084 2840 1116">Plate 46: The property at 4510 Elgin Mills Road East.</p>

Feature I.D.	Type of Resource	Type of Property	Address or Location	Heritage Status and Recognition	Description of Property and Known or Potential C.H.V.I.	Photographs/ Digital Image
					mapping (Figure 4) illustrates the property within the crossroads community of Cashel.	
K15	B.H.R.	Residence (Former Hotel)	4510 Elgin Mills Road East	Known B.H.R. – Designated under Part IV of the <i>Ontario Heritage Act</i> (By-law # 298-78)	The residence (formerly a hotel) is located at the northeast corner of the intersection of Elgin Mills Road and Kennedy Road. The known heritage attributes include the two-storey red brick former hotel, known as the Cashel Road House and the Llandon Plains Hotel. The property features a two-storey red brick pseudo-Georgian structure, constructed in 1835. The building is five bays wide and has its front façade facing south. A single-storey northern wing was added after 1888 (City of Markham, n.d.). The property also features a shed, circulation routes, and vegetative windbreak surrounding the house. For additional information, please see the City’s website with the by-law information available. The 1860 mapping (Figure 3) depicts a large structure in the location of the extant structure.

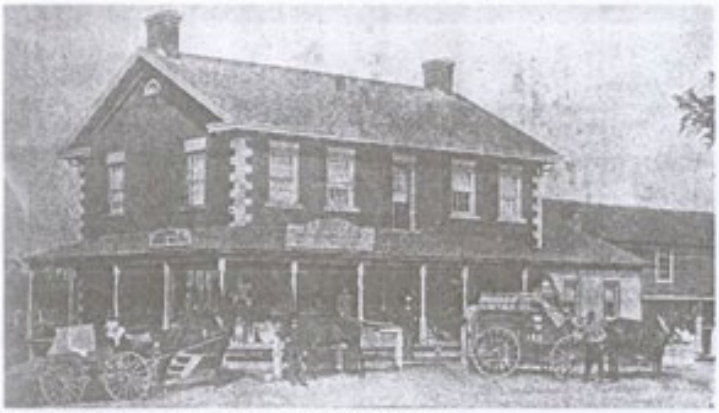
<p data-bbox="2116 1548 2800 1568"><small>Cashel general store and post office, originally the Cashel Hotel, built in 1835.</small></p> <p data-bbox="2069 1576 2840 1657">Plate 47: Historical photograph of the former hotel (City of Markham, n.d.).</p>

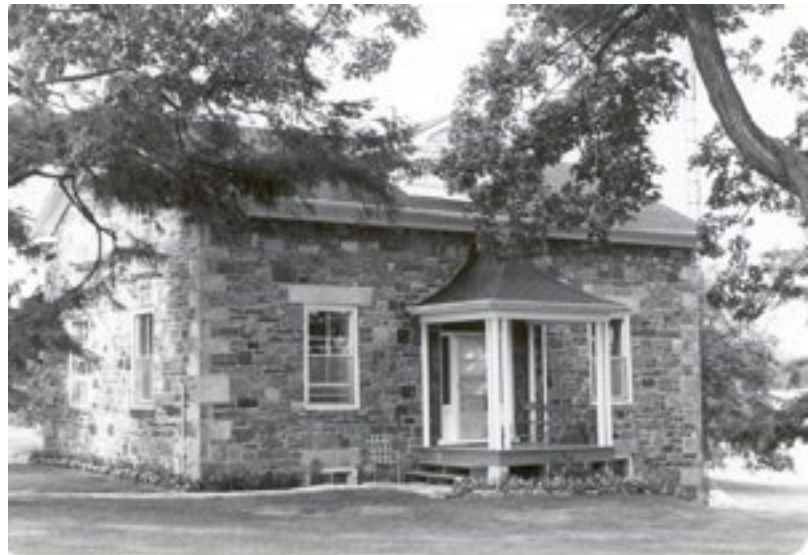
<p>Plate 49: Undated photograph of the residence at 4044 Elgin Mills Road East (City of Markham, n.d.).</p>

Feature I.D.	Type of Resource	Type of Property	Address or Location	Heritage Status and Recognition	Description of Property and Known or Potential C.H.V.I.	Photographs/ Digital Image
K16	C.H.L.	Farmscape	4044 Elgin Mills Road East	Known C.H.L. – Listed on the <i>Register of Properties of Cultural Heritage Value or Interest</i> (City of Markham, n.d.b)	<p>The farmscape is located on the north side of Elgin Mills Road, between Warden Avenue and Kennedy Road. The known heritage attributes include the one-and-a-half storey residence that was constructed in 1858 in the Classical Revival style by the Markham register (City of Markham, n.d.). For additional information, please see the City’s website with the listing information available. An undated photograph of the residence (Plate 16) shows that it is a rectangular one-and-a-half storey fieldstone house with a central dormer window and covered front entrance flanked by windows. A tree-line driveway leads from Elgin Mills Road East to the residence. The property also features active agricultural fields and a large pond. The 1860 mapping (Figure 3) depicts a residence in the vicinity of the extant structure.</p>

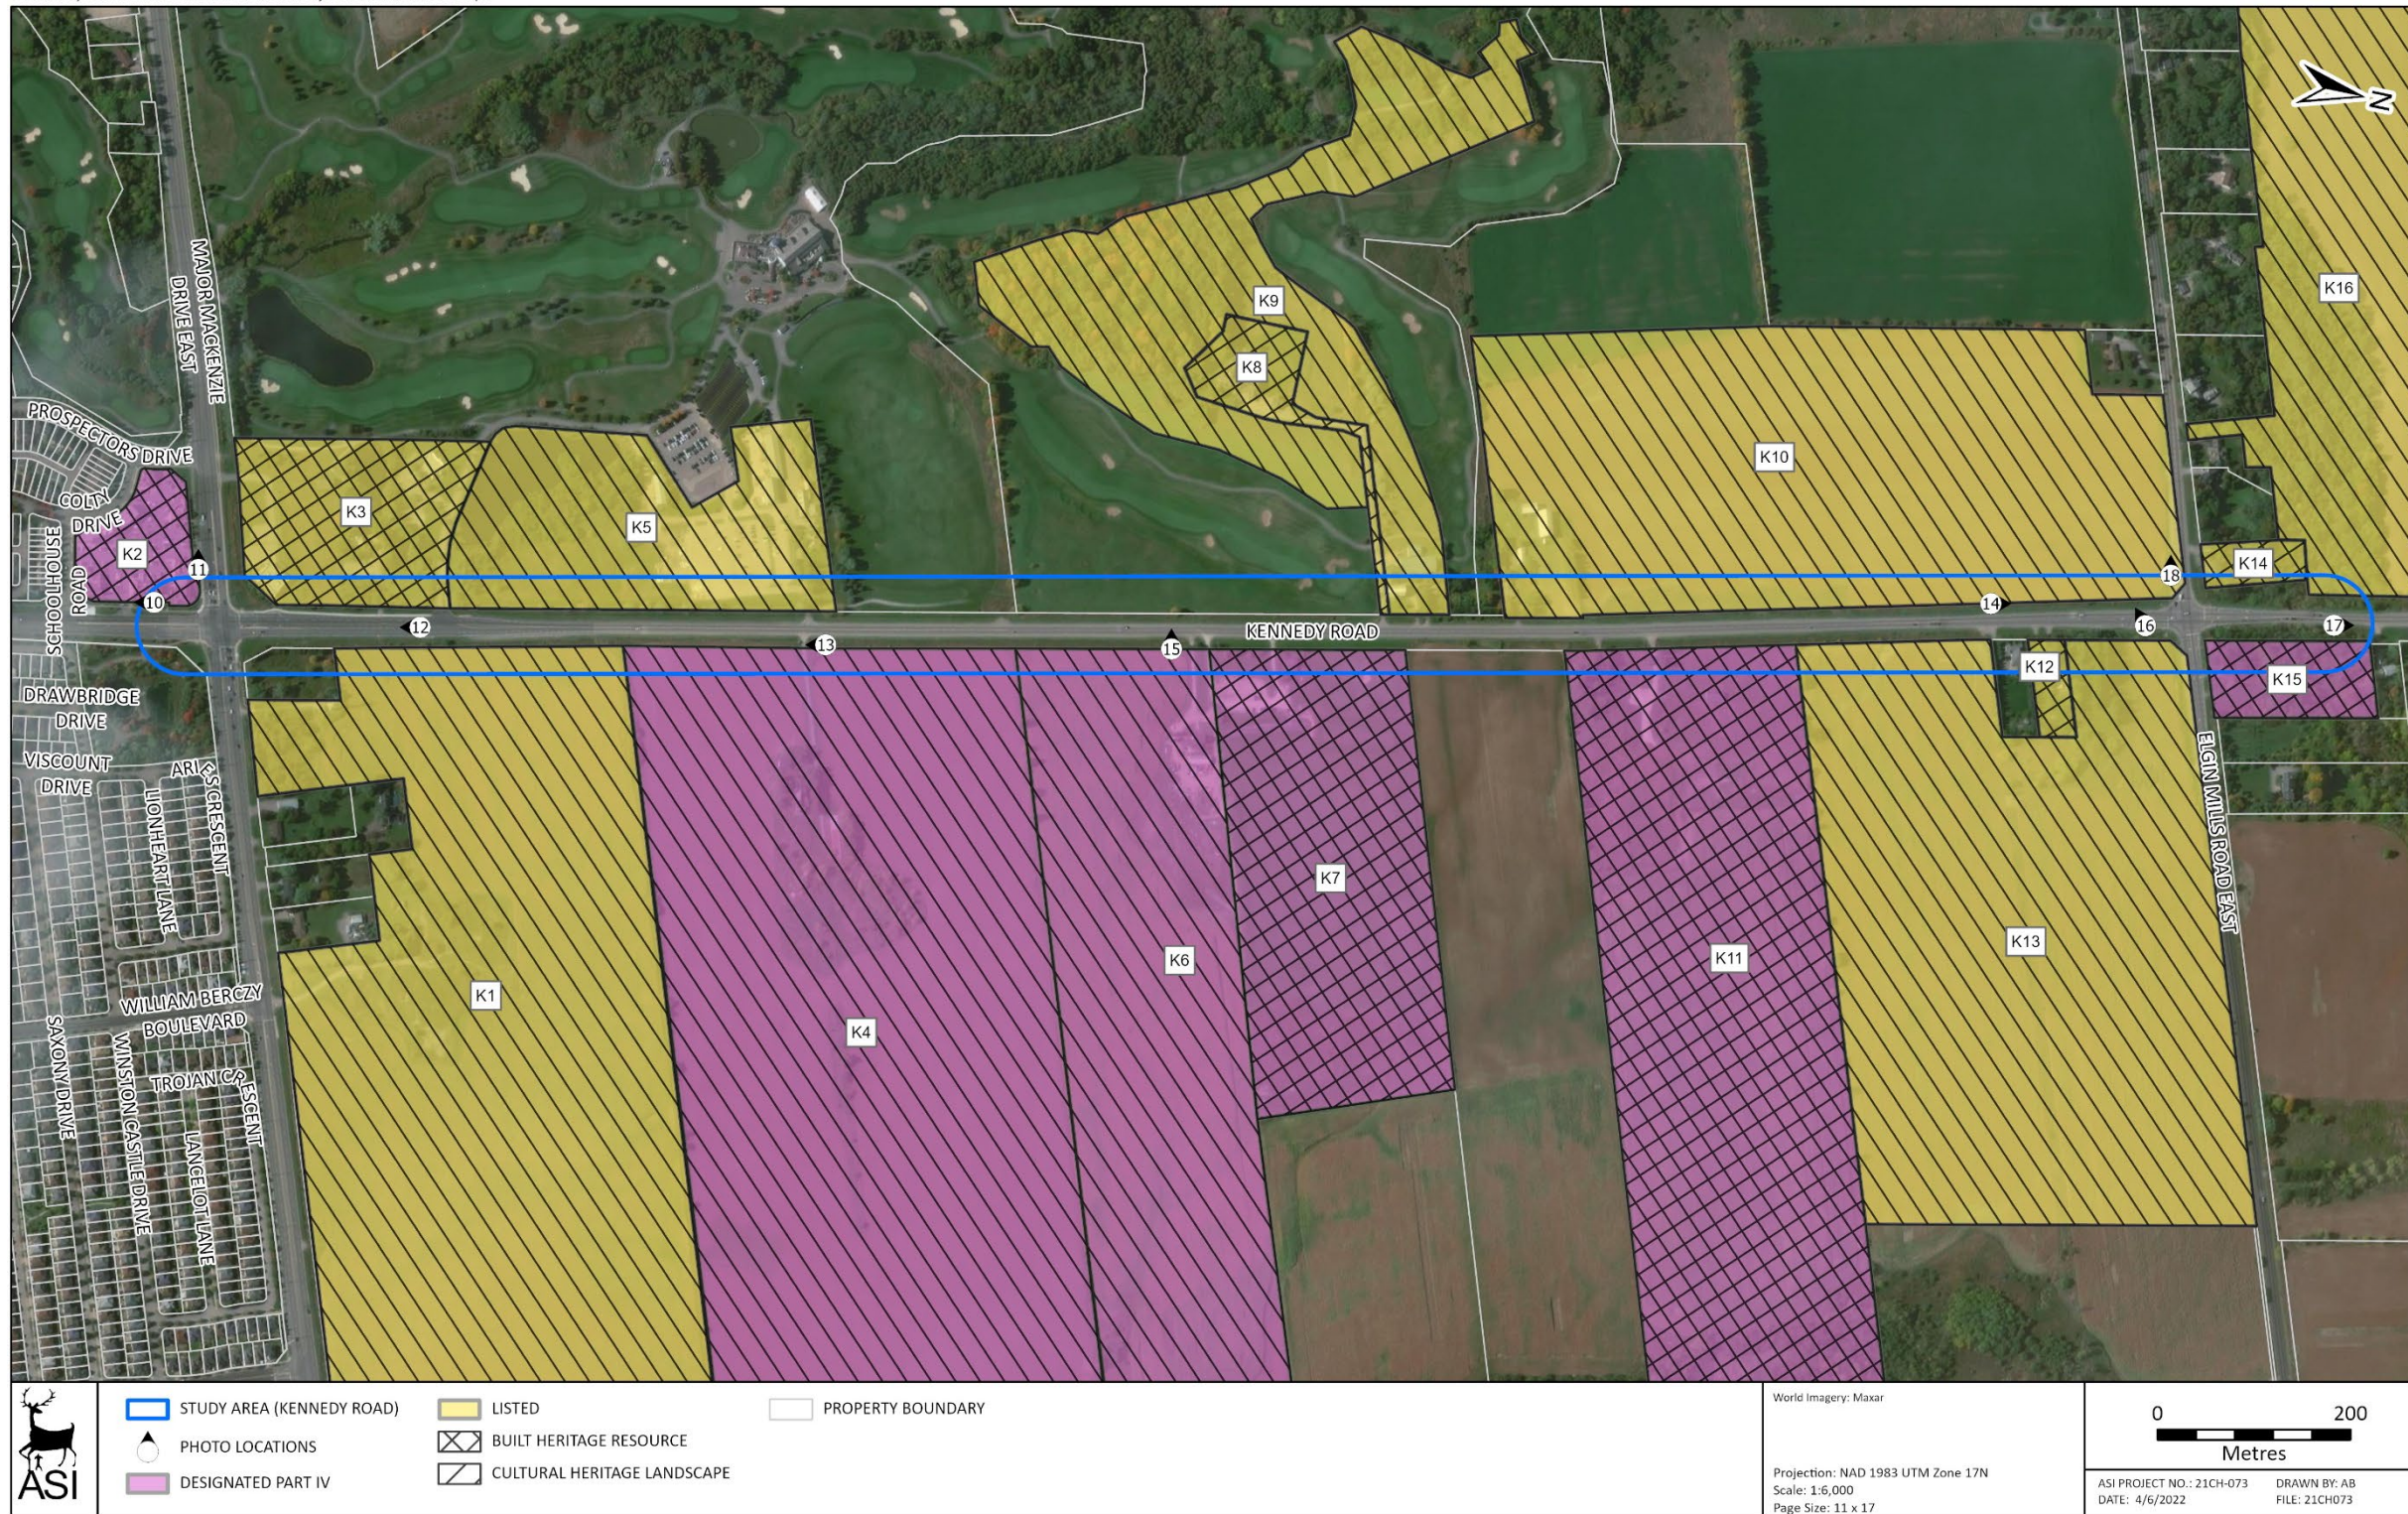
Figure 9: Location of Identified Built Heritage Resources (B.H.R.) and Cultural Heritage Landscapes (C.H.L.) in the Kennedy Road Study Area.
