# Heritage Impact Assessment Addendum

Nobleton Water and  
Wastewater Upgrades

**Regional Municipality of York**

File no. 23265C

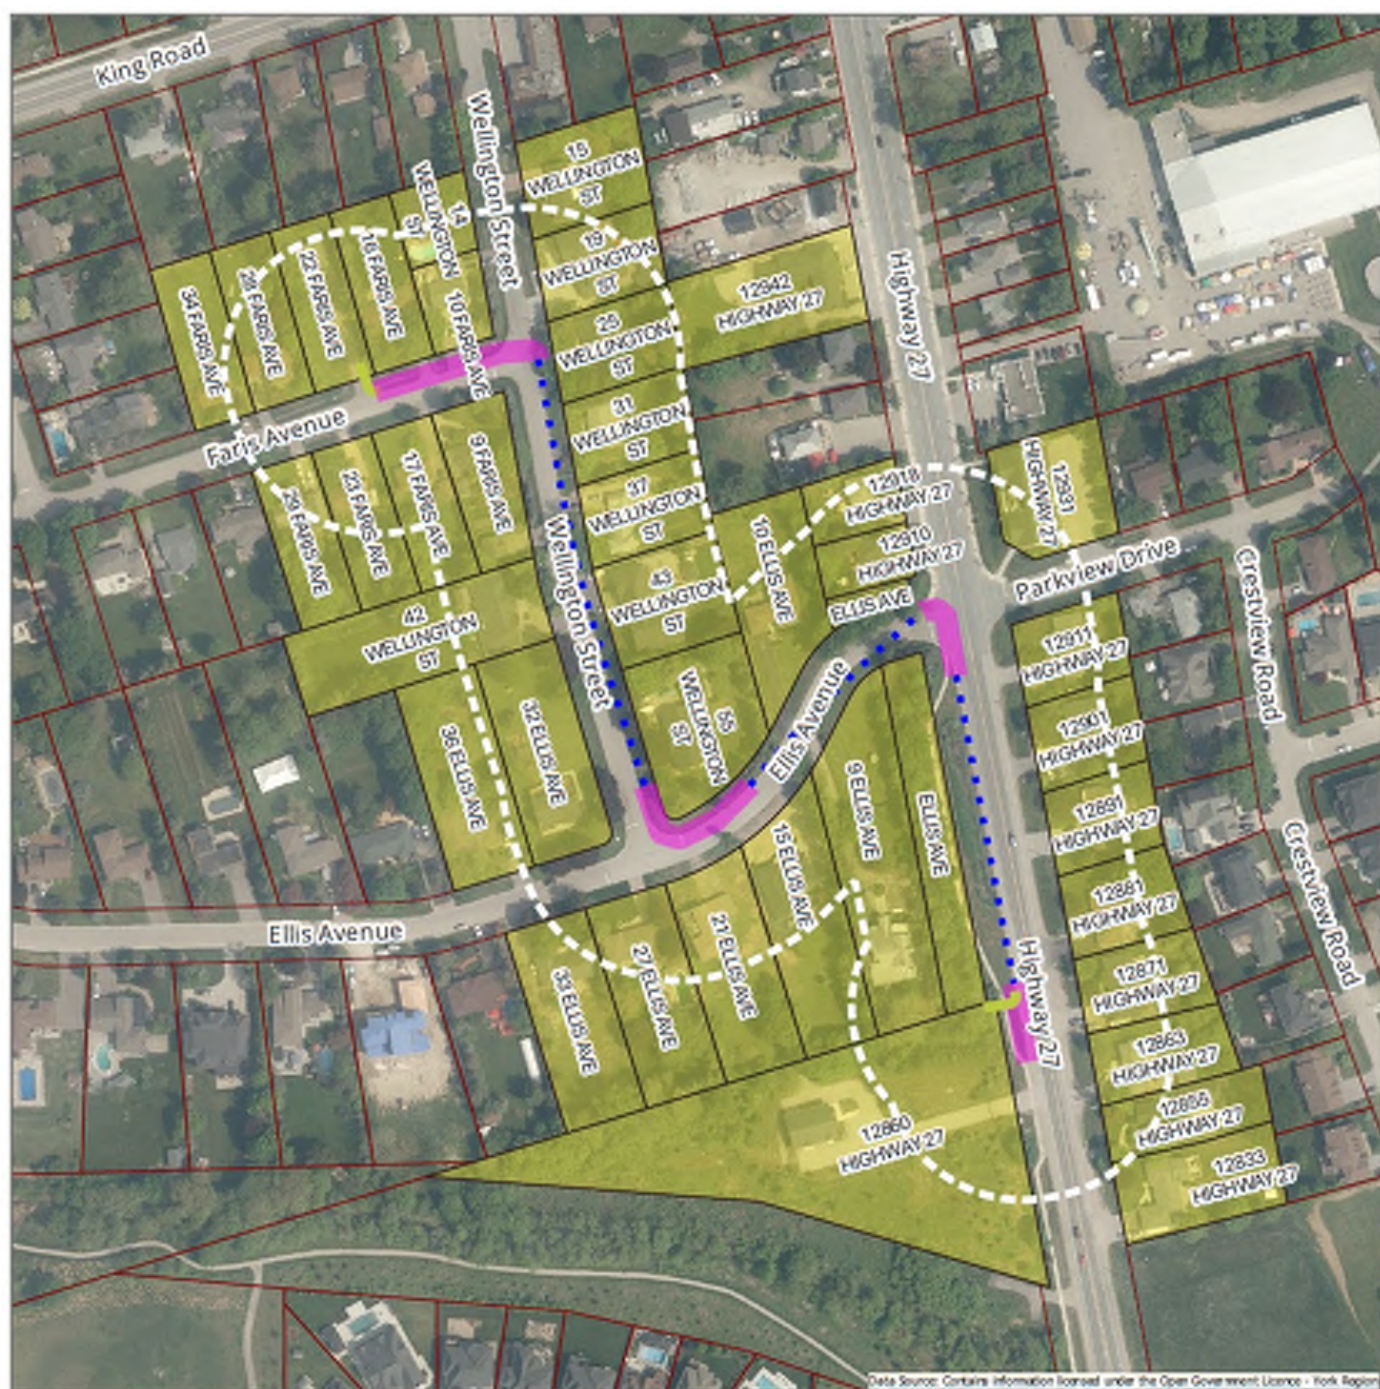
**Figure 2 - Project Area: Properties within 50m from Pipe Lines**

- Future Connection Point
- Proposed 300mm PVC WM (DR 18) - 1.8m Trench Boxes
- - - Proposed 300mm PVC (HDD) WM - No Excavation
- - - 50m Buffer

The purpose of this Heritage Impact Assessment Addendum is to screen the updated Project Area for potential BHRs, to confirm the existing conditions of the known and potential BHRs within the expanded Project Area, which includes portions of Faris Avenue, Wellington Street, Ellis Avenue, and Highway 27 (see **Figure 2**), and to assess for potential impacts resulting from the proposed upgrades. Mitigation and conservation measures are recommended where applicable.

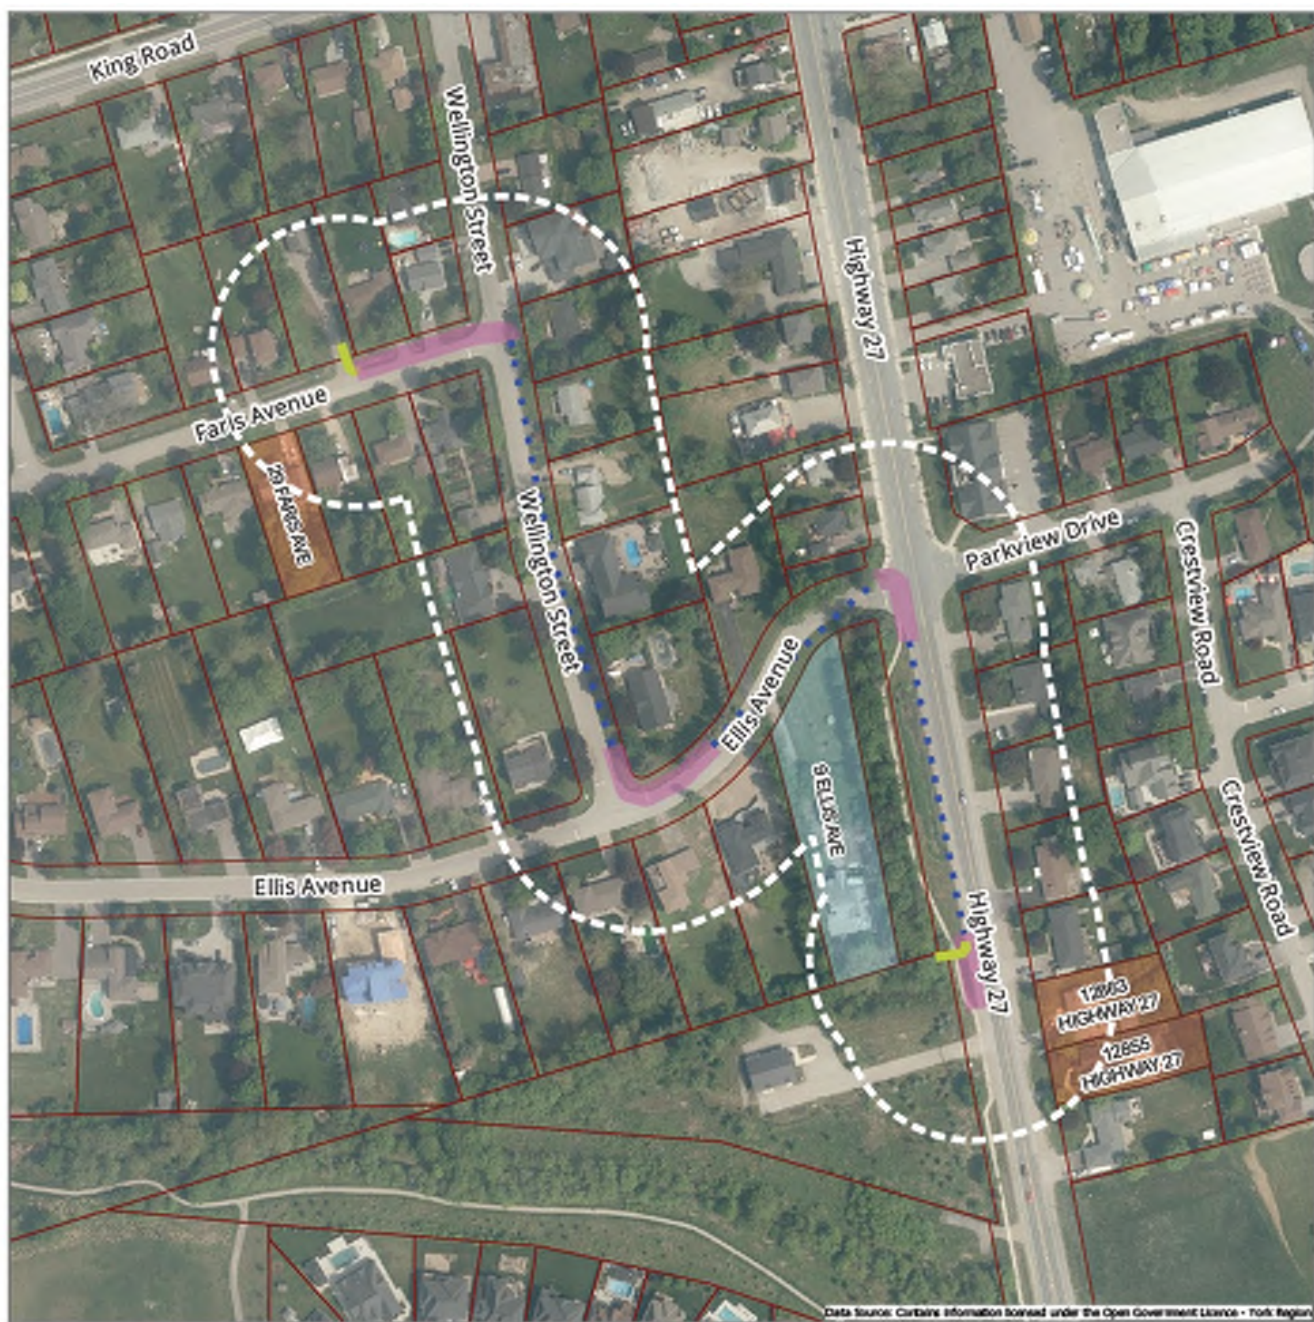
**Figure 12 - Properties within 50m from Pipe Lines**

Three potential BHRs were previously identified through the above-listed criteria that fall within the Project Area which is subject to this Addendum. They include the properties located at 12855 Highway 27, 12863 Highway 27, and 29 Faris Ave (see **Figure 12**).

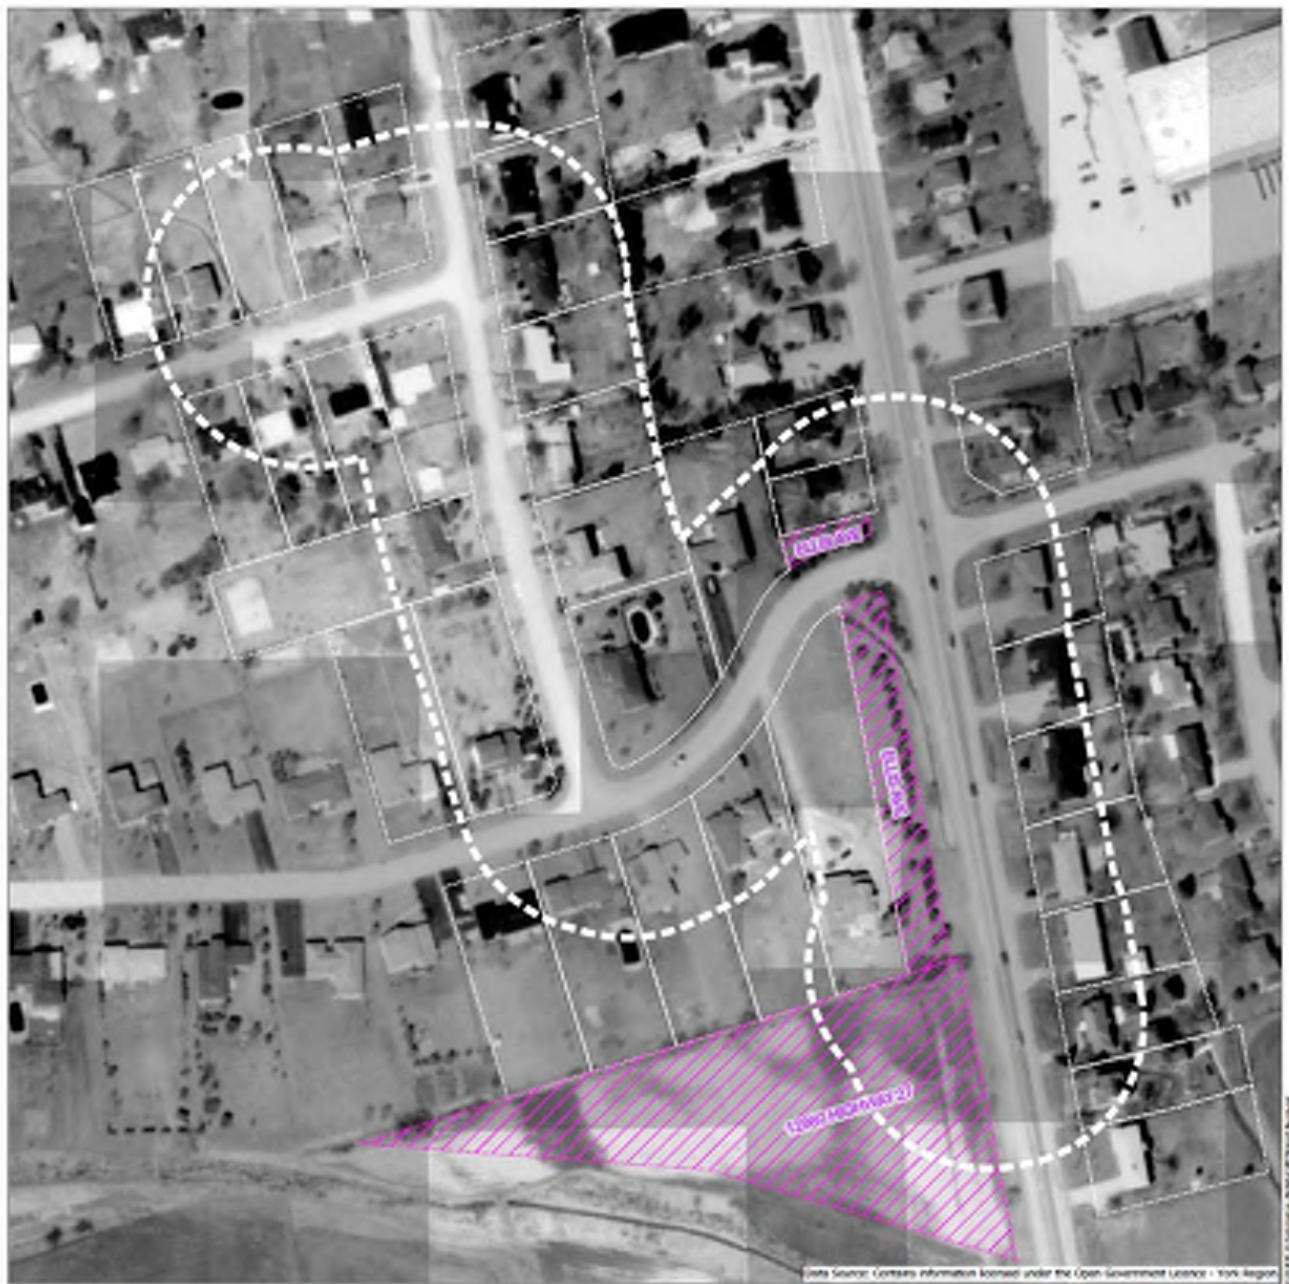
**Figure - 1988 Airphoto**

**Figure 17:** Excerpt from a 1988 airphoto indicating what the properties within the Project Area looked like at the time. (MHBC, 2025)

These properties did not fall within the 40-year age limit mandated by the Ministry of Tourism, Culture and Sport in the Criteria for Evaluating Potential for Built Heritage Resources and Cultural Heritage Landscapes (see **Figures 17-19**). These properties are therefore not considered potential BHRs.<sup>1</sup>

<sup>1</sup> Note: a sufficiently clear airphoto from 1985 was not available, and therefore a combination of airphotos from 1978 and 1988 were analyzed to capture which buildings were present but either removed or substantially altered within the required timeframe (see **Figures 17-19**).

It is minimally visible from the public realm as a result of its deep setback and screening of mature trees on the property. The architectural features and conditions of the existing dwelling could not be observed at this time. However, as indicated in the historic aerial photographs (see **Figures 17-19**), the footprint of the existing dwelling has been substantially altered within the last 40 years and the property is no longer listed on the Township of King Heritage Register (updated July 15<sup>th</sup>, 2024). The property is therefore no longer considered to include an identified BHR.

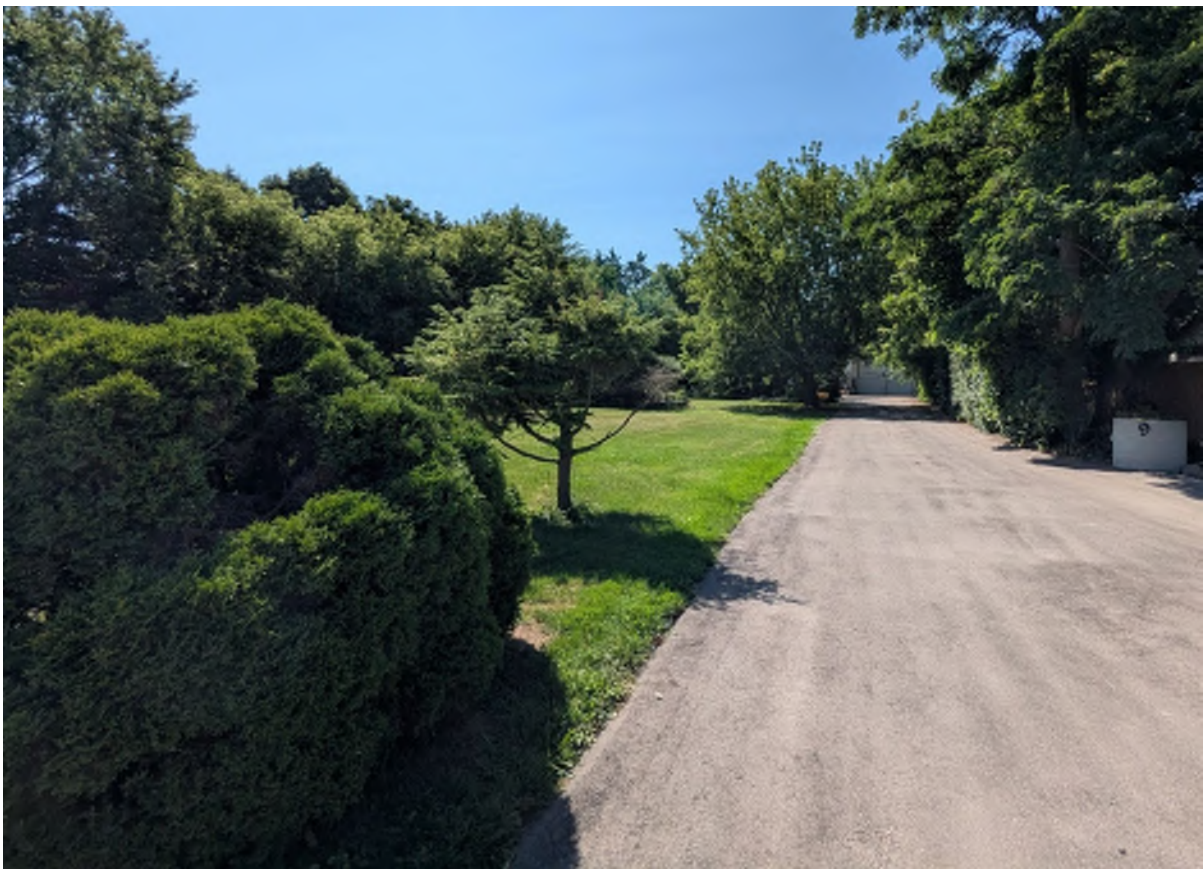
**Figure 20:** View of 9 Ellis Avenue from the public realm where the driveway interfaces with Ellis Avenue. (MHBC, 2025)

The property located at 9 Ellis Avenue was identified in the previous Cultural Heritage Report: Existing Conditions and Preliminary Impact Assessment (ASI, 2021) as a listed property.

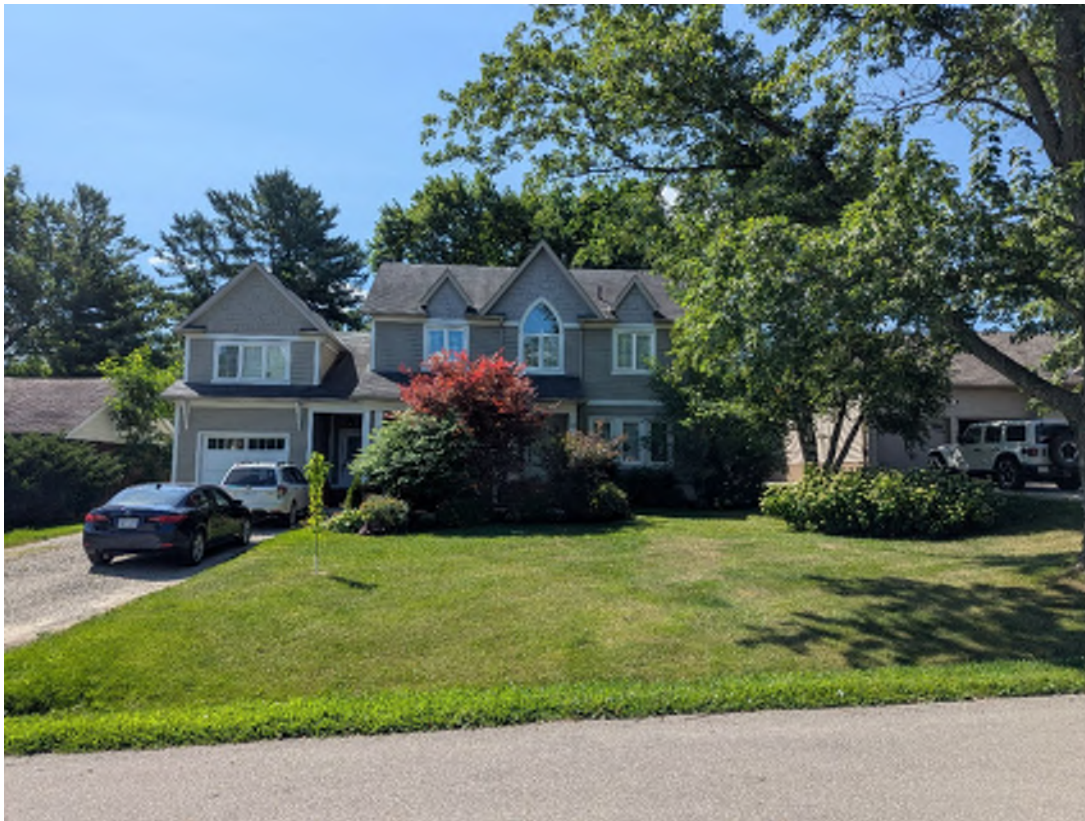
**Figure 22:** View of the principal elevation of 29 Faris Avenue. (MHBC, 2025)

This property was identified by ASI in the previous Cultural Heritage Report: Existing Conditions and Preliminary Impact Assessment (2021) as a potential Built Heritage Resource.

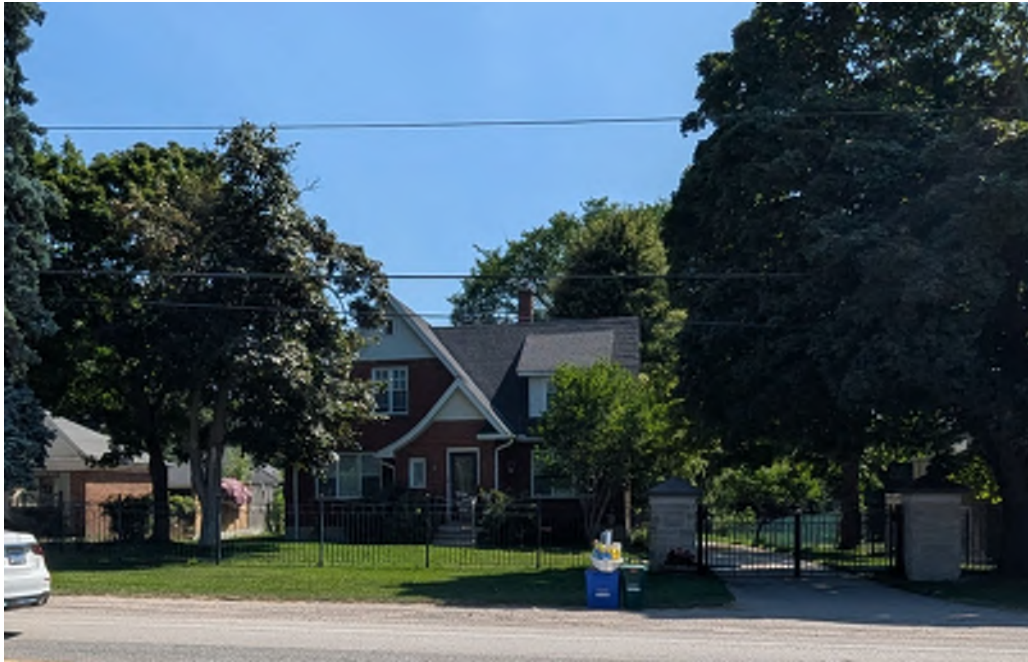
**Figure 23:** View of the principal elevation of 12855 Highway 27. (MHBC, 2025)

This property was identified by ASI in the previous Cultural Heritage Report: Existing Conditions and Preliminary Impact Assessment (2021) as a potential Built Heritage Resource.

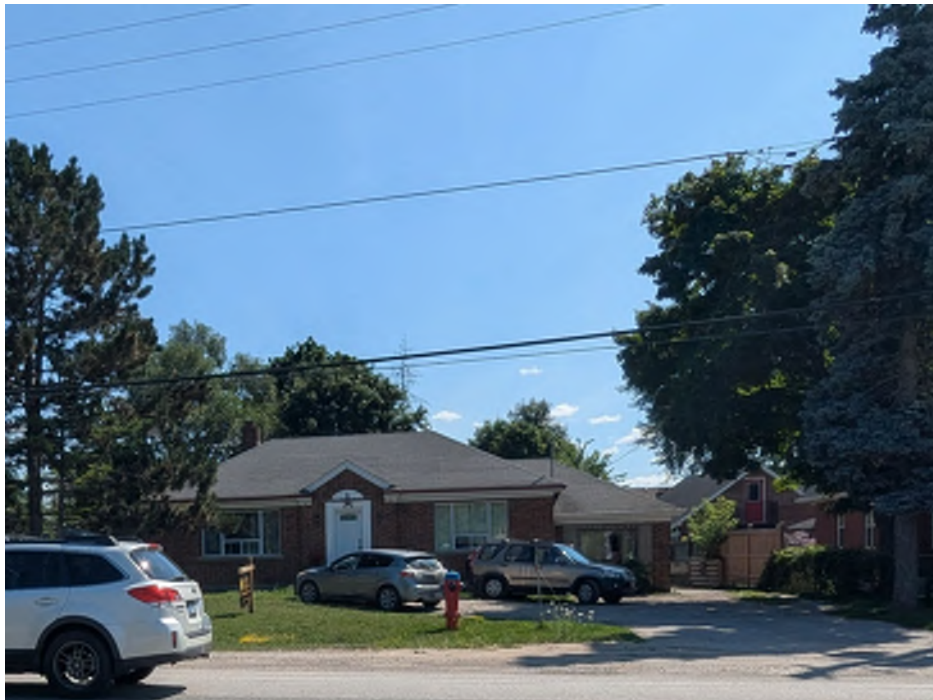
**Figure 24:** View of the principal elevation of 12863 Highway 27. (MHBC, 2025)

The property located at 12863 Highway 27 includes a one-storey single detached dwelling with a hip roof and brick chimney at the north elevation. The building is constructed of polychrome brickwork and includes a decorative cast stone cement block foundation. Openings are rectangular and the principal entrance includes a front-facing gable. The property also includes a driveway which interfaces with Highway 27, a parking pad, grass lawn, and two mature trees.

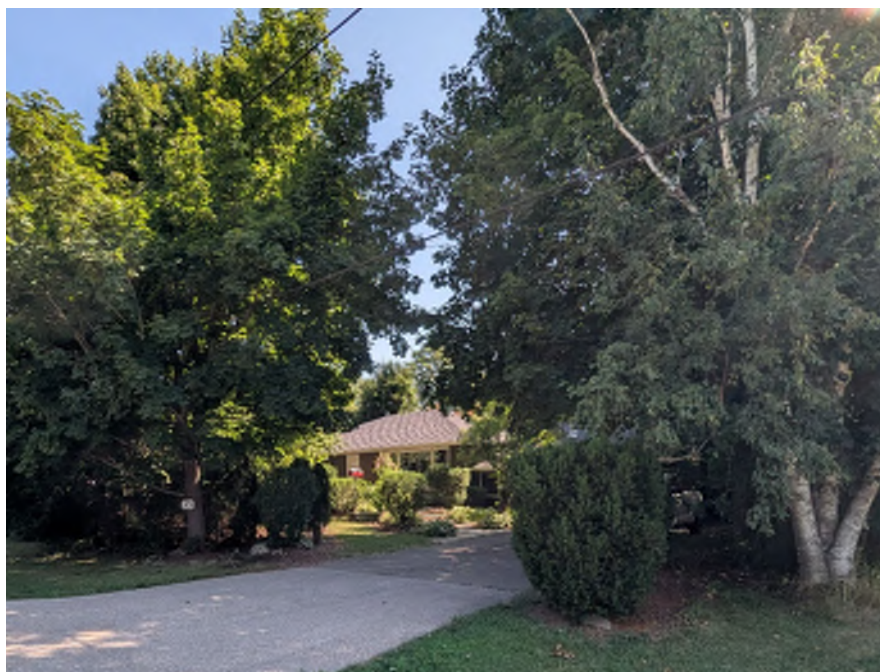
**Figure 25:** View of the principal elevation of 25 Wellington Street. (MHBC, 2025)

The property located at 25 Wellington Street is screened by mature trees and many of the property's architectural features and details cannot be viewed from the public realm. However, the property contains a one-storey single detached dwelling with a hip roof and attached garage. The property also includes landscaping features, mature trees, and a paved driveway which interfaces with Wellington Street.

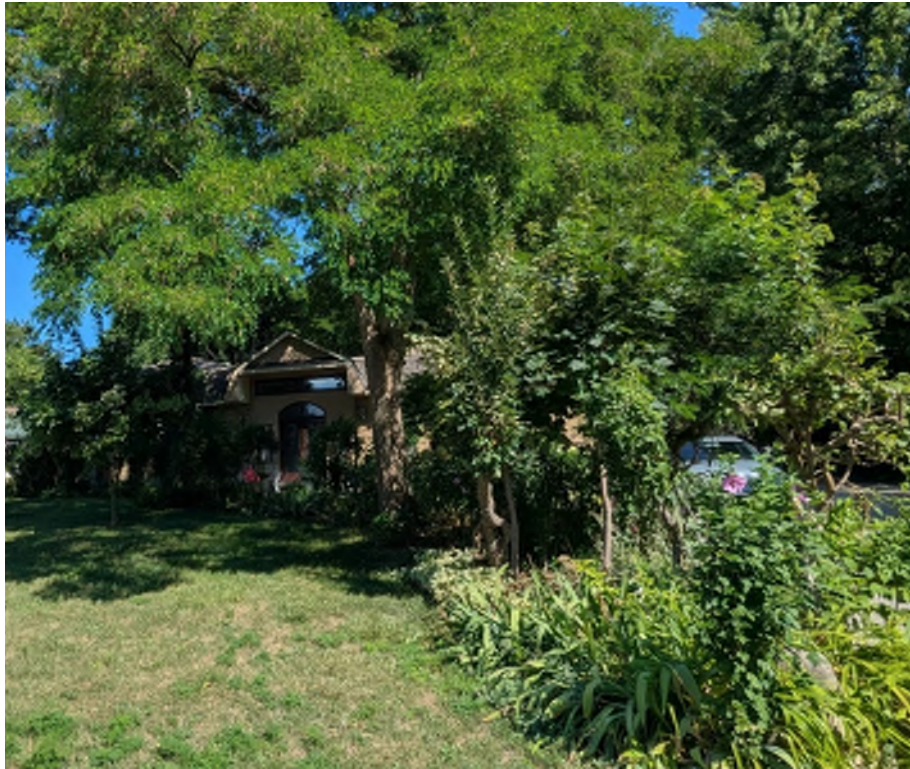
**Figure 26:** View of the principal elevation of 36 Ellis Avenue. (MHBC, 2025)

The property located at 36 Ellis Avenue includes a one-storey single detached brick dwelling with an L-shaped plan and a hip-and-valley roof. While much of the dwelling was shielded from the public realm by mature trees and vegetation, some of the building's features could be observed including an arched transom above the double door principal entrance and a triangular pedimented portico at the principal elevation with a decorative motif. The grounds also include a grass lawn, mature trees, landscape plantings, and a driveway interfacing with Ellis Avenue.

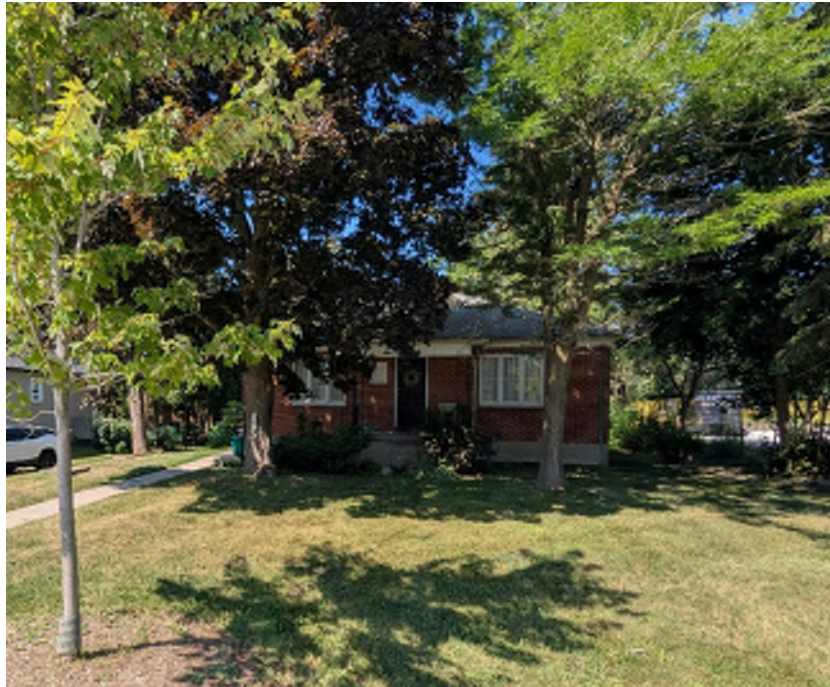
**Figure 27:** View of the principal elevation of 12918 Highway 27. (MHBC, 2025)

The property at 12918 Highway 27 currently includes a one-storey symmetrical single detached red brick bungalow with a hip roof. The building includes a concrete foundation and hip roofed portico above the principal entrance. The property also includes a parking pad and paved driveway interfacing with Highway 27, a concrete walkway providing access to the rear yard, mature and semi-mature trees, and a grass lawn.

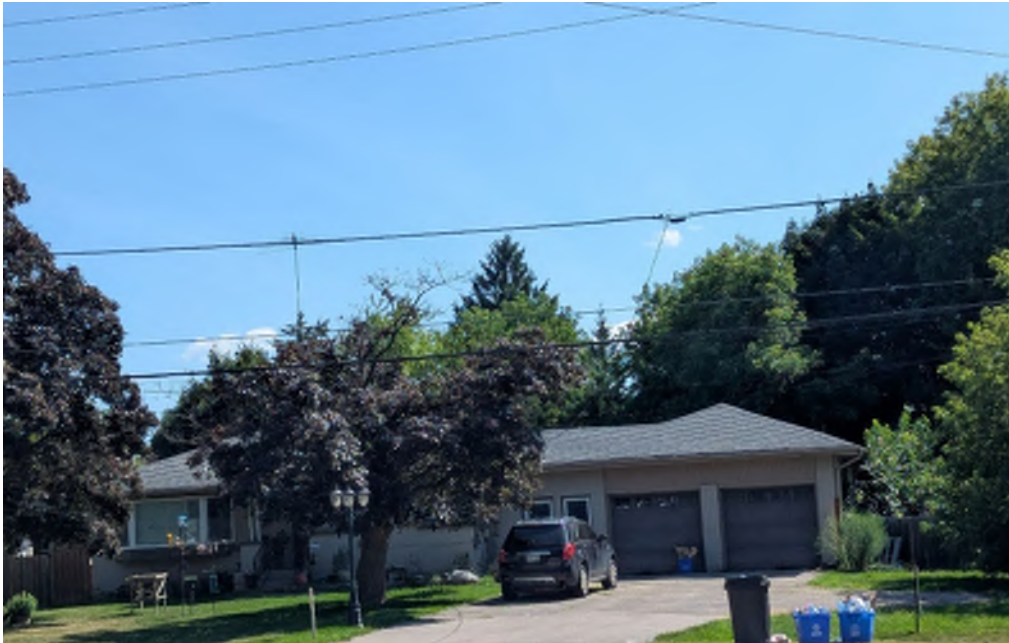
**Figure 28:** View of the principal elevation of 12911 Highway 27. (MHBC, 2025)

The property at 12911 Highway 27 is a corner property which includes a one-storey single detached dwelling in brick which has been painted. The building includes a hip-and-valley roof, chimney at the north elevation, and attached double garage. Original openings are rectangular and the property also includes a paved driveway interfacing with Highway 27 as well as a grass lawn and a wood fence enclosing the rear yard.

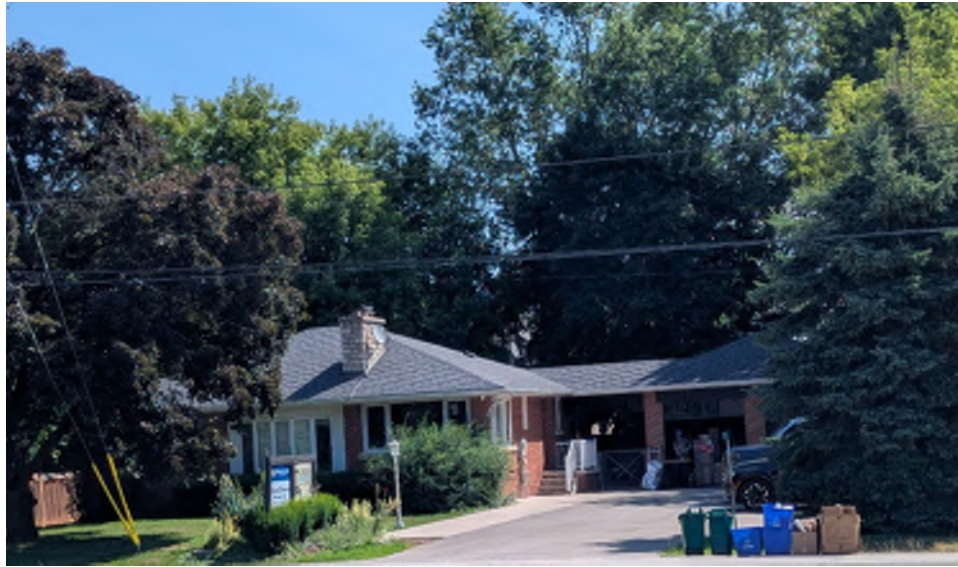
**Figure 29:** View of the principal elevation of 12901 Highway 27. (MHBC, 2025)

The property includes a red brick one-storey single detached dwelling with a hip roof and attached double garage. The principal entrance is located on the south (side) elevation and the building includes an open port connecting the house and garage. There is an internal stone chimney visible above the roofline and the window openings include concrete sills. The property also includes several mature trees, landscape plantings, a grass lawn as well as a paved driveway which interfaces with Highway 27.

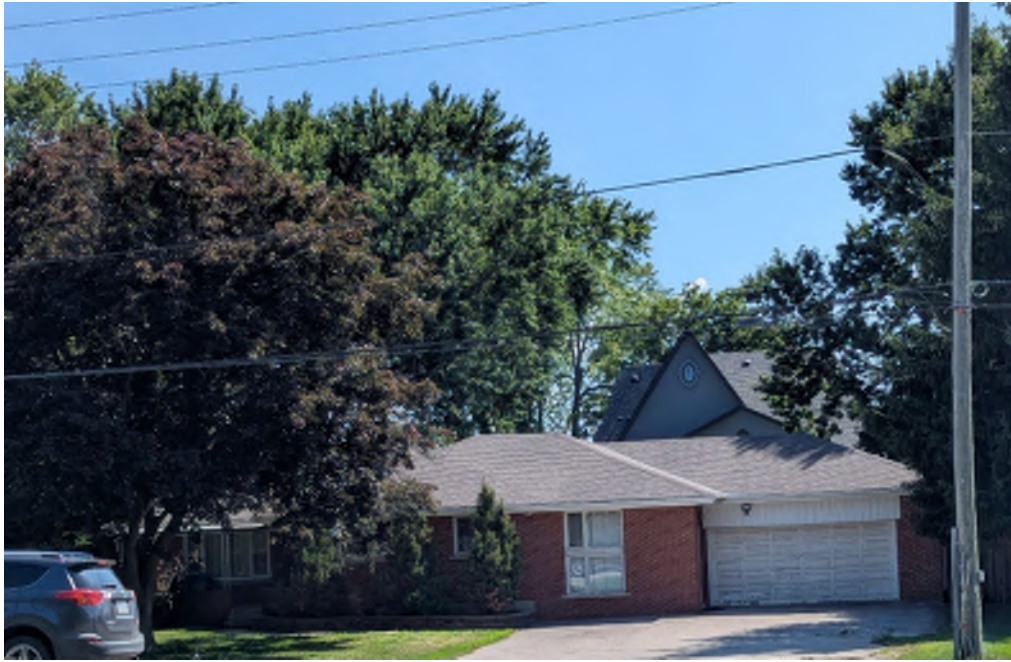
**Figure 30:** View of the principal elevation of 12891 Highway 27. (MHBC, 2025)

The property currently includes a one-storey red brick single detached dwelling with a hip-and-valley roof and attached garage. The building includes an asymmetrical entrance and rectangular openings. Windows include concrete sills. The property also includes two mature trees, a grass lawn, and a paved driveway which interfaces with Highway 27.

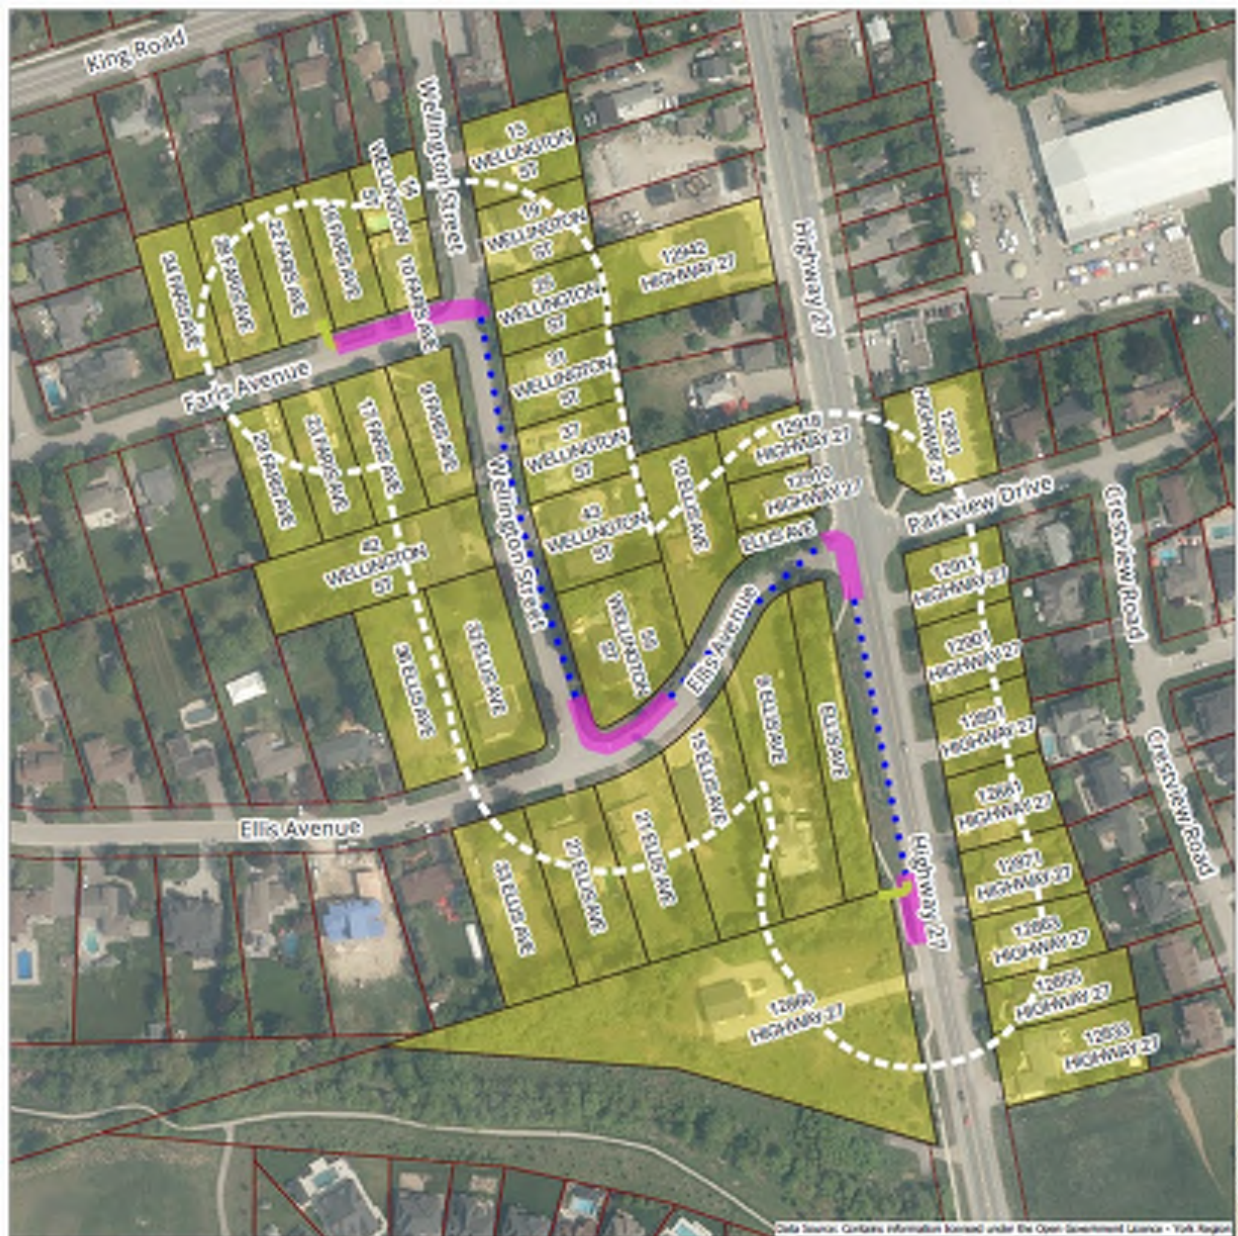
**Figure 2 - Project Area: Properties within 50m from Pipe Lines**

As the watermain component of these additional upgrades was not previously screened, it is the subject of this Heritage Impact Assessment addendum. The watermain component includes a combination of trench box excavation and horizontal directional drilling without excavation. The portions which include excavation are proposed to take place along the east portion of Faris Avenue west of Wellington Street, at the corner of Wellington Street and Ellis Avenue, at the corner of Ellis Avenue and Highway 27, and adjacent to 12860 Highway 27. The portions which include horizontal directional drilling without excavation are proposed to take place along Wellington Street between Faris Avenue and Ellis Avenue, along Ellis Avenue between Wellington Street and Highway 27, and along Highway 27 south of Ellis Avenue. Excavation sites are indicated in purple in **Figures 31** below and horizontal drilling sections are indicated with a blue dashed line. All proposed works are proposed to remain within the road right-of-way.

**Figure 31:** View of the proposed work with the trench excavation sites noted in purple and the horizontal drilling locations noted with a blue dashed line. (MHBC, 2025)

It is recommended that vibration monitoring be conducted during excavation and construction activities to ensure that adjacent potential BHRs are not adversely impacted due to vibrations for the duration of the proposed excavation and construction activities.

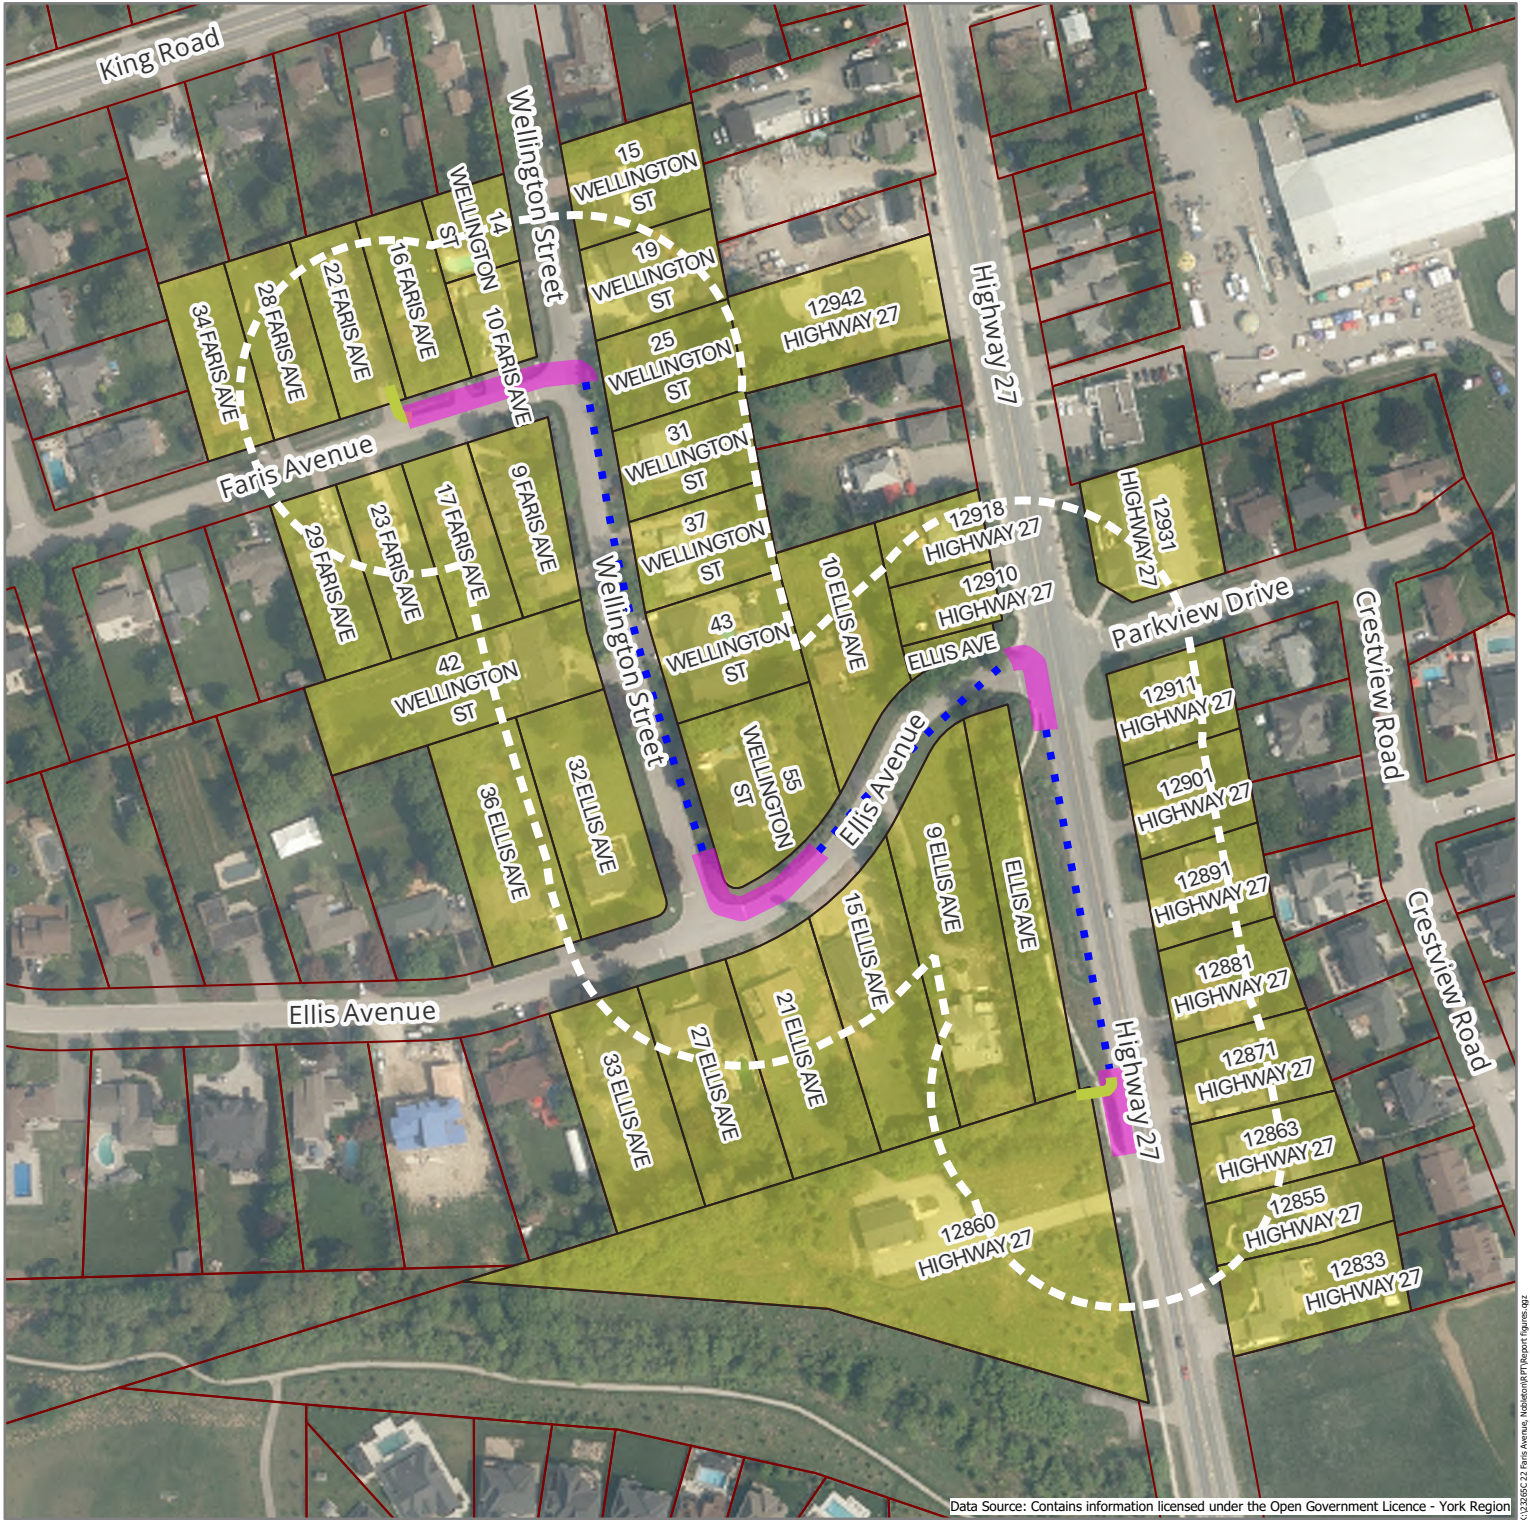
**Figure 2 - Project Area: Properties within 50m from Pipe Lines**

- Future Connection Point
- Proposed 300mm PVC WM (DR 18) - 1.8m Trench Boxes
- Proposed 300mm PVC (HDD) WM - No Excavation
- 50m Buffer

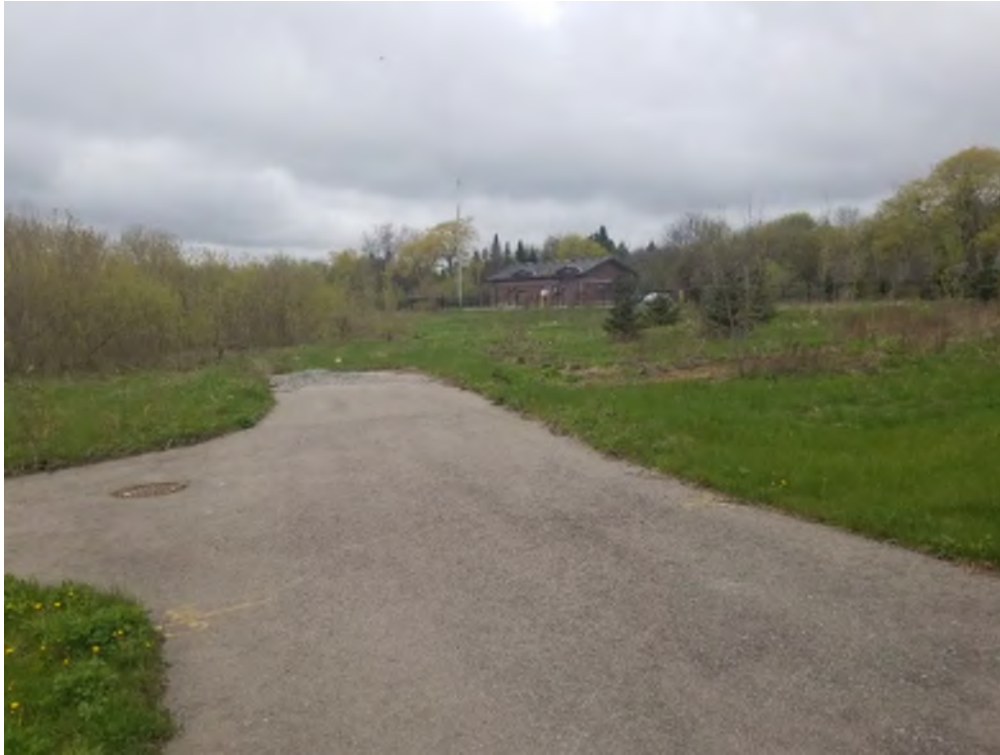
Plate 1: View northwest towards the pumphouse and treatment building and the naturalized area around the property.

The Well Site H property at 12860 Highway 27 includes the pumphouse and treatment building (Plate 1 and Plate 2). The property is surrounded by residential properties and a farm to the southeast along with a naturalized area along a tributary of King Creek. The tributary of King Creek flows from the northwest to southeast through the study area.

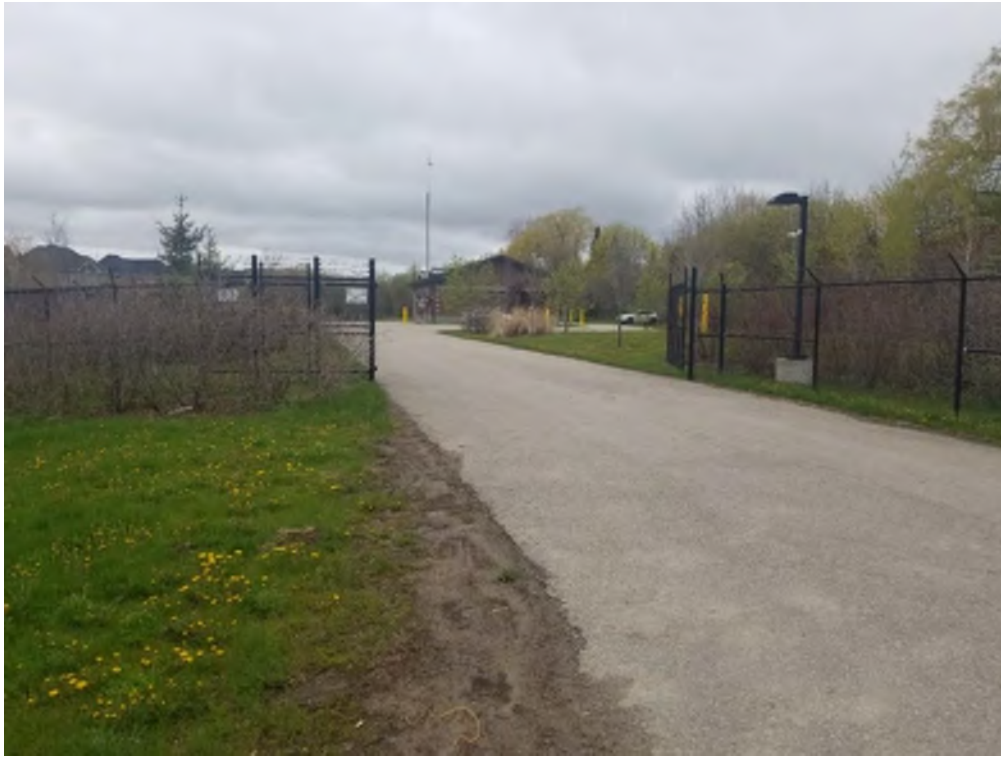
Plate 2: View west-northwest towards the pumphouse and treatment building.

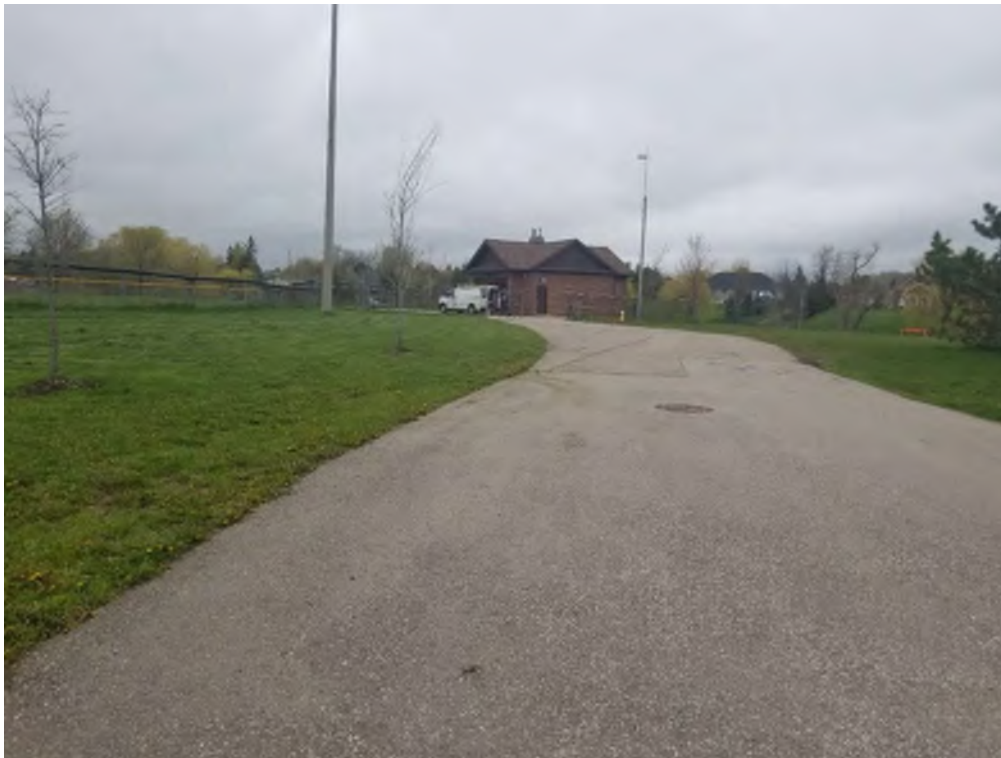
Plate 3: View northeast to the Janet Avenue SPS.

The eastern portion of the study area begins at the Janet Avenue SPS, located at 66 Janet Avenue (Plate 3). The Janet Avenue SPS includes the pumping station building. The surrounding area is the residential neighbourhood along Janet Avenue and the Nobleton Community Centre recreational fields. The study area travels northwards to King Road. A tributary of King Creek flows in a north-northwest to south-southeast orientation through the eastern portion of the study area.

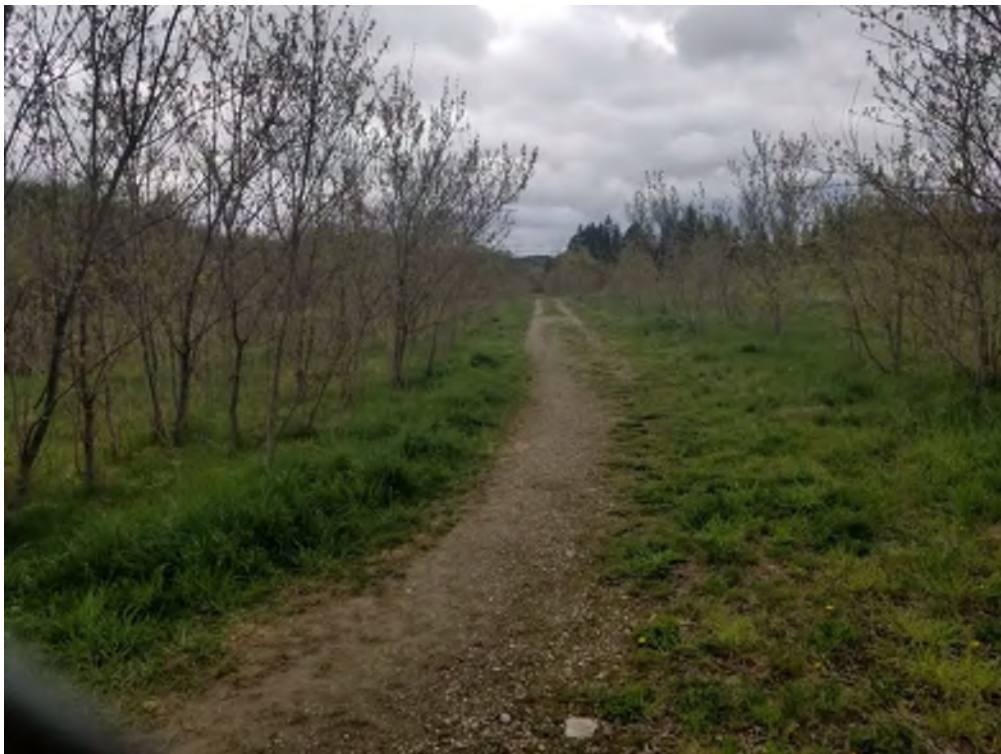
Plate 13: View of the trail south of the terminus of Concession Road 11, looking south.

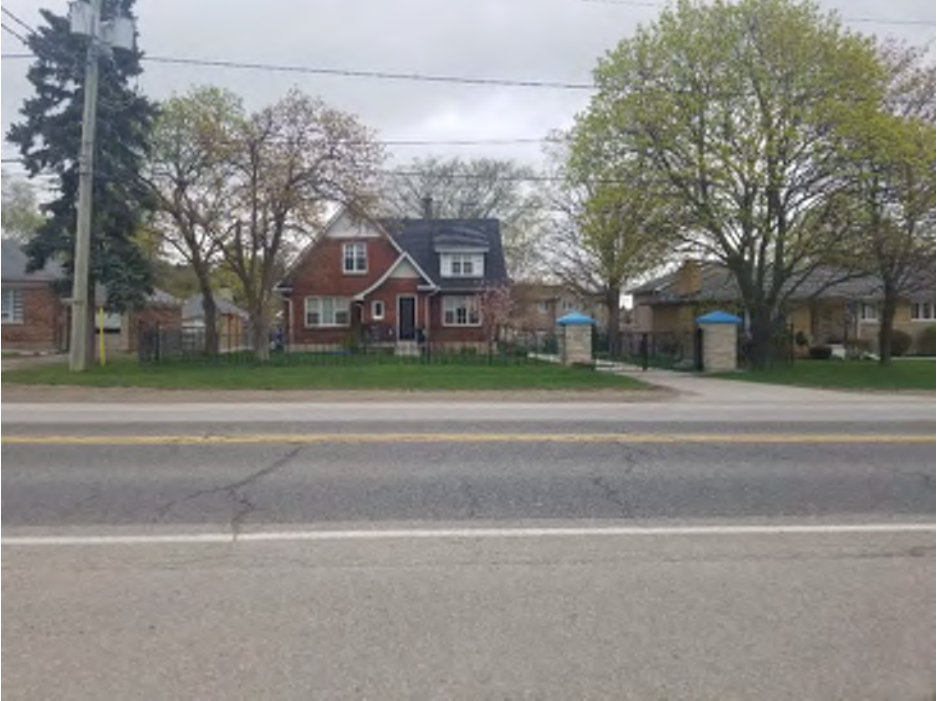
Feature ID	Type of Property	Address or Location	Heritage Status and Recognition	Description of Property and Known or Potential CHVI	Photographs/ Digital Image
BHR 1	Residence	12855 Highway 27	Potential BHR – Identified during background research and field review	<p>The residence is located east of Highway 27 and south of Parkview Avenue. The potential heritage attributes include the one-and-half storey Arts and Crafts red brick residence. The house features an asymmetrical front (western) elevation and L-shaped footprint. The 1954 aerial photography (Figure 5) depicts a residence in the location of the extant house.</p> <p>This property has the potential to retain historical, design, and contextual value as a twentieth-century residence within the community of Nobleton in the Township of King.</p>

<p>Plate 14: View east towards the residence at 12855 Highway 27.</p>
BHR 2	Residence	12863 Highway 27	Potential BHR – Identified during background research and field review	<p>The residence is located east of Highway 27 and south of Parkview Avenue. The potential heritage attributes include single-storey red brick bungalow. The house features a symmetrical front (western) elevation with a central door and large windows on either side and a hipped roof with small gable end above the front door. The 1954 aerial photography (Figure 5) depicts a residence in the location of the extant house.</p> <p>This property has the potential to retain historical, design, and contextual value as a twentieth-century residence within the community of Nobleton in the Township of King.</p>
