# Heritage Impact Assessment Addendum

Nobleton Water and  
Wastewater Upgrades

**Regional Municipality of York**

File no. 23265C

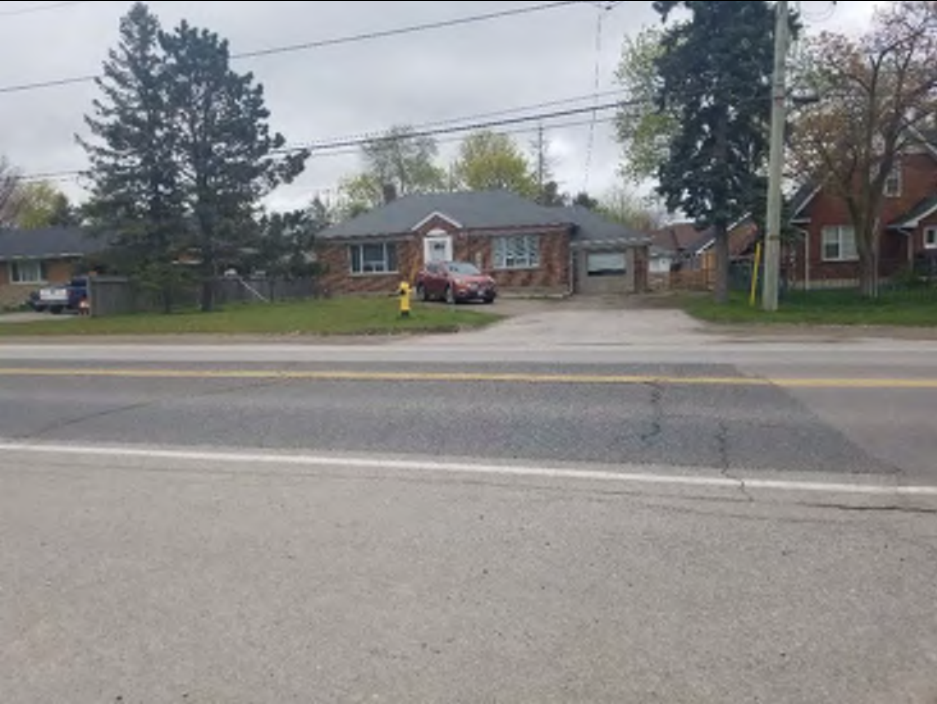
<p>Plate 15: View northeast towards the residence at 12863 Highway 27.</p>

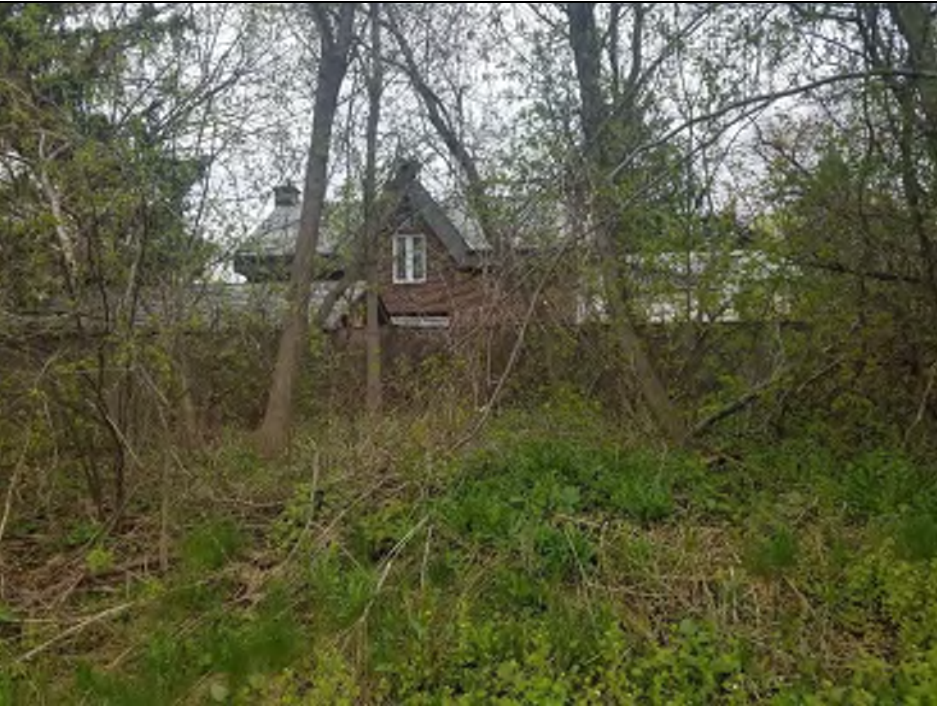
Feature ID	Type of Property	Address or Location	Heritage Status and Recognition	Description of Property and Known or Potential CHVI	Photographs/ Digital Image
BHR 3	Residence	9 Ellis Avenue	Known BHR – Listed on the <i>Cultural Heritage Property Inventory</i>	<p>The residence is located southwest of the Ellis Avenue and Highway 27 intersection. The known heritage attributes include the one-and-a-half storey residence with a gable roof and centre gable along the eastern elevation. The residence also features a western addition. The residence was obscured from the right-of-way by fencing and vegetation. The 1914 topographic map (Figure 4) depicts a brick or stone residence in the vicinity of the extant house.</p> <p>This property is listed on the <i>Cultural Heritage Property Inventory</i> for its <u>potential to retain cultural heritage value but has not been formally evaluated against the criteria outlined in <i>Ontario Regulation 9/06</i></u>. The property has potential to meet design and historical value as a late-nineteenth century residence within the community of Nobleton in the Township of King.</p>

<p>Plate 16:. View west towards the residence at 9 Ellis Avenue.</p>

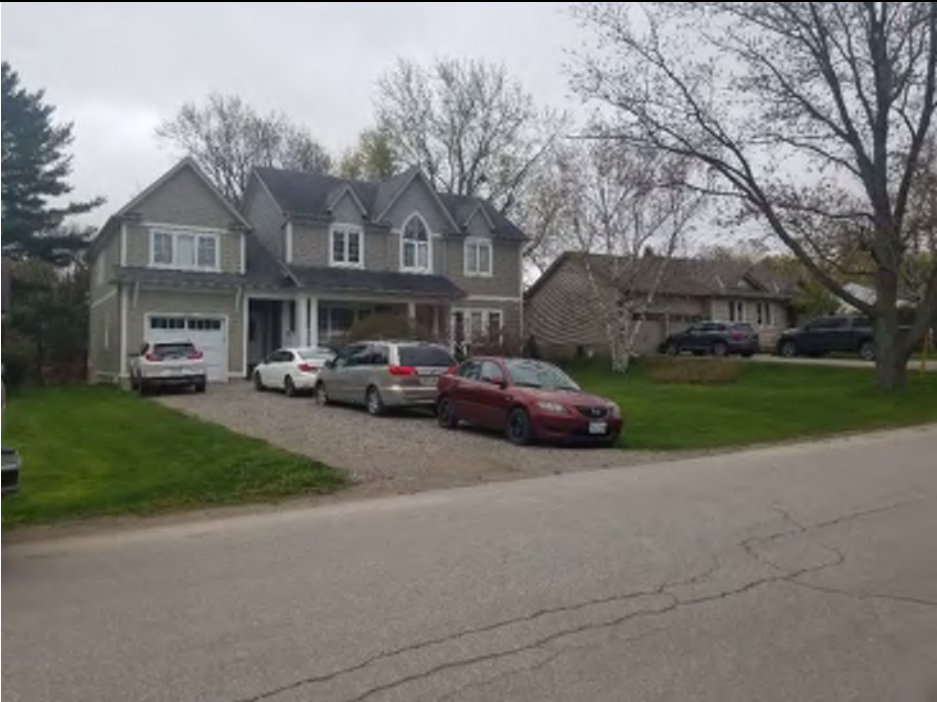
BHR 4	Residence	29 Faris Avenue	Potential BHR – Identified during background research and field review	<p>The residence is located south of Faris Avenue, roughly equidistant from Wellington Street and Kinsley Street. The potential heritage attributes include the two-storey residence with gable roof, centre gable, and two smaller gables to the east and west. The 1954 aerial photography (Figure 5) depicts a residence in the location of the extant house.</p> <p>This property has the potential to historical, design, and contextual value as a twentieth-century residence within the community of Nobleton in the Township of King.</p>

<p>Plate 17: View southwest towards the residence at 29 Faris Avenue.</p>

BHR 4	29 Faris Avenue	Well 2	As the recommended solution is to do nothing, no direct or indirect impacts are anticipated to the property at 29 Faris Avenue.	No further work required.
CHL 1	12805 Highway 27	Well 5/Site H	<p>No direct impacts are anticipated as the proposed work will not be taking place on the property at 12805 Highway 27.</p> <p>Indirect adverse impacts due to construction related vibration are possible as the structure sits within 50 m from the proposed work. These impacts are expected to be limited and temporary. No other indirect impacts are anticipated.</p>	To ensure this property is not adversely impacted during construction, baseline vibration monitoring should be undertaken during detailed design. Should this advance monitoring assessment conclude that any structures or landscape features on this property will be subject to vibrations, prepare and implement a vibration monitoring plan as part of the detailed design phase of the project to lessen vibration impacts related to construction.

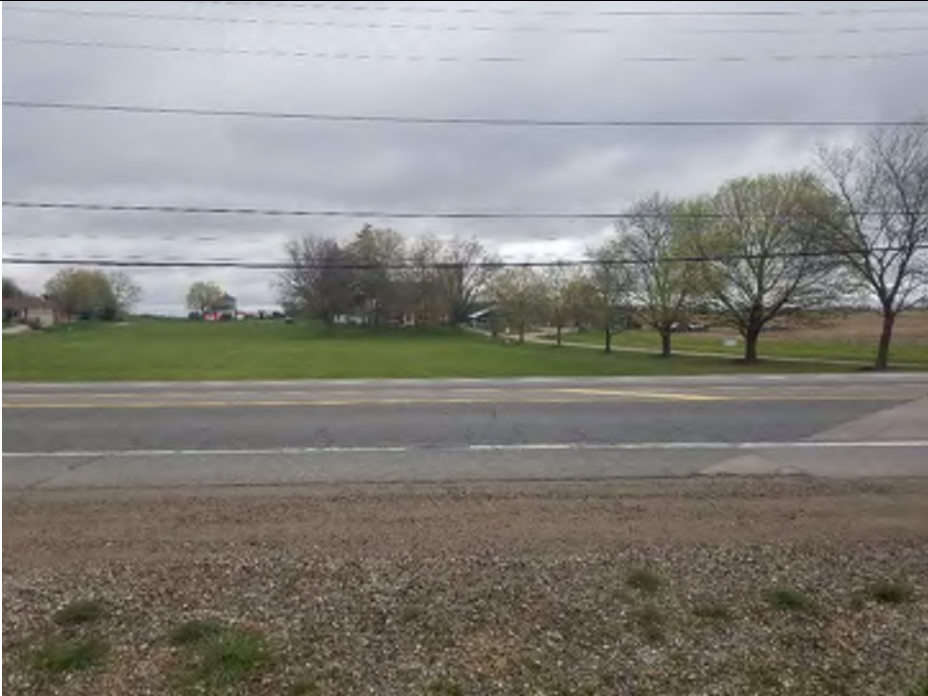
Feature ID	Type of Property	Address or Location	Heritage Status and Recognition	Description of Property and Known or Potential CHVI	Photographs/ Digital Image
CHL 1	Farmscape	12805 Highway 27	Known CHL – Listed on the <i>Cultural Heritage Property Inventory</i>	<p>The farmscape is located east of the Highway 27 and Oliver Emerson Avenue intersection. The known heritage attributes include the one-and-a-half storey red brick residence with a gable roof, and T-shaped footprint. The property also features barns, outbuildings, long tree-line driveway, a pond, and agricultural fields. The 1860 map (Figure 2) depicts a residence in the location of the extant house.</p> <p>This farmscape is listed on the <i>Cultural Heritage Property Inventory</i> for its <u>potential to retain cultural heritage value but has not been formally evaluated against the criteria outlined in <i>Ontario Regulation 9/06</i></u>. The property has potential to meet historical and contextual value as a late-nineteenth century farmscape in the Township of King.</p>

<p>Plate 18: View southeast towards the farmscape at 12805 Highway 27.</p>

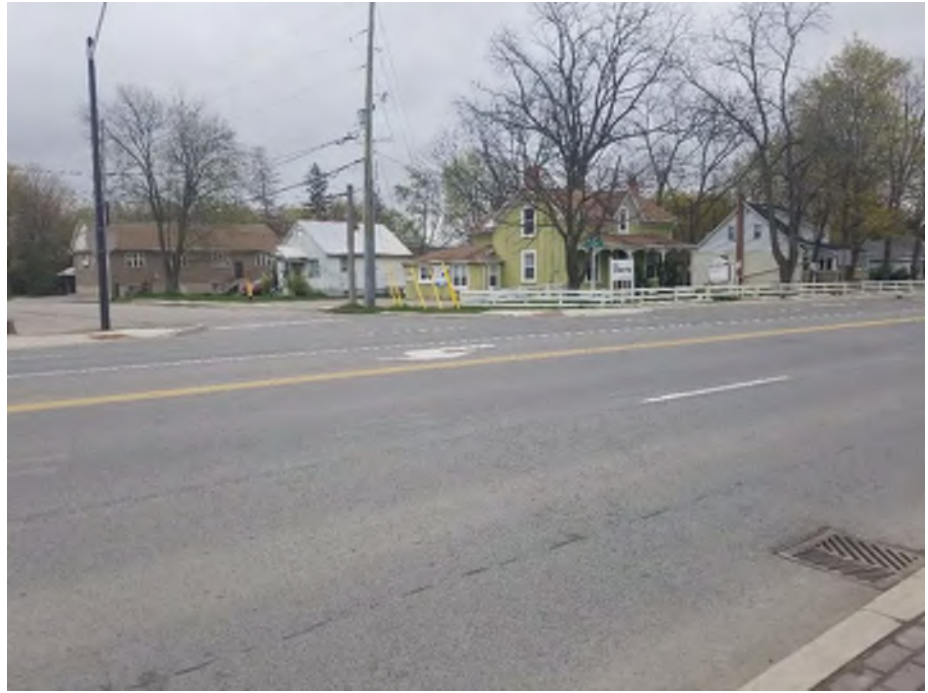
CHL 2	Settlement Centre	Nobleton Settlement Centre	Potential CHL – Identified during background research and field review	<p>This landscape is located in the historic downtown Nobleton and is generally focused around the King Road and Highway 27 intersection. The landscape extends westward to the west of Wellington Street, and includes many of the properties along Old King Road. The potential heritage attributes include the variety of nineteenth-century architectural styles, the mixture of residential and commercial, and the early- to mid-twentieth century recreational properties. The 1860 map (Figure 2) depicts the historic core of Nobleton.</p> <p>This settlement centre has the potential to retain historical and contextual value as a nineteenth-century settlement centre in the Township of King and the community of Nobleton.</p> <p>Within this CHL are the following properties, protected under the OHA:</p> <ul style="list-style-type: none"><li>- 7 Old King Road, listed on the <i>Cultural Heritage Property Inventory</i></li><li>- 12 Old King Road, listed on the <i>Cultural Heritage Property Inventory</i></li><li>- 15-19 Old King Road, designated under Part IV of the OHA (By-law # 2007-60). This property is directly adjacent to the Janet Avenue SPS and contains a recreational complex. The Nobleton Community Hall is a Depression era institutional building and is located at 19 Old King Road, approximately 350 northwest of the Janet Avenue SPS parcel. For additional information, please see the by-law available at:</li></ul>

<p>Plate 19: View southeast towards properties located along Old King Road and Highway 27 in the Nobleton Settlement centre.</p>

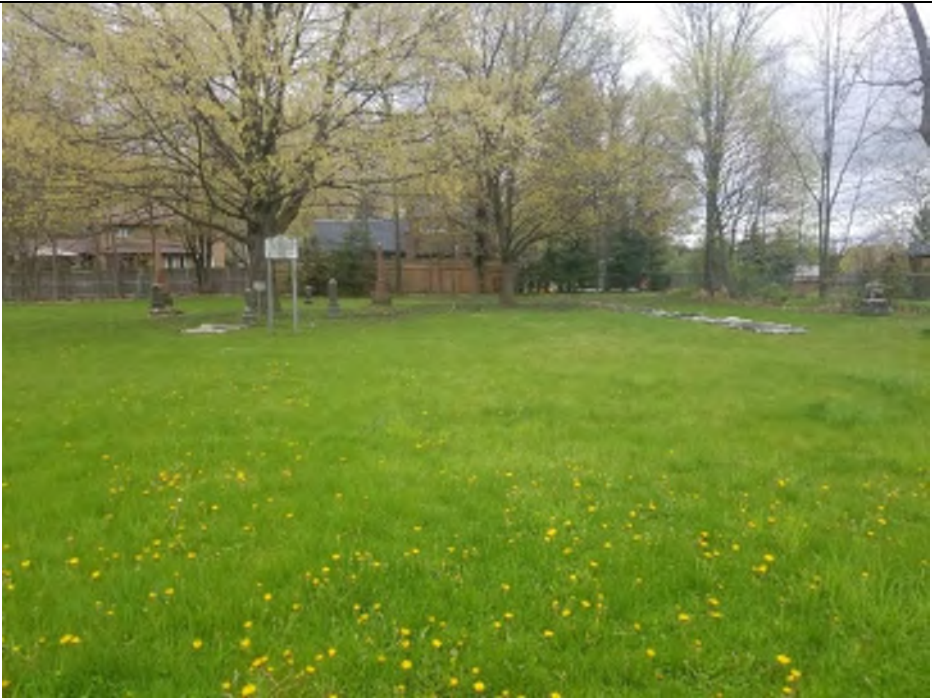
CHL 3	Cemetery	6400 King Road	Known CHL – Designated Part IV (By-law # 2009-109)	<p>The cemetery is located north of King Road and east of Nobleview Drive. The known heritage attributes include the variety of styles of the original grave markers and monuments, the placement of the markers and monuments, the grassy landscape, and the mature trees (Township of King 2009). The 1914 map (Figure 4) depicts a cemetery in the location of the extant cemetery.</p> <p>The property has historical and contextual value as a mid- to late-nineteenth-century cemetery through its connection to many early families of the village of Nobleton, and its influence on the continued rural character of the immediate landscape. For additional information, please see the by-law available at: <a href="https://www.heritagetrust.on.ca/en/oha/details?id=3991&amp;backlinkslug=search-results&amp;fields%5Blocation%5D=51%2C196">https://www.heritagetrust.on.ca/en/oha/details?id=3991&amp;backlinkslug=search-results&amp;fields%5Blocation%5D=51%2C196</a></p>

<p>Plate 20: View north towards the cemetery at 6400 King Road.</p>

CHL 3	6400 King Road	Forcemain	As the recommended solution does not require twinning of the forcemain and outfall, no direct or indirect impacts are anticipated to the property at 6400 King Road.	No further work required.
CHL 4	6770 King Road	Forcemain	As the recommended solution does not require twinning of the forcemain and outfall, no direct or indirect impacts are anticipated to the property at 6770 King Road.	No further work required.

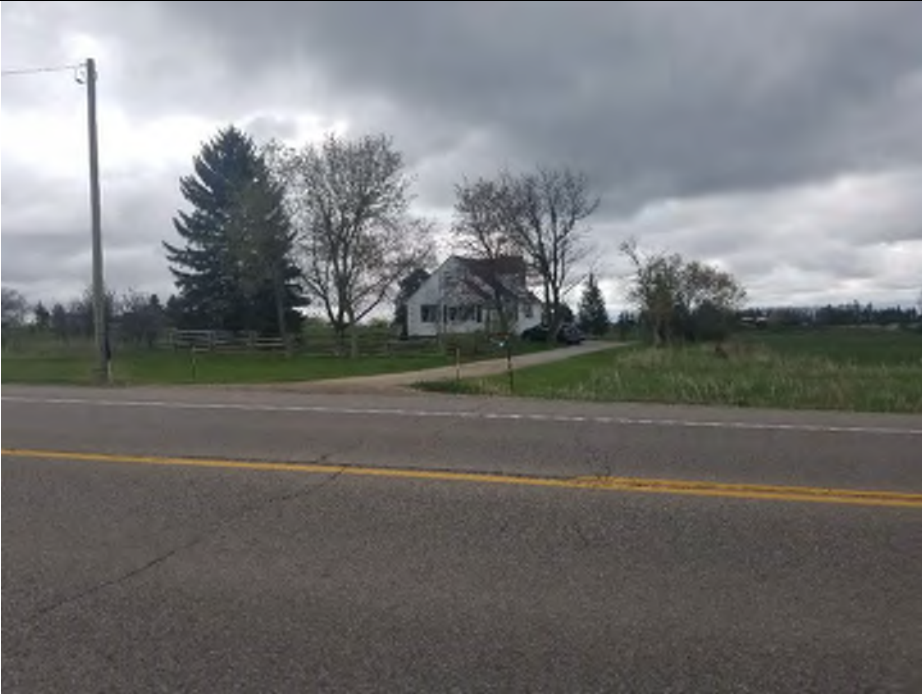
CHL 5	Former Farmscape	6845 King Road	Potential CHL – Identified during background research and field review	<p>The former farmscape is located south of King Road west of Concession Road 10. The potential heritage attributes include the one-and-a-half storey residence with a gable roof and dormer window on the western elevation, the driveway, and mature trees. The agricultural fields surrounding the property may have been formerly associated with the property. The 1914 map (Figure 4) depicts a wooden structure in the location of the extant house.</p> <p>This property has the potential to retain historical and contextual value as a twentieth-century farmscape in the Township of King.</p>

<p>Plate 22: View southeast towards the residence at 6845 King Road.</p>

Feature ID	Location/Name	Project Component	Type and Description of Potential/Anticipated Impact	Mitigation Strategies
CHL 5	6845 King Road	Forcemain	As the recommended solution does not require twinning of the forcemain and outfall, no direct or indirect impacts are anticipated to the property at 6845 King Road.	No further work required.
CHL 6	7300 King Road	Forcemain	As the recommended solution does not require twinning of the forcemain and outfall, no direct or indirect impacts are anticipated to the property at 7300 King Road.	No further work required.
CHL 7	7305 King Road	Nobleton WRRF	<p>No direct impacts are anticipated as the proposed work will not be taking place on the properties within the property at 7305 King Road.</p> <p>Indirect adverse impacts due to construction related vibration are possible as the structure sits within 50 m from the proposed work. These impacts are expected to be limited and temporary. No other indirect impacts are anticipated.</p>	To ensure this property is not adversely impacted during construction, baseline vibration monitoring should be undertaken during detailed design. Should this advance monitoring assessment conclude that any structures or landscape features on this property will be subject to vibrations, prepare and implement a vibration monitoring plan as part of the detailed design phase of the project to lessen vibration impacts related to construction.

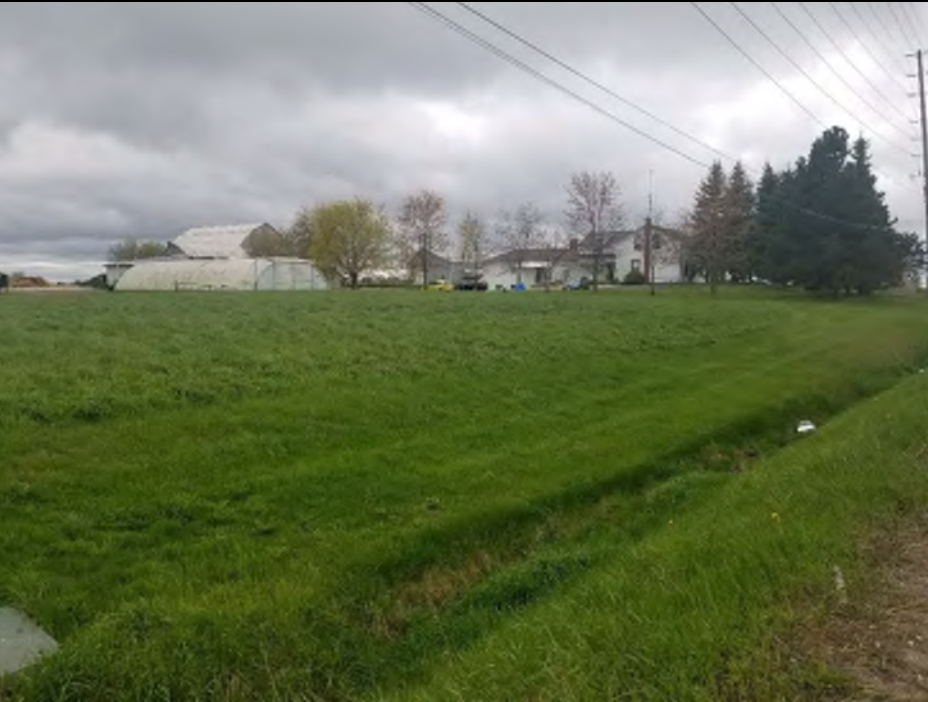
CHL 7	Farmscape	7305 King Road	Known CHL – Listed on the <i>Cultural Heritage Property Inventory</i>	<p>The farmscape is located south of King Road and east of Concession Road 11. The known heritage attributes include the one-and-a-half storey frame residence, barns, outbuildings, mature trees, and agricultural fields. The 1878 map (Figure 3) depicts a structure in the vicinity of the extant house.</p> <p>This farmscape is listed on the <i>Cultural Heritage Property Inventory</i> for its <u>potential to retain cultural heritage value but has not been formally evaluated against the criteria outlined in <i>Ontario Regulation 9/06</i></u>. The property has potential to meet historical, design, and contextual value as a late-nineteenth century farmscape in the Township of King.</p>

<p>Plate 24: View west-southwest towards the farmscape at 7305 King Road.</p>

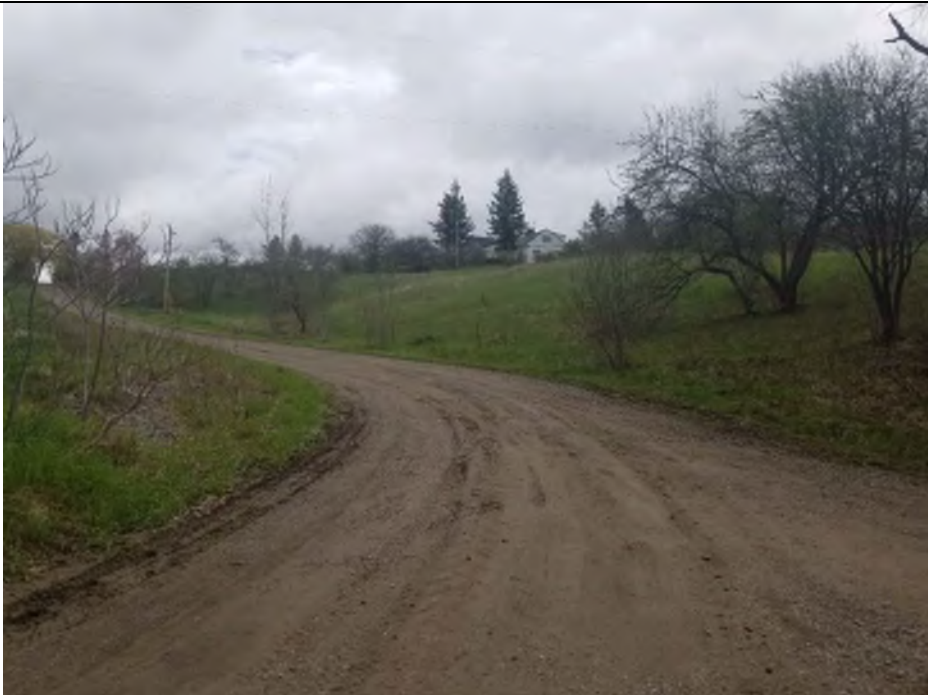
<p>Plate 25: View southeast towards the farmscape at 12705 Concession Road 11.</p>
CHL 9	Waterway	Humber River	Known CHL – Canadian Heritage River System	<p>The Humber River is located south of Concession Road 11 in a general east-west orientation. The known heritage attributes include its historical and contextual value as a significant waterway. Information on the designation of the Humber River as a Canadian Heritage River System, including its cultural and recreational values, is outlined on the <a href="#">Canadian Heritage Rivers System website</a>. The 1860 map (Figure 2) depicts the Humber River in a more north-south orientation. By the 1914 map (Figure 4) the orientation is more closely aligned with its present orientation.</p> <p>The Humber River is a Canadian Heritage River System with known cultural heritage value due to its historical and contextual value as a significant waterway, <u>but the river has not been formally evaluated against the criteria outlined in <i>Ontario Regulation 9/06</i></u>. The Humber River has potential to meet historical and contextual value as a significant waterway in Ontario.</p>

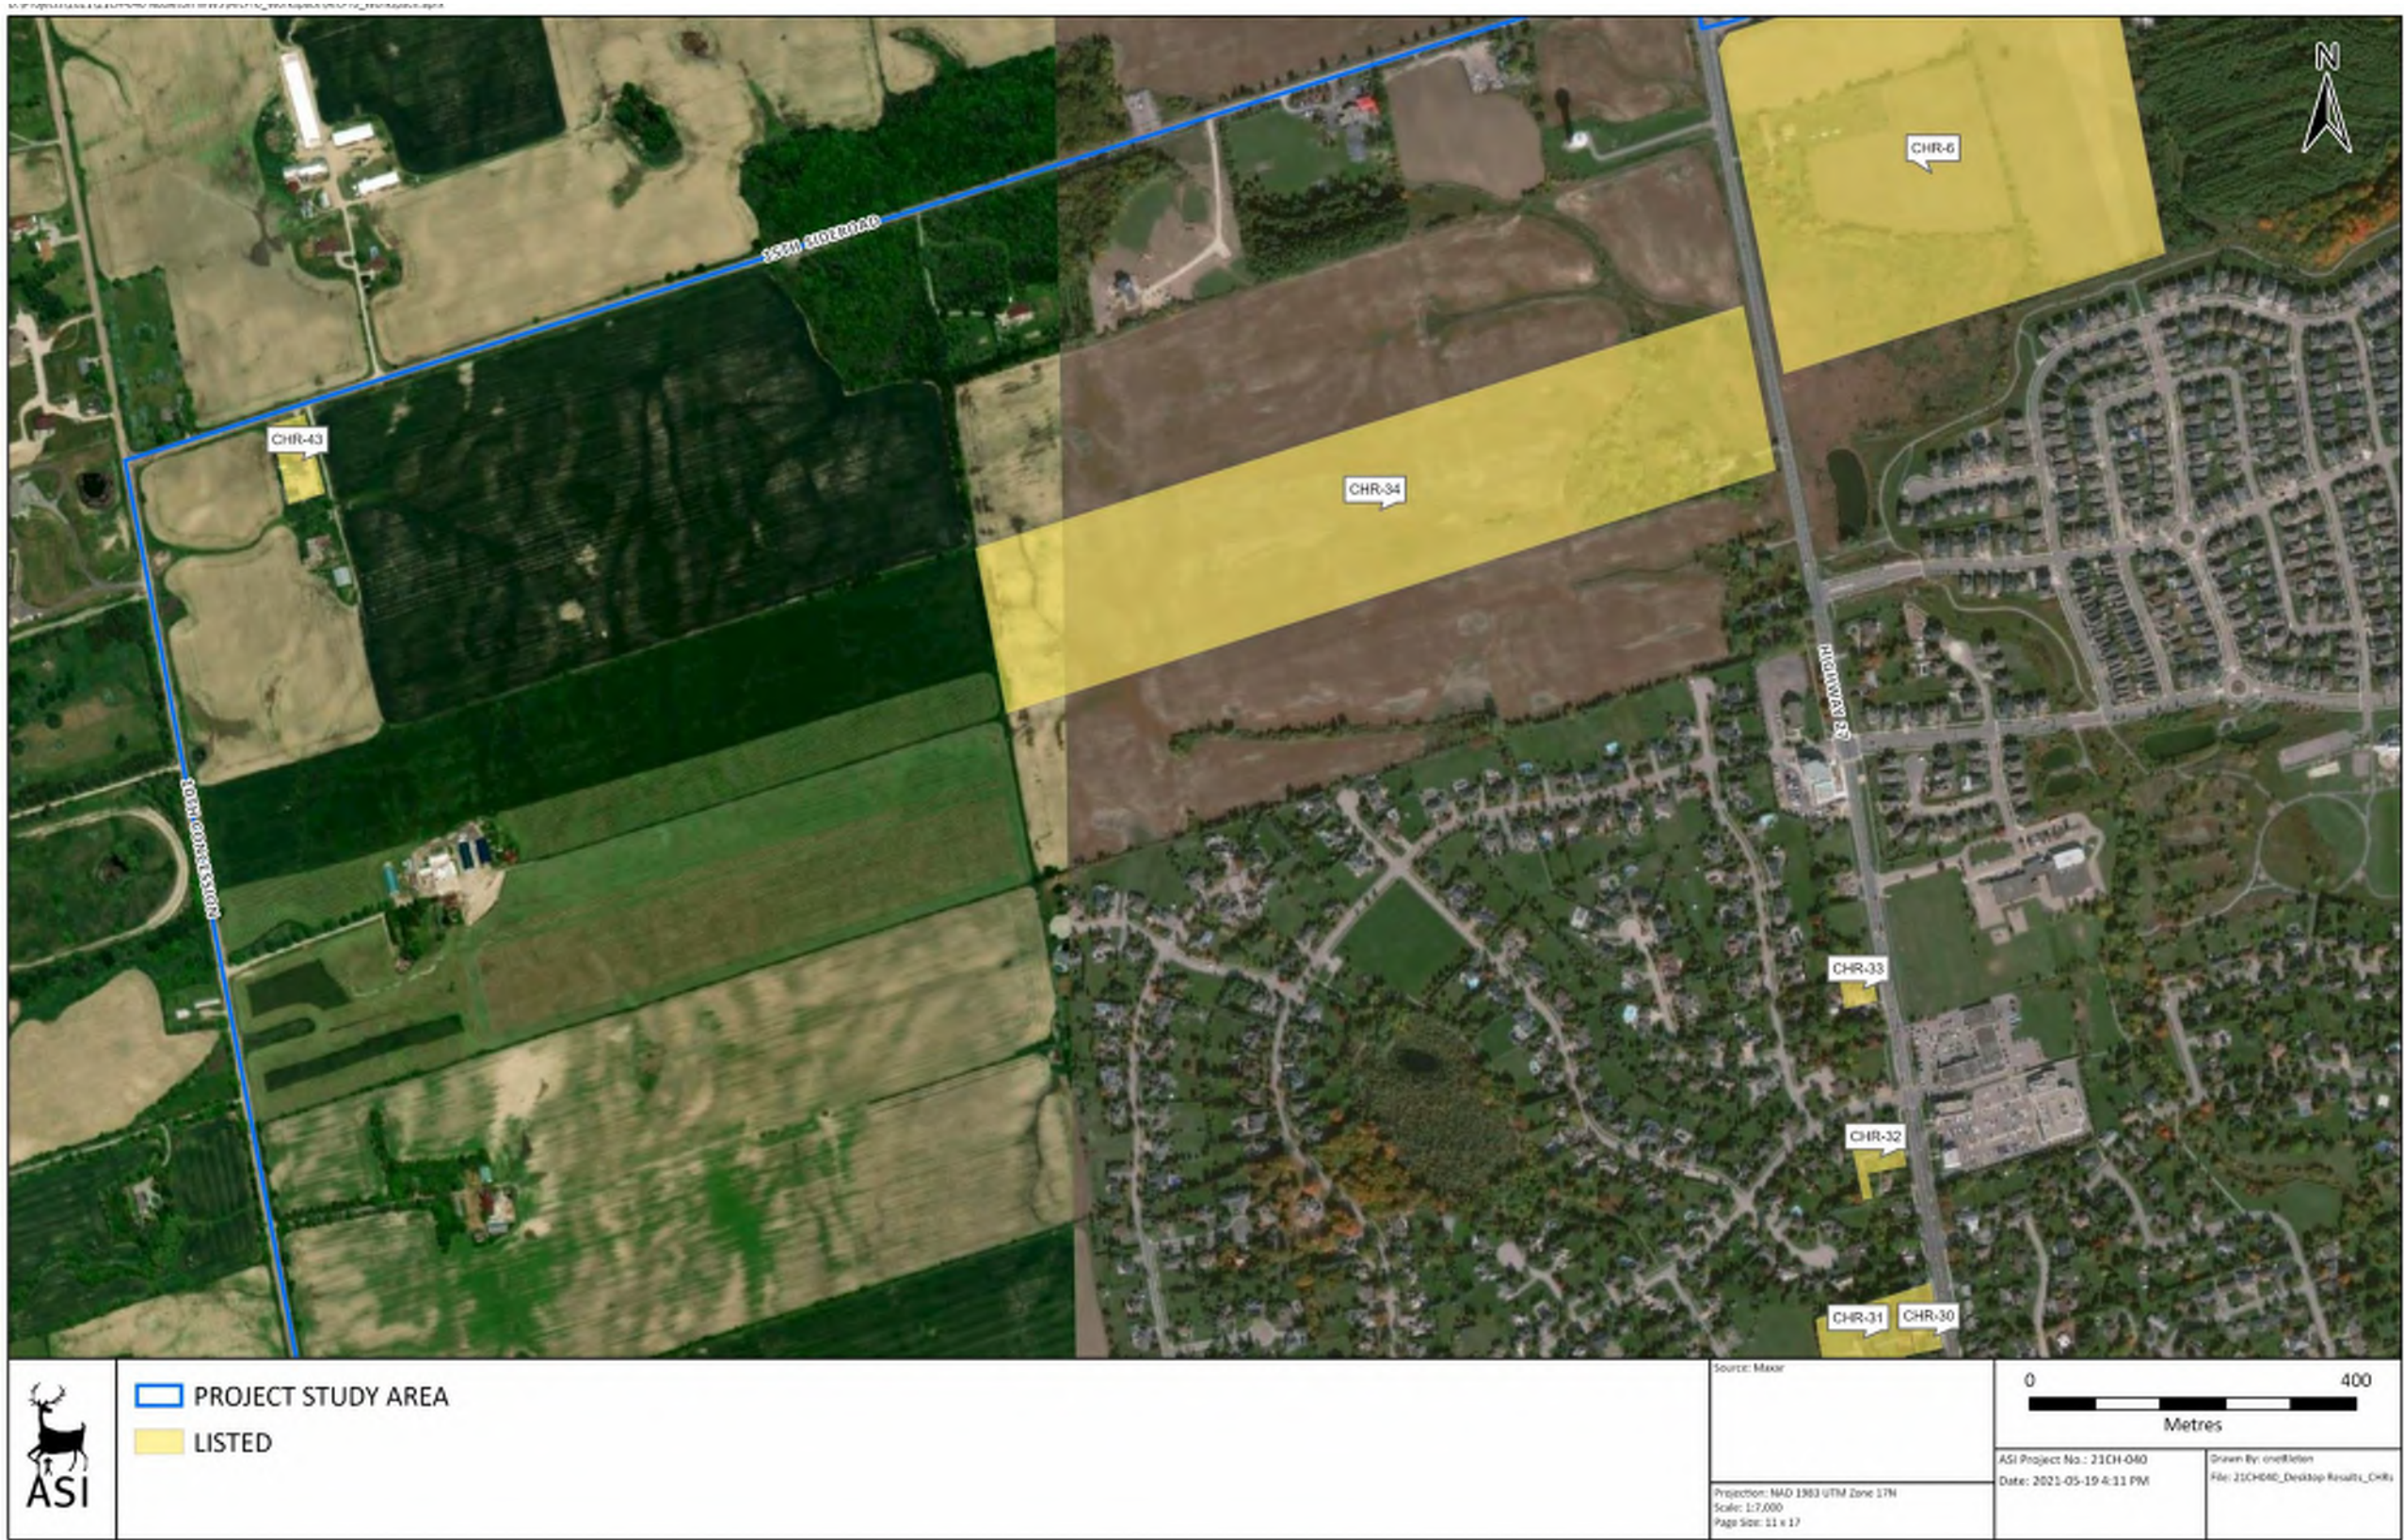
Figure 18: Location of Known Built Heritage Resources and Cultural Heritage Landscapes in the Overall Project Study Area (Sheet 4)

Based on the review of available municipal, provincial, and federal data, and the results of public consultation, there are 49 previously identified BHRs and CHLs within the overall project study area. These resources include properties designated under Part IV of the OHA (Designated Part IV), listed on the *Cultural Heritage Property Inventory* (Listed) (Township of King Heritage Committee 2008), rivers identified as a Canadian Heritage River System, and properties identified by the Ontario Heritage Trust (OHT) as Places of Worship. These properties are listed below and their locations are mapped in Figure 14 to Figure 21:
