APPENDIX D

SWM Pond Drawings

APPENDIX B: Existing Drainage Elements and Site Investigation Photos

Culvert/Site Inspection for Teston Road

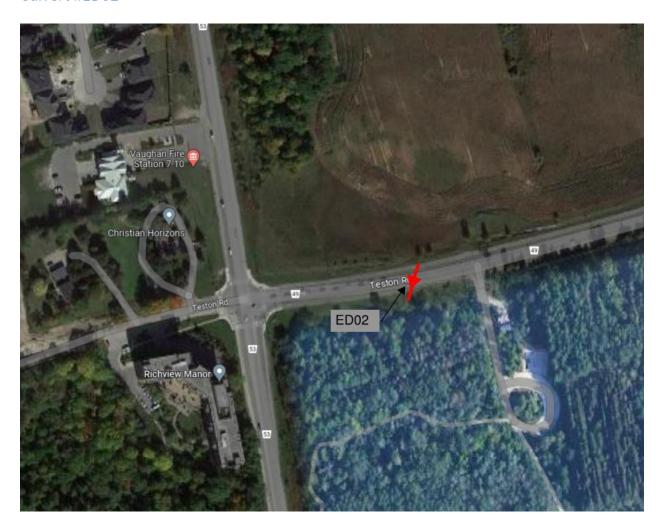
Culvert #ED02

Culvert Field Investiget	ion Data Sheet (Culvert #ED02)
Date (mm/dd/yy): 10/26/2022	Field Crew: Jenny Dai, Ken Luong
Client: York Region	Highway/Road No.: Teston rd.
Culvert Crossing Type: Centreline Culvert	Blockage in Culvert: no
Culvert Material: Concrete	Culvert Condition: Good
Culvert Shape: Circular	Inlet Condition: Good
Culvert Bottom:	Outlet Condition: Good
Culvert Flow Direction: SW (Downstream)	Additional Field Notes:
Culvert Size (mm): 31.5" (800mm)	Inlet: Near inlet, two small diameter trees (< 10cm)
Depth of Water in Culvert: no water	About 10 cm of sediment at inlet
	Outlet: Outlet has plunge pool
	Overall: Field measured 800mm concrete pipe, with HW
	Good condition, not much sediment
	no water
	Recommendation:

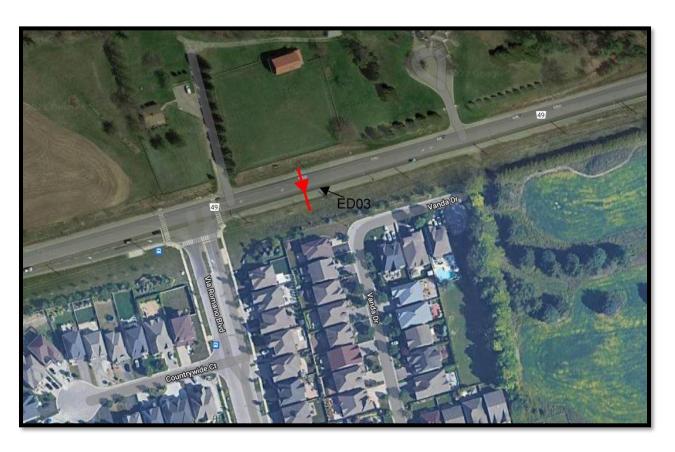
Culvert #ED03

Date (mm/dd/yy): 10/26/2022	Field Crew: Jenny Dai, Ken Luong
Client: York Region	Highway/Road No.: Teston Rd.
Culvert Crossing Type: Centreline Culvert	Blockage in Culvert: no
Culvert Material: Concrete	Culvert Condition: good
Culvert Shape: Circular	Inlet Condition: good
Culvert Bottom:	Outlet Condition: good
Culvert Flow Direction: north to south	Additional Field Notes:
Culvert Size (mm): 35.4" (900mm)	Inlet: Inlet invert perched by about 200mm; headwall
epth of Water in Culvert (mm):	
	Outlet: outlet has a headwall
	Outlet to ditch and ditch ID to into STM network
	Ditch and culvert flows into STM network via DI
	Recommendation:

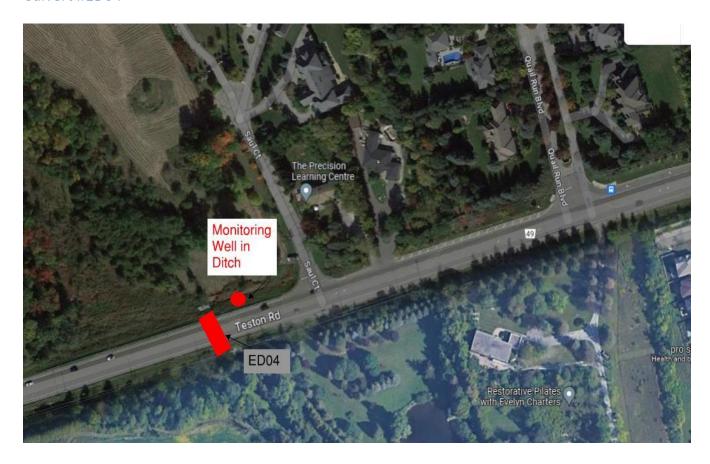
Culvert #ED04

Date (mm/dd/yy): 10/26/2022	tion Data Sheet (Culvert #ED04) Field Crew: Jenny Dai, Ken Luong
Client: York Region	Highway/Road No.: Teston rd.
Culvert Crossing Type: Centreline Culvert	Blockage in Culvert: no
Culvert Material: Concrete	Culvert Condition: good
Culvert Shape: Box	Inlet Condition: good
Culvert Bottom: Open footing	Outlet Condition: good
Culvert Flow Direction: North to South	Additional Field Notes:
Culvert Size (mm): 23.6" * 70.9" (6000mm*1800mm)	
Depth of Water in Culvert (mm.)	Inlet: Field measured opening= 1500mm under slab to top of sediment
Depth of Water in Galvert (min)	Seament
	Outlet: Field measured opening= 1400mm under slab to top of
	sediment
	Overall: measured outside span = 732cm
	wall thickness = 40cm
	approximate inside span = 650cm
	Skew to roadway alignment
	Recommendation:

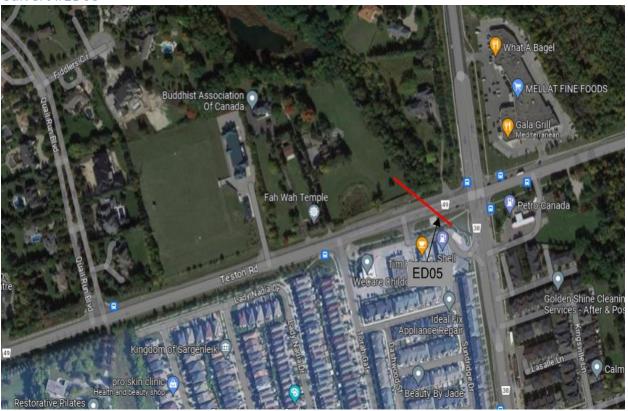
Culvert #ED05

Date (mm/dd/yy): 10/26/2022	Field Crew: Jenny Dai, Ken Luong
Client: York Region	Highway/Road No.: Teston Rd.
Culvert Crossing Type: Centreline Culvert	Blockage in Culvert: no
Culvert Material: Concrete (Upstream End) with gabion	Culvert Condition: good
Culvert Shape: Circular	Inlet Condition: good
Culvert Bottom:	Outlet Condition: N/A
Culvert Flow Direction: north to south	Additional Field Notes:
Culvert Size (mm): 55" (1050mm)	Inlet:
Depth of Water in Culvert (mm): 0.78" (20mm)	
	Field measured 1000mm concrete pipe embedded with stone substrate 2cm of water Outlet: Cannot see through to another end, suspect pipe is connected to STM sewer downstream
	Recommendation:

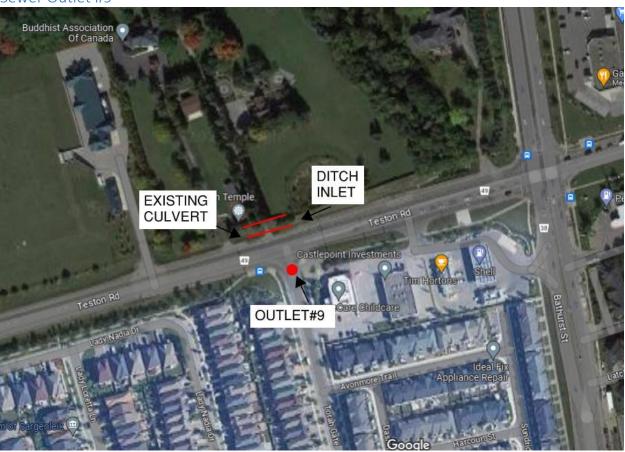
Sewer Outlet #9

Field Investigation Data Sheet (Outlet Sewer #9)	
Date (mm/dd/yy): 10/26/2022	Field Crew: Jenny Dai, Ken Luong
	Highway/Road No.: Teston Rd.
	Additional Field Notes:
Client: York Region	Twin CSP above outlet 9 (800mm * 12.06mm and 800mm *
	12.01mm)

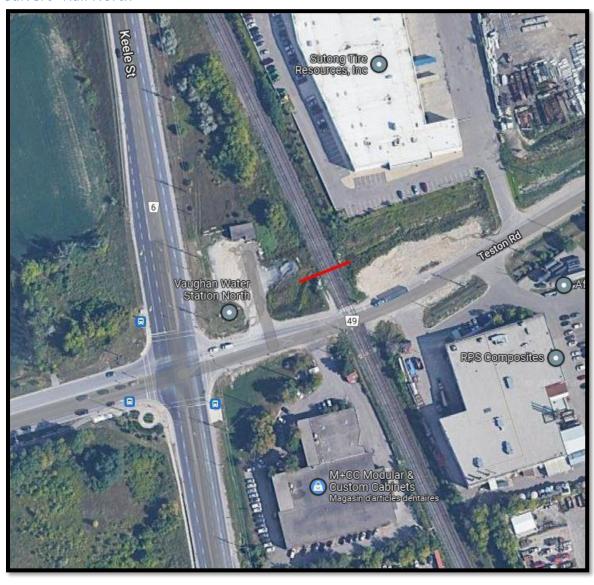
Culvert "Rail North"

ray/Road No.: Railway age in Culvert: rt Condition: good Condition: good Condition: good
rt Condition: good Condition: good Condition: good
Condition: good Condition: good
Condition: good
onal Field Notes:
nll: Field measured 900mm concrete pipe
rt inlet, about 180cm water depth,
of sediment.
n seument.
mmendation:

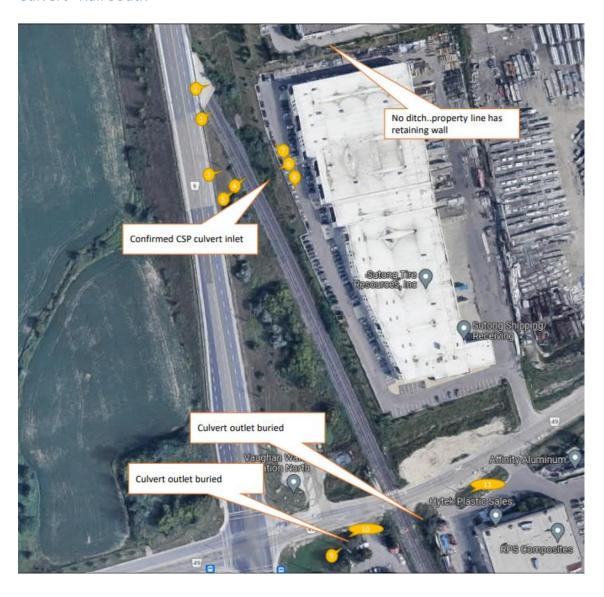
Culvert "Rail South"

gation Data Sheet (Culvert "Rail South")
Date (mm/dd/yy): 07/11/2023	Field Crew: Ken Luong
Client: York Region	Highway/Road No.: Railway
Culvert Crossing Type:	Blockage in Culvert:
Culvert Material: concrete	Culvert Condition:
Culvert Shape: circular	Inlet Condition: good
Culvert Bottom:	Outlet Condition: buried
Culvert Flow Direction: East to West	Additional Field Notes:
Culvert Size (mm): 450	
Depth of Water in Culvert (mm <i>):</i>	Overall: Culvert crosses entrance roadway and railway
	Recommendation:

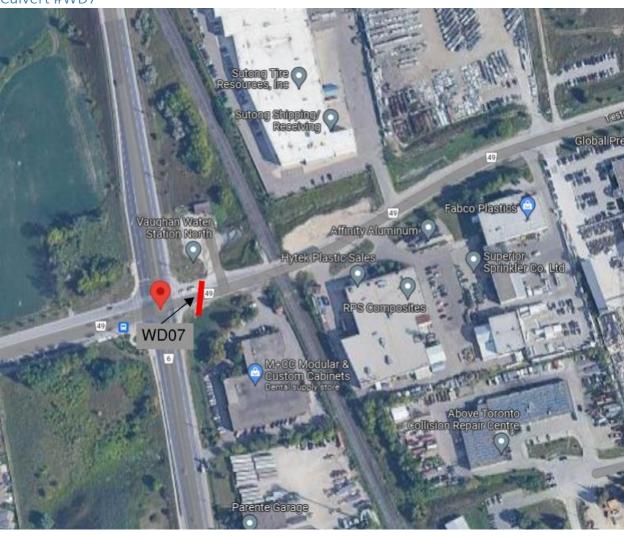
Culvert #WD7

Culvert Field Investigation Data Sheet (Culvert #WD7)	
Date (mm/dd/yy): 10/26/2022	Field Crew: Jenny Dai, Ken Luong
Client: York Region	Highway/Road No.: Teston Rd.
Culvert Crossing Type: Centreline Culvert	Blockage in Culvert:
Culvert Material: CSP - Corrugated Steel Pipe	Culvert Condition: good
Culvert Shape: Circular	Inlet Condition: good
Culvert Bottom:	Outlet Condition: collapsed
Culvert Flow Direction:	Additional Field Notes:
Culvert Size (mm): 53.1" (1350mm)	
Depth of Water in Culvert (mm):	Overall:
	Field measured 1350mm CSP (u/s) - About 5cm of flowing water There is low lying area draining towards the culvert. But construction at time of visit obstructed actual ditch grades. Recommendation:
