Appendix U - Part 1

Contamination Overview Study Report

**Contamination Overview Study
Warden Avenue and Kennedy Road
between Major Mackenzie Drive East
and Elgin Mills Road East**

**January 2023
300052314.0000**

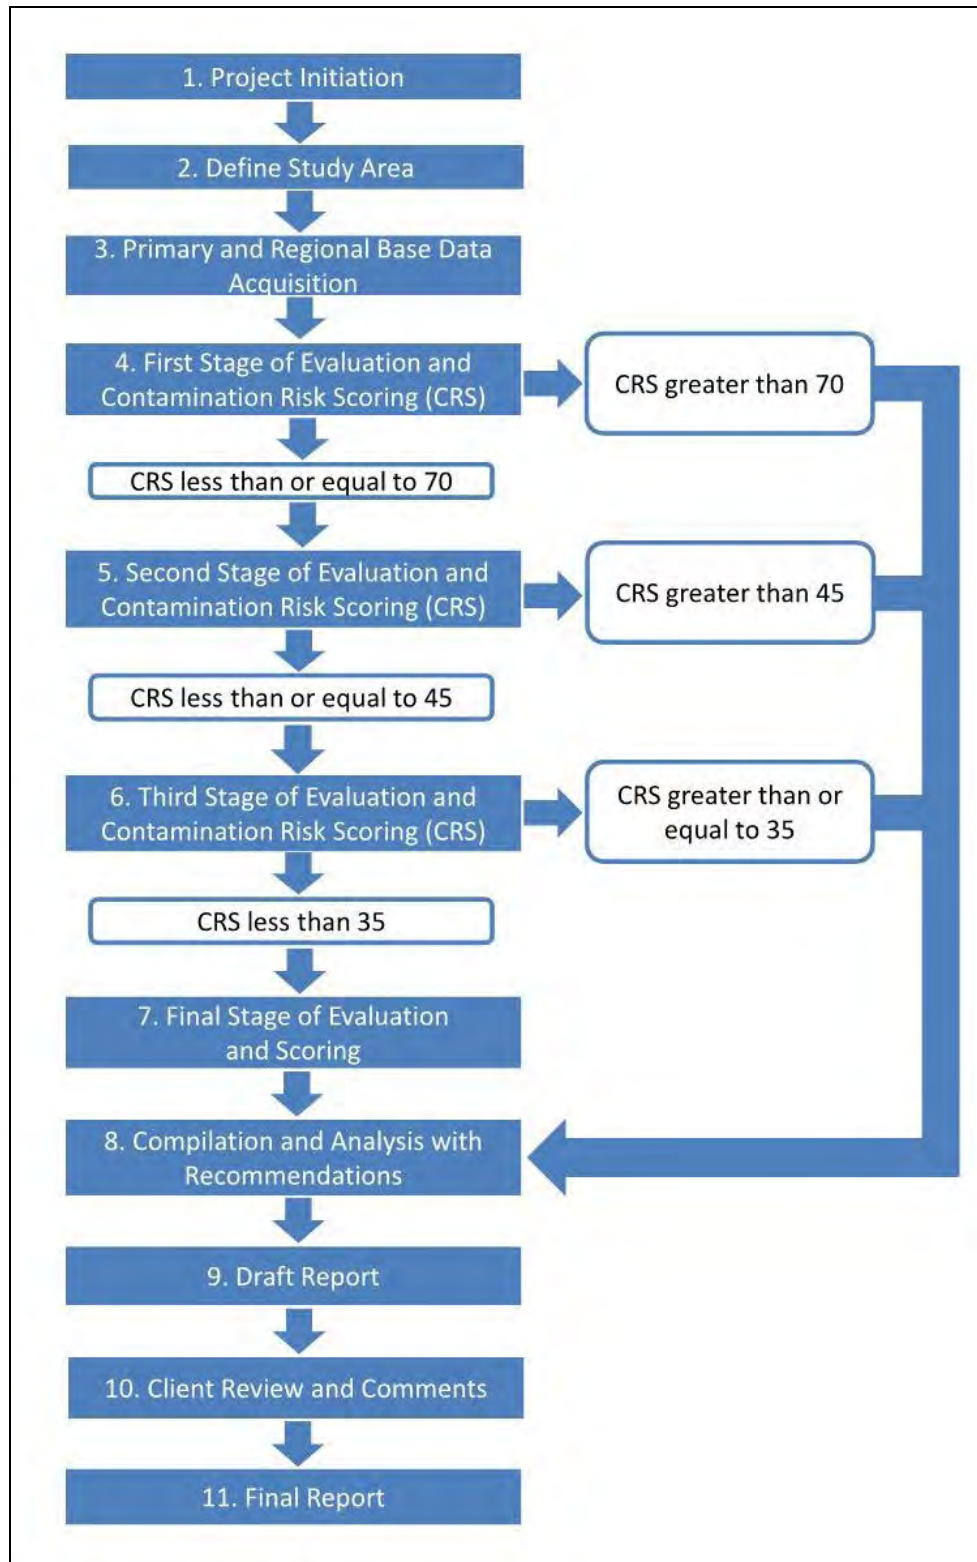
Chart 1: Contamination Overview Study Flow Chart

Chart 1 is a flow chart which displays the general steps of the COS process to evaluate and score an individual Site.

As shown in Chart 1, the evaluation is based on a step-by-step iterative process where each Site is screened and scored until each is defined within one of the environmental risk categories noted above. As shown, once a Site has been determined to be High Environmental Concern, it is no longer scrutinized in detail as the risk level determined by the CRS cannot be lowered, and as such, any additional scrutiny is of limited value to the final outcome and recommendations. This same approach is taken with each successive screening step. Further details are provided below to support Chart 1.

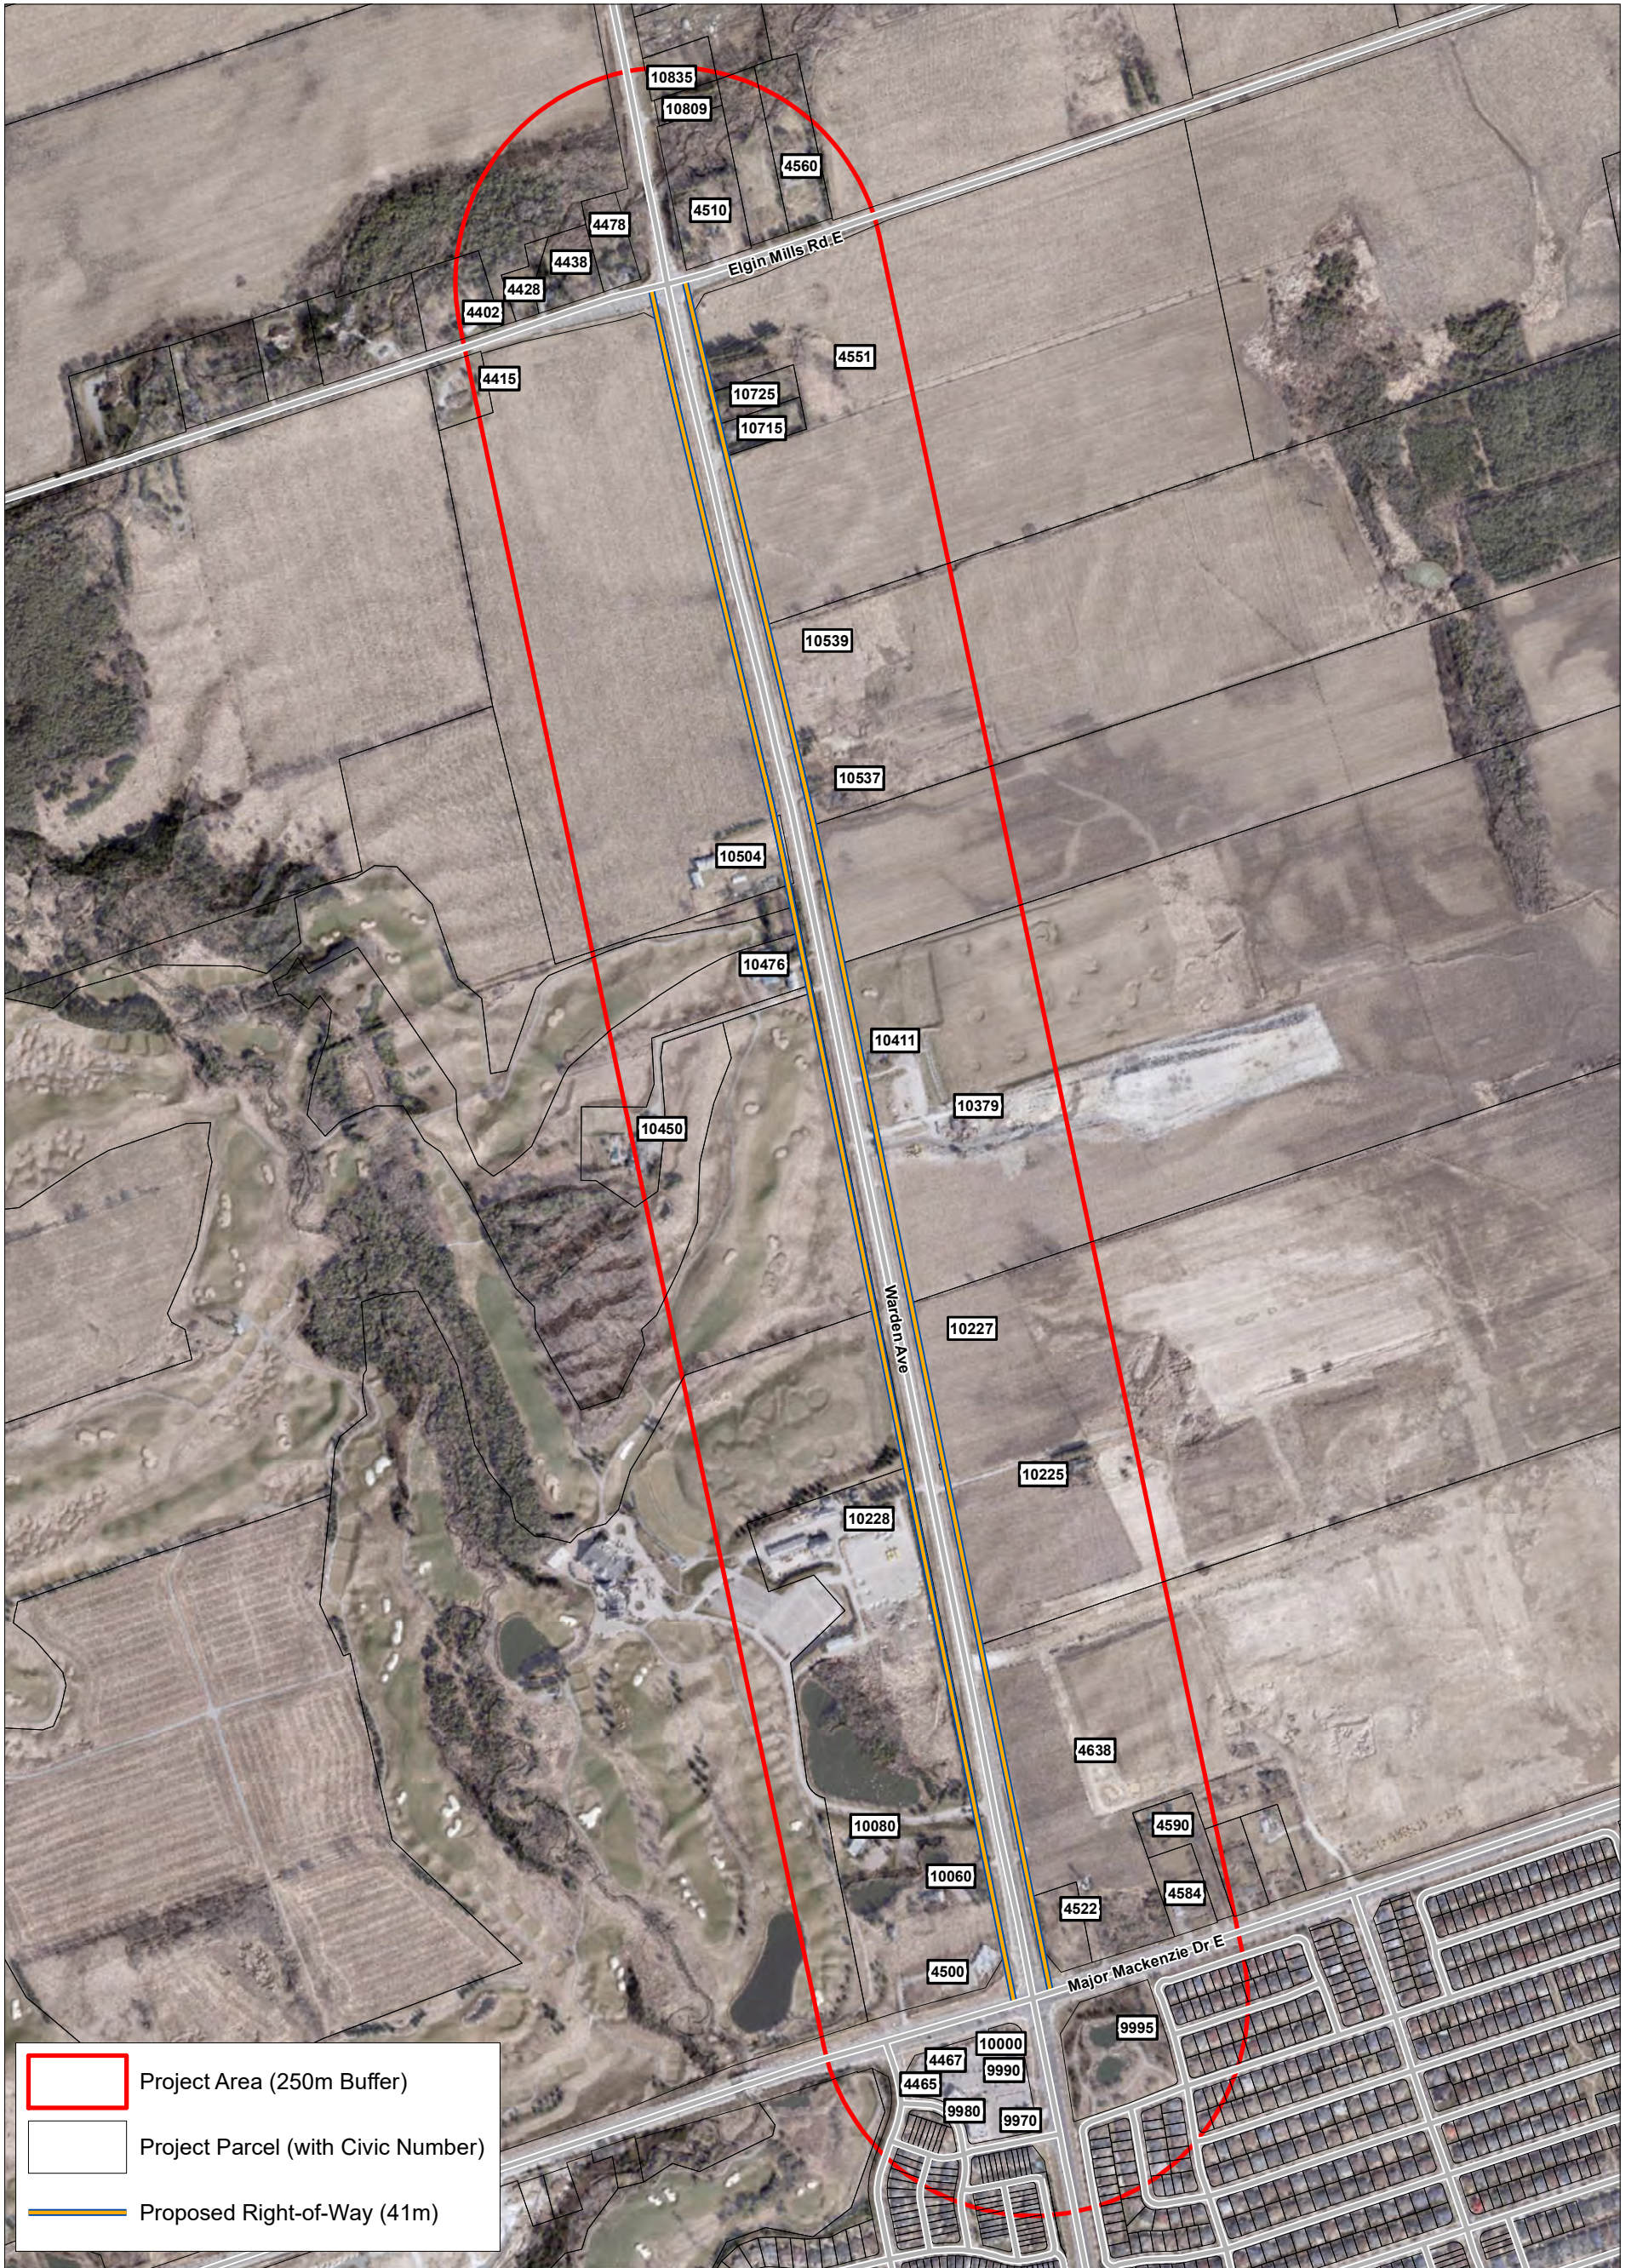
Drawn	Checked	Date	Figure No. 2
SK	KL	2023/01/04	
Scale	Project No.		
H 1:7,500			300052314

Map Title
**CONTAMINATION OVERVIEW
 STUDY**
 PARCELS WITHIN STUDY AREA
 (KENNEDY RD.)
